April 2013

Dealer Service Instructions for:

Customer Satisfaction Notification N06 Instrument and Door Panel Applique Delamination

2012 (WK) Jeep® Grand Cherokee SRT8

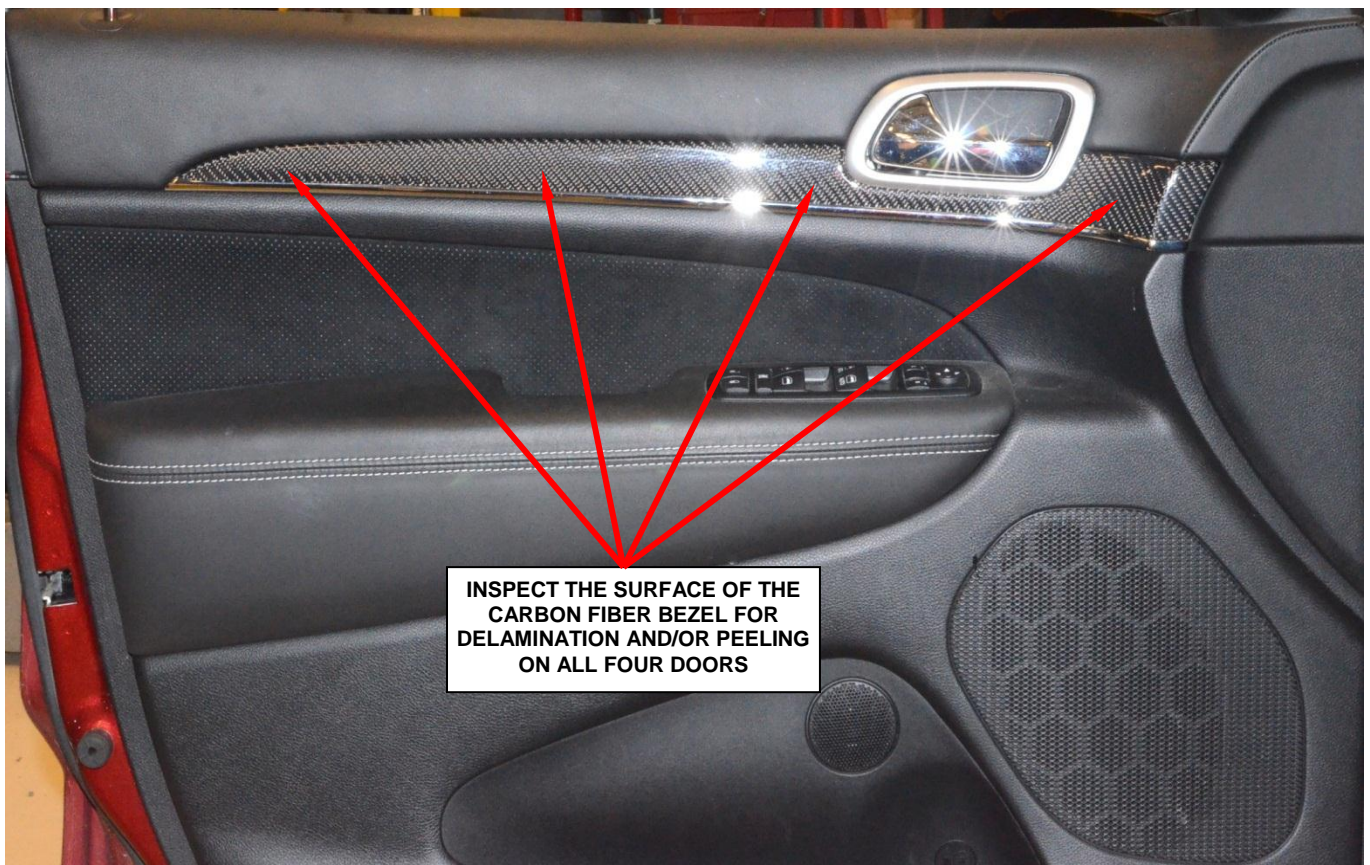
Figure 13 – Inspect All Door Trim Panel Carbon Fiber Bezels (left front door shown)

Inspect the carbon fiber bezels on all four doors (Figure 13):

- If **none** of the carbon fiber bezels on the door panels are delaminated or peeling, connect the negative battery cable to the battery and return the vehicle to the customer.
- If there is any delamination or peeling of the carbon fiber on **only the front door bezel(s)**, continue with **Section C. Replace Front Door Carbon Fiber Bezel(s)**.
- If there is any delamination or peeling of the carbon fiber on **only the rear door bezel(s)**, continue with **Section D. Replace Rear Door Carbon Fiber Bezel(s)**.
- If there is any delamination or peeling of the carbon fiber on the **front and rear door bezel(s)**, continue with **Section C. Replace Front Door Carbon Fiber Bezel(s)**.
