Third Revision December 2013

Dealer Service Instructions for:

## **Safety Recall N58 / NHTSA 13V-483 Reprogram Instrument Cluster & ABS Module / Alternator Ground Wire**

**2014 (WK) Jeep® Grand Cherokee**

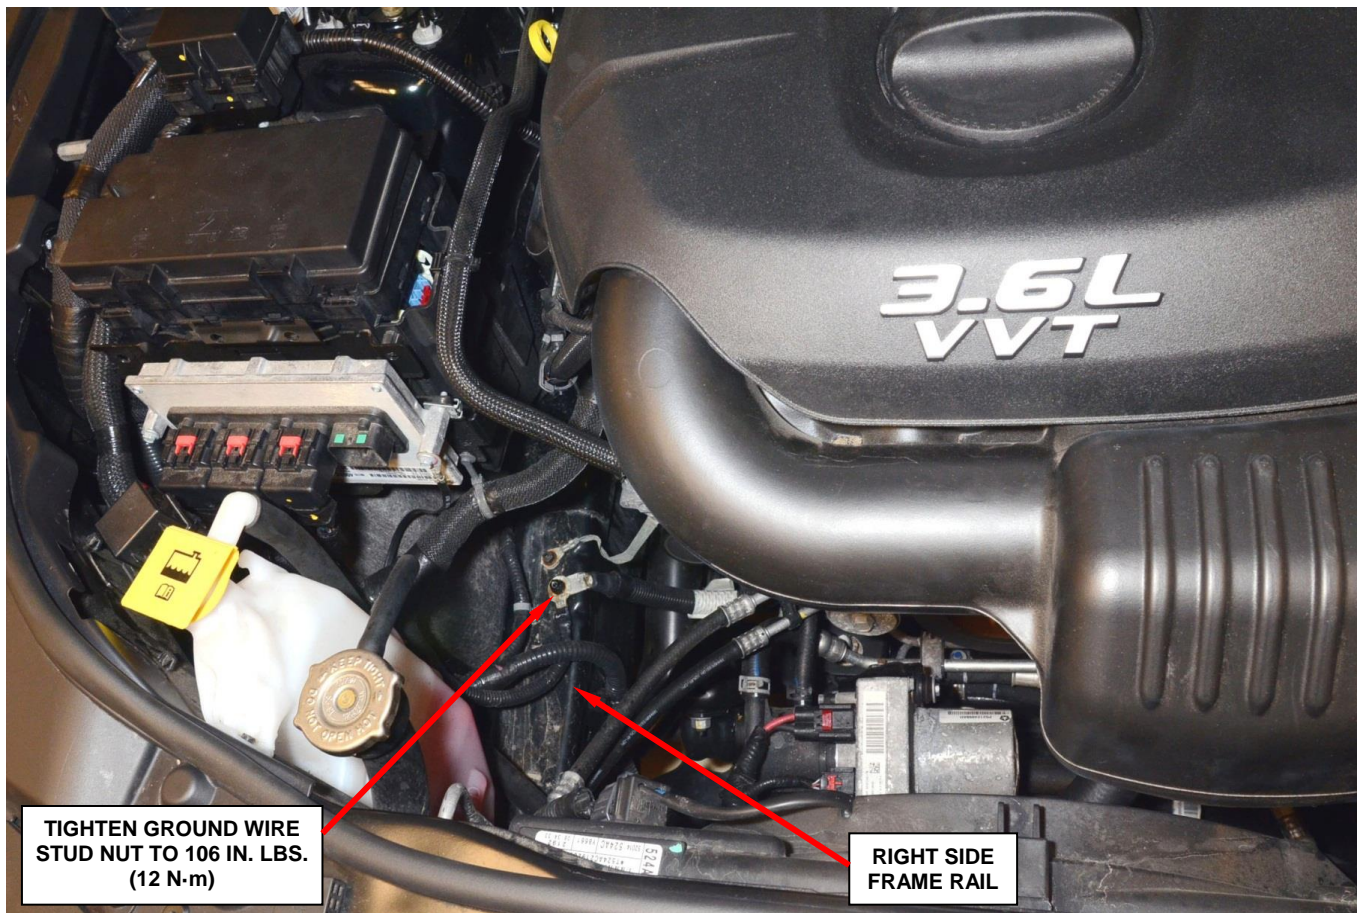
**Figure 1 – Alternator Ground Wire Location**

The instrument cluster on about 90,900 of the above vehicles may experience cluster blackout, illumination of multiple cluster warning lights and/or a loss of anti-lock brake system (ABS) / electronic stability control system function. These vehicles fail to conform to the requirements of Federal Motor Vehicle Safety Standard (FMVSS) No. 101 – Controls and Displays and No. 126 – Electronic Stability Control Systems. A loss of instrument cluster illumination and/or loss of ABS function during certain driving conditions could cause a crash without warning.

1. Open the hood.
2. Locate the ground wire stud nut on top of the right frame rail (Figure 1).
3. Using a torque wrench and 10 mm socket, tighten the ground wire stud nut to 106 in. lbs. (12 N·m).
4. Continue with **Section B. – Reprogram Instrument Cluster & ABS Module.**
