# **Safety Recall P36 / NHTSA 14V-391**

## **Sun Visor Wiring**

**2011 – 2014 (WD) Dodge Durango**

**(WK) Jeep® Grand Cherokee**

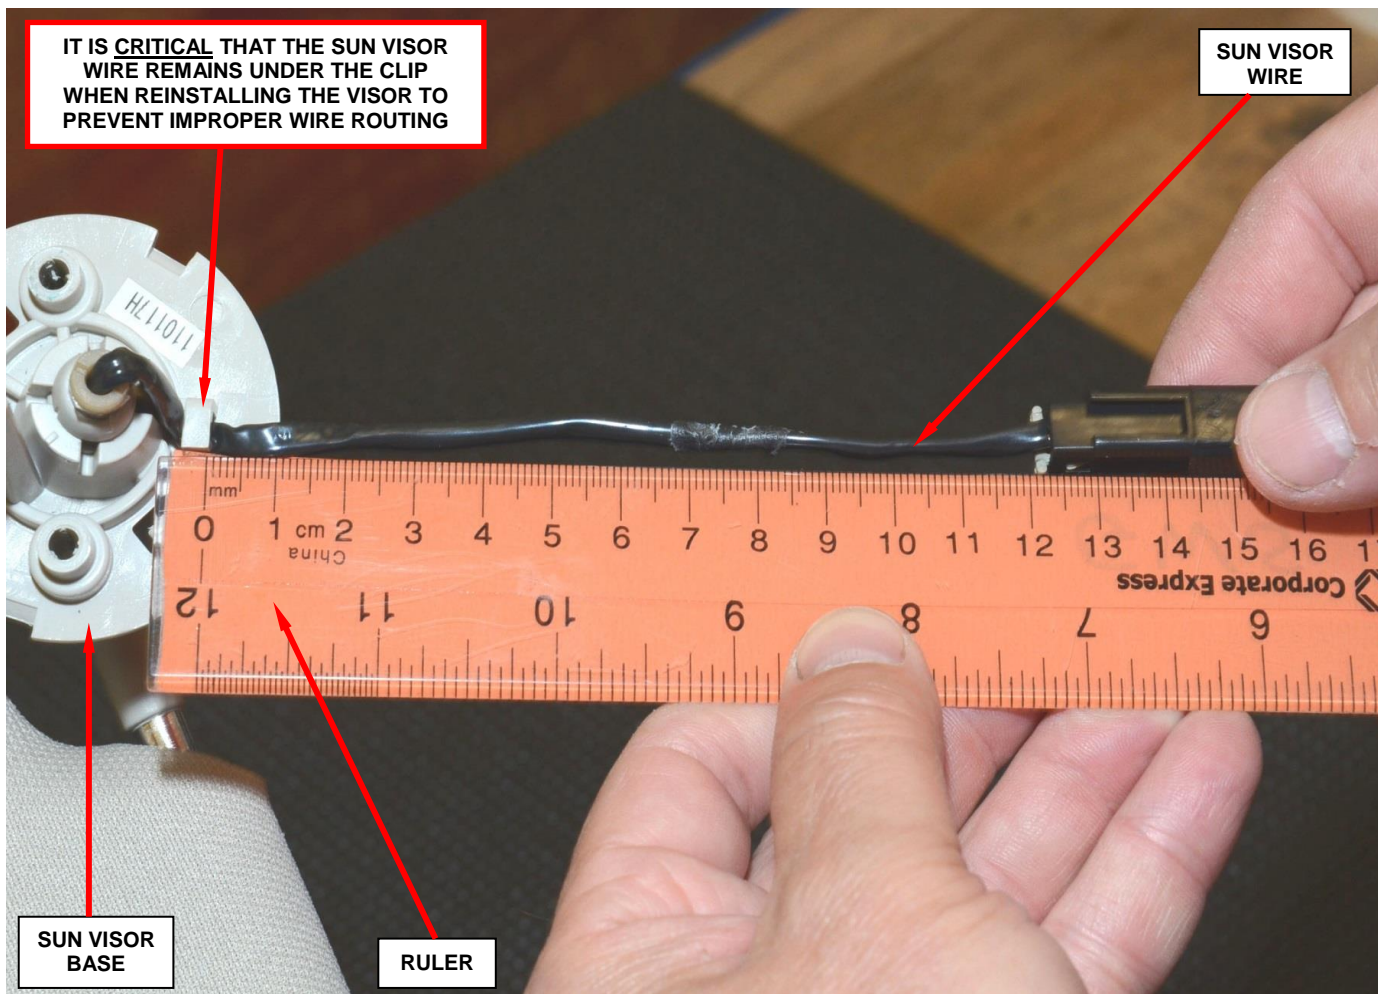
**Figure 20 – Measure Wire Length**

**NOTE:** The majority of the vehicles built before September 01, 2012 will have a 4 <sup>3</sup>/<sub>4</sub> inch (120 mm) long sun visor wire. The majority of the vehicles built after September 01, 2012 will have a 2 <sup>3</sup>/<sub>4</sub> inch (70 mm) long sun visor wire.

36. Remove and discard the original right and left side sun visor wire guides.
37. Measure the length of the sun visor wire to determine the correct wire routing (Figure 20).

**CAUTION:** It is critical that the sun visor wire remains under the clip shown in Figure 20 when reinstalling the visor to prevent improper wire routing.
