Dealer Service Instructions for:

Safety Recall R71 / NHTSA 15V-879

Sun Visor Wiring

2011 – 2012 (WD) Dodge Durango

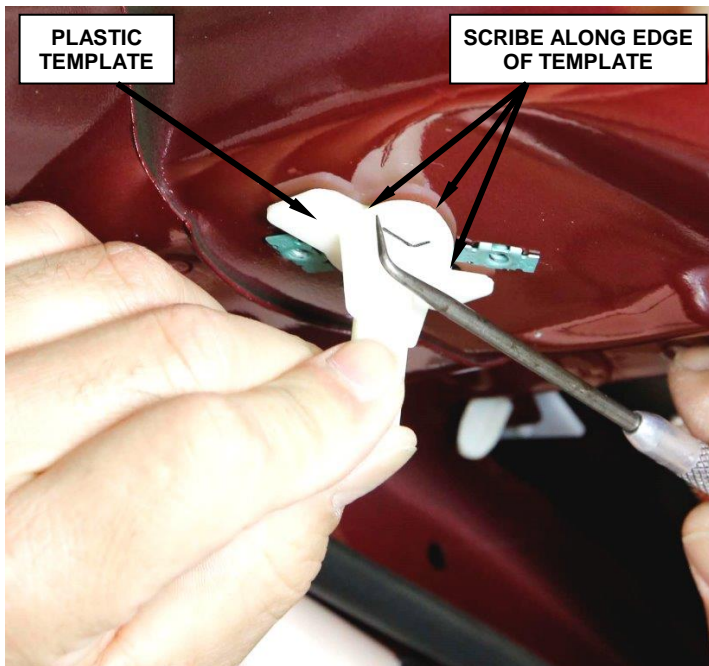
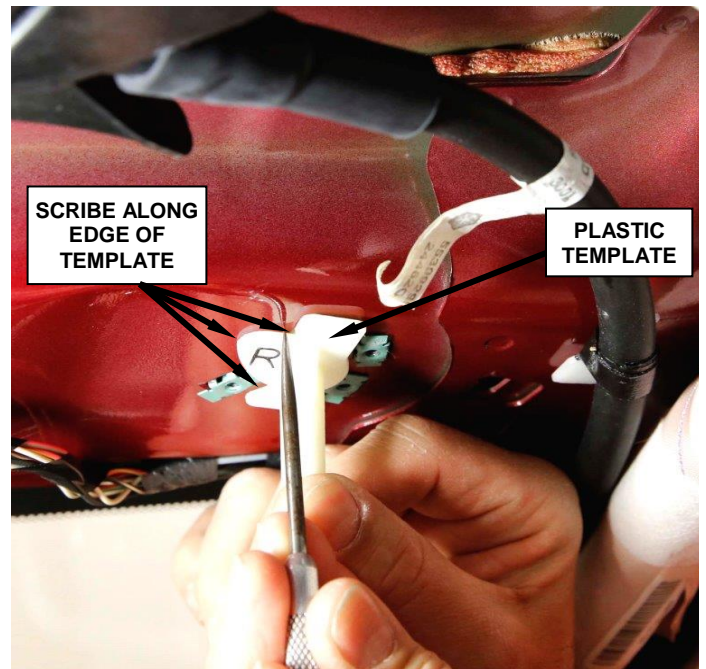
Figure 12 – Install Template and Scribe Cut Line

31. Hold the plastic template marked “L” into the left visor hole opening in the roof panel and scribe a line on the sheet metal (Figure 12).
32. Remove and save the left template. Verify that the scribe mark is visible (Figure 13).
33. Hold the plastic template marked “R” into the right visor hole opening in the roof panel and scribe a line on the sheet metal (Figure 12).
34. Remove and save the right template. Verify that the scribe mark is visible (Figure 13).

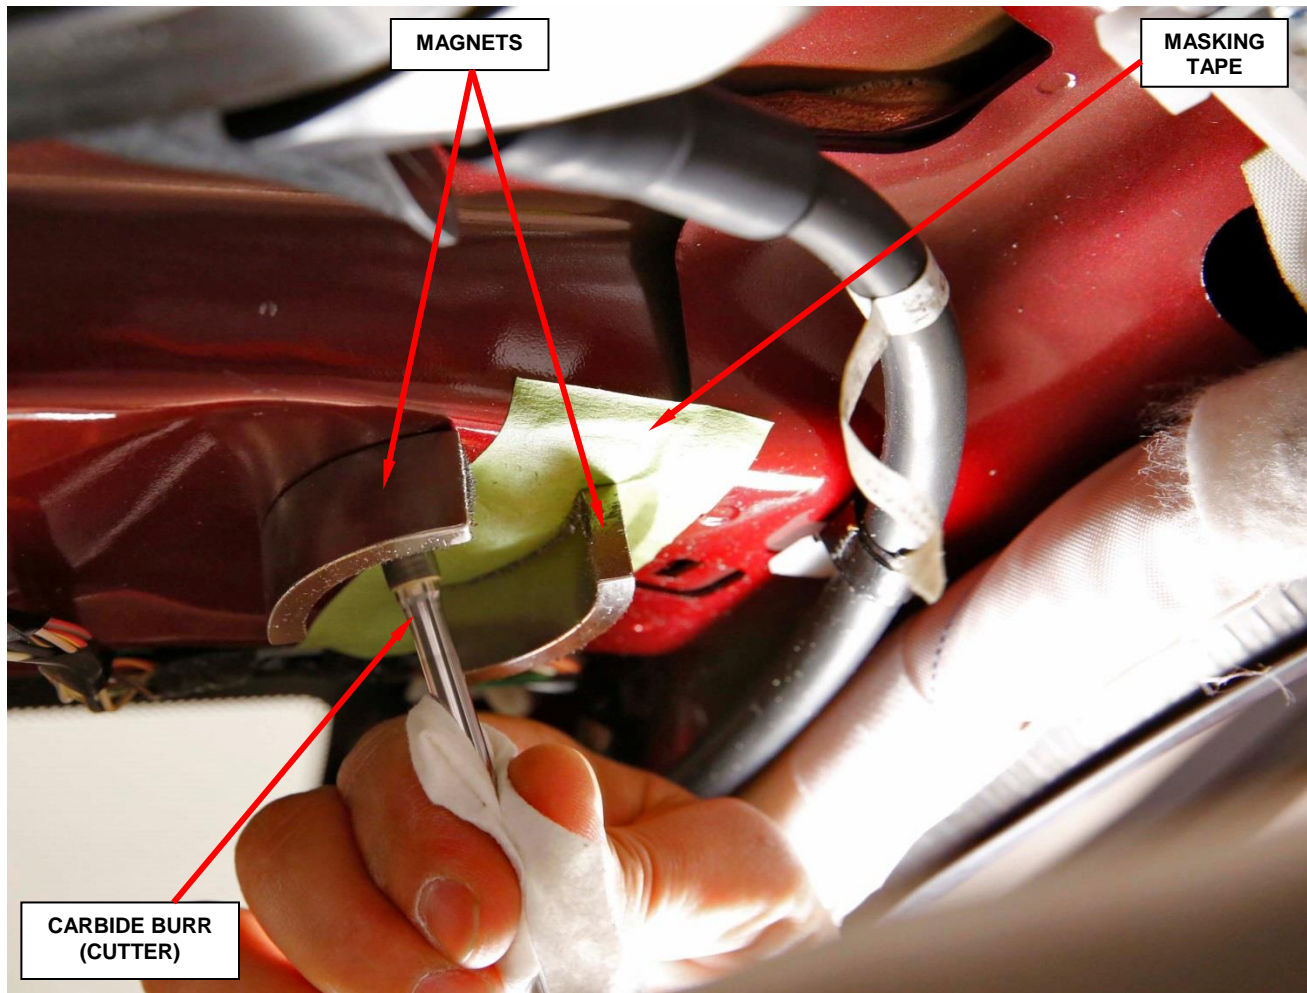
Figure 16 – Grind Away Sheet Metal Inside Scribe Mark (right side shown)

38. Using the supplied carbide burr and a die grinder, grind a relief in the left visor hole opening (Figure 16).

CAUTION: Do not grind beyond the scribe marks made in Steps 31 and 33.

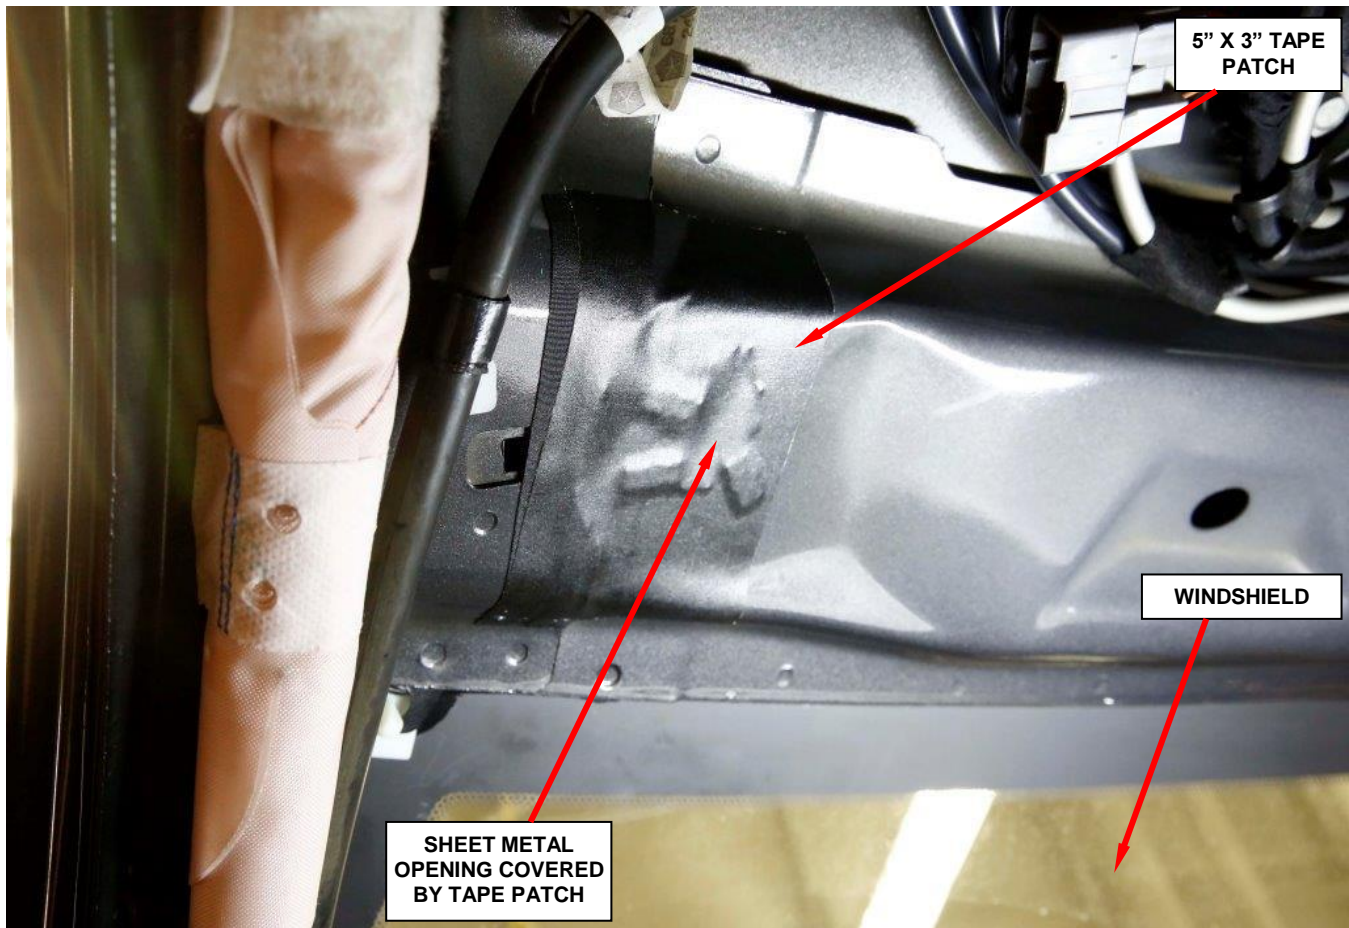
Figure 21 – Apply 5"x 3" Tape Patch over the Abrasion Tape (left side shown)

47. Apply one piece of (5"x 3") tape patch over the tape applied in Step 46 (Figure 21).

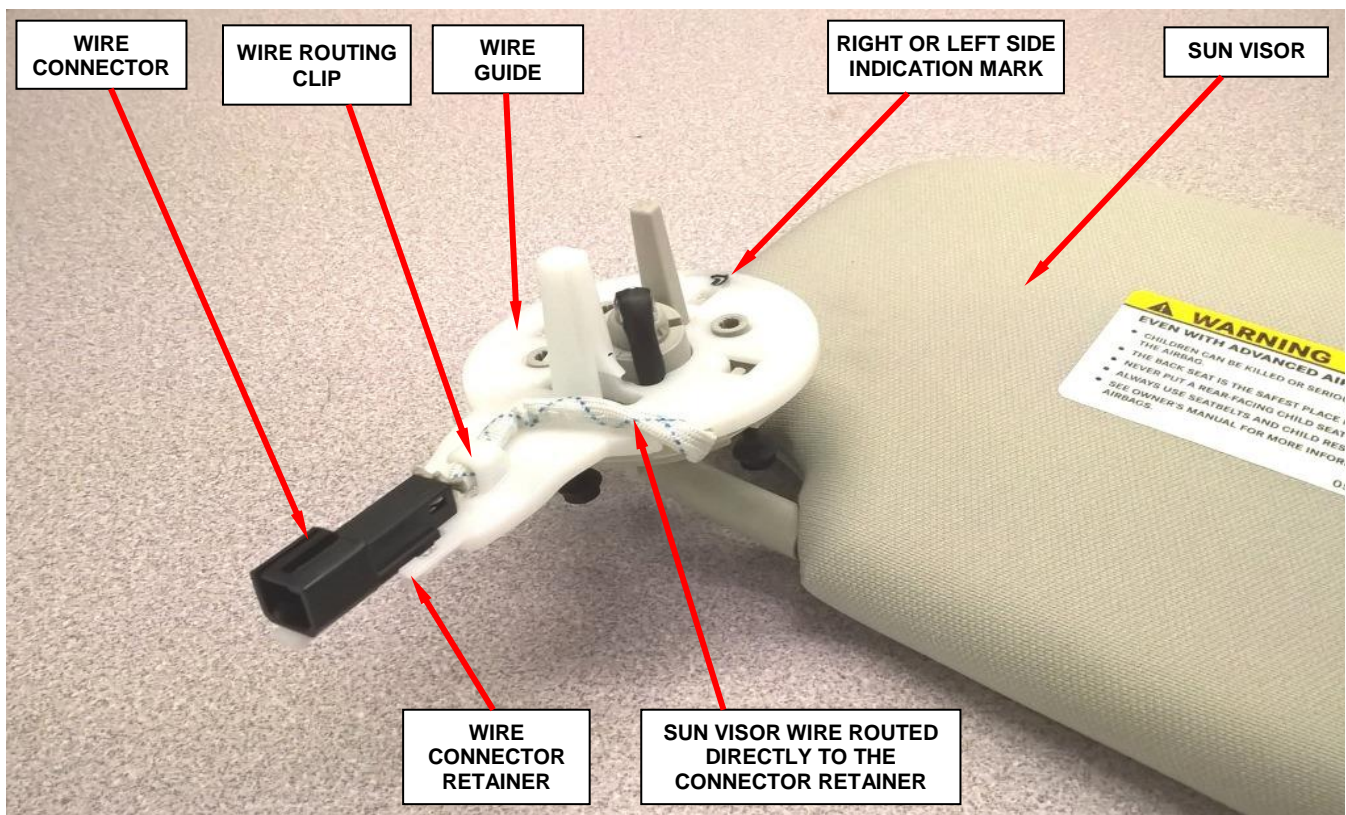
Figure 28 - Sun Visor Wire Routing
(Parts removed from vehicle for photographic purposes only)

56. Route the sun visor wire as shown in Figure 28. Then connect the sun visor wire harness electrical connector to the wire guide connector retainer.

CAUTION: Be sure to route the sun visor wire in the wire groove on the plastic wire guide (Figure 28).

CAUTION: It is critical that the sun visor wire remains under the wire routing clip shown in Figure 28 when reinstalling the visor to prevent improper wire routing.
