NUMBER: 02-005-10

GROUP: Front Suspension

Squeaking Noise From Front Of The Vehicle When Driving

2011 WK Grand Cherokee

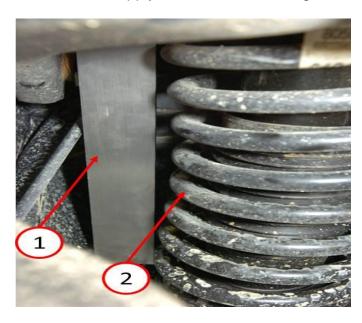
Fig. 1 Coil Spring Bowing

- 1. Raise the vehicle on a 2 point chassis hoist. Refer to the detailed service procedures available in DealerCONNECT> TechCONNECT under: Service Info> 04- Vehicle Quick Reference> Hoisting> Standard Procedure> Hoisting
- 2. Inspect the front right and left coil spring for the correct orientation using a straight edge and place it against the furthest outboard upper and lower coil on the spring as shown in (Fig. 1). Did the spring appear to be bowing?
 - a. Yes>>> Proceed to Step #3.
 - b. No>>> This bulletin does not apply, continue further diagnosis.

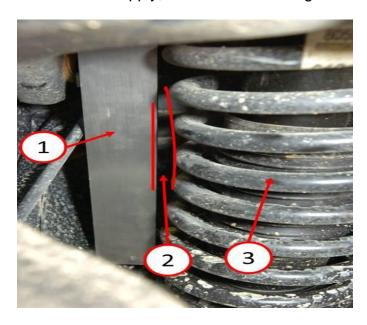
Fig. 2 Coil Spring

- 3. Using a 7mm (17/64") drill bit insert it between the straight edge and the inner most bowed area of the spring(Fig. 2). Did the drill bit fit between the spring and the straight edge?
 - a. Yes>>> Proceed to Step #4
 - b. No>>> This bulletin does not apply, continue further diagnosis.

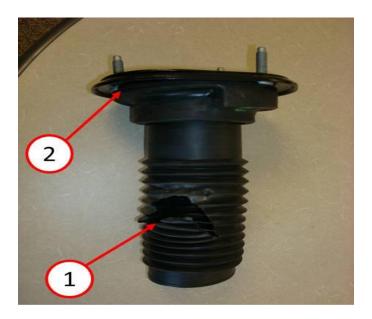
Fig. 3 Dust Boot Shield

- 4. Was the shock absorber dust boot shield torn and/or damaged (Fig. 3)?
 - a. Yes>>> Replace when installing new front coil spring.
 - b. No>>> Proceed to Step #5.
