NUMBER: 03-001-16 REV. A

GROUP: Differential &
Driveline

Replace Left Front Axle Half Shaft

2015 - 2016	(WK)	Jeep Grand Cherokee
2015 - 2016	(WD)	Dodge Durango

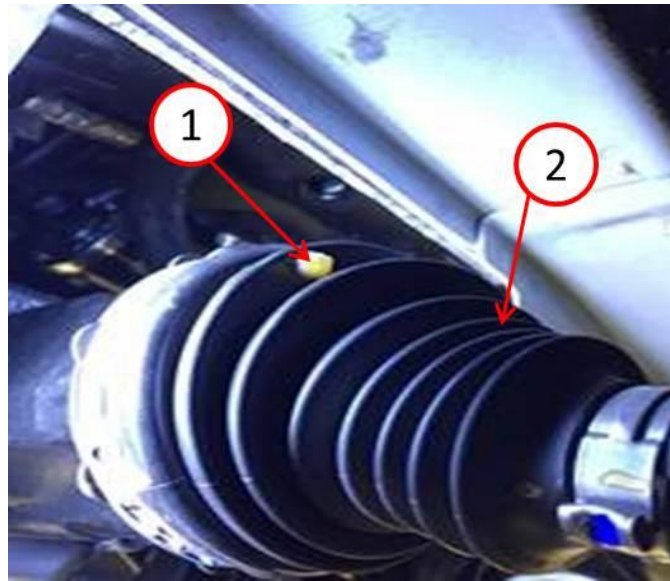
Fig. 1 Half Shaft Boot Leak

The customer or technician may find grease leaking out of the left front axle half shaft inner boot (Fig. 1).

1 - Grease Leaking

2 - Half Shaft Boot

1. Is grease leaking from the left front axle half shaft inner boot?
 - a. YES>>> Proceed to [Step #2](#).
 - b. NO>>> This bulletin has been completed, use LOP (02-13-05-9C) to close the active RRT.
2. Replace the left front axle half shaft. Refer to the detailed service procedures available in DealerCONNECT> TechCONNECT under: Service Info> 03 - Differential and Driveline/Half Shaft, Front/Removal/Installation.
