NUMBER: 08-003-14 REV. A

Integrated Center Stack Missing Buttons

This bulletin involves replacing the integrated center stack (ICS) bezel.

2014 (WK) Jeep Grand Cherokee

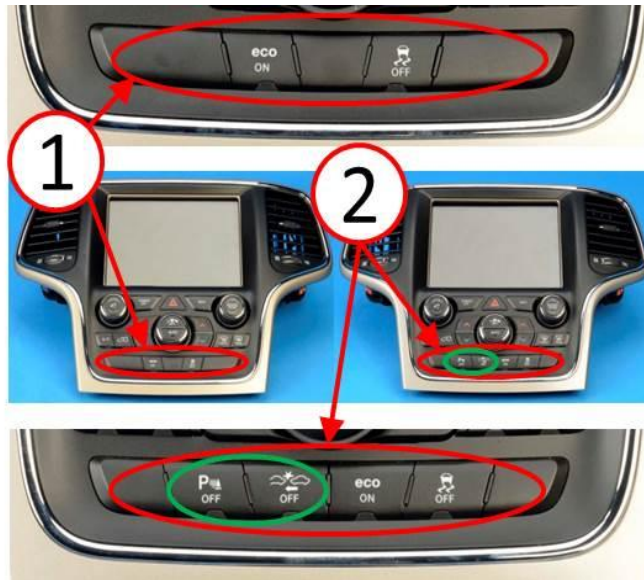
Fig. 1 ICS Button Content Inspection

Summit Edition (sales code AAU) vehicles built with incorrect ICS, missing buttons for Front & Rear Park Assist (sales code XAG) and Forward Collision Warning (sales code LSR).

- 1 - Buttons Missing - Replace ICS
- 2 - Buttons Present - Correct ICS

1. Inspect the ICS button content for the Front & Rear Park Assist and Forward Collision Warning buttons (Fig. 1).
 - a. Buttons missing, only two buttons in lower row (1) >>> Proceed with Repair Procedure.
 - b. Buttons present, four buttons in lower row (2) >>> Repair Procedure does not apply, return vehicle to customer.

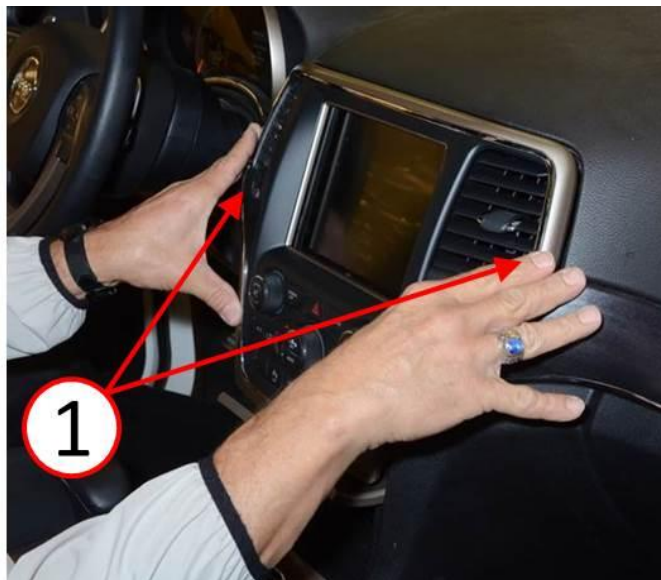
Fig. 14 ICS Bezel Installation

1 - Plastic Injection Molding Flash Bump

19. Using both hands firmly push on the perimeter of the ICS bezel to fully engage the attachment clips (Fig. 14).

NOTE: Verify that no damage has been done to wood appliques.
