DATE: January 19, 2017

Incorrect Stop Lamp Sensor Installed

This bulletin involves replacement of the stop lamp sensor.

2017	(WD)	Dodge Durango
2017	(WK)	Jeep Grand Cherokee

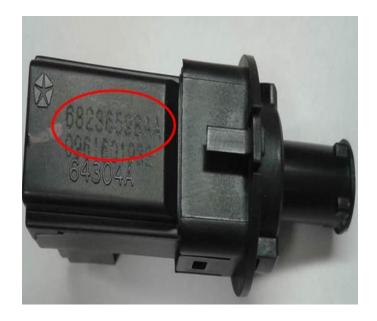
Fig. 2 Incorrect Part Number

NOTE: The two stop lamp sensors visually look identical except for the part number stamped on them. Incorrect Mopar P/N is 68236598AA (Fig. 2), the correct Mopar P/N is 68078700AE (Fig. 3).

- 1. Disconnect and isolate the battery negative cable.
- 2. Remove the push pins for the silencer pad from below the steering column and disconnect the electrical connector for the light from the pad.
- 3. Locate the stop lamp sensor on the brake pedal support bracket under the instrument panel.
- 4. Disconnect the electrical wire harness connector from the sensor.
- 5. Remove the sensor by turning it counter clockwise 1/4 turn from the brake pedal support bracket.
- 6. Discard the old sensor P/N is 68236598AA (do not reuse).
