Vehicle No Crank, Vehicle Appears To Have A Dead Battery

2011	(WK)	Grand Cherokee
2011	(WD)	Durango

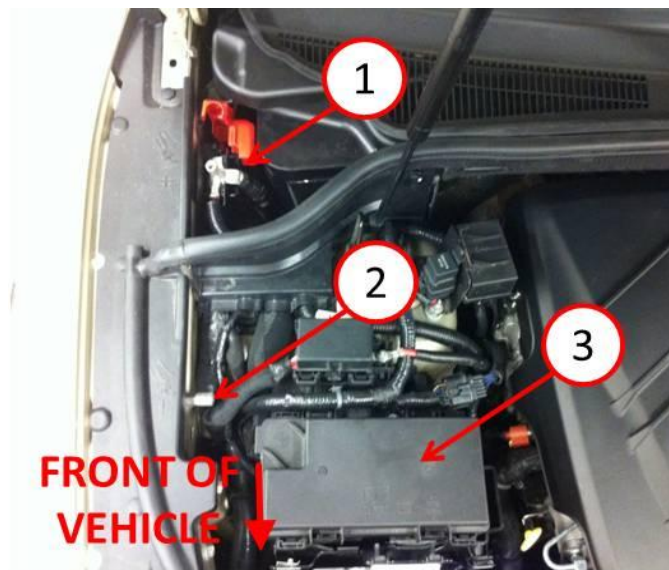
Fig. 1 Jumper Post Locations

The battery jumper posts must be used when jump starting the vehicle in order to avoid damage to the vehicles 150 Amp TIPM Battery Feed Fuse. Jumper post locations are shown in (Fig. 1).

- 1 - Battery (+) Jumper Post
- 2 - Battery (-) Jumper Post
- 3 - TIPM

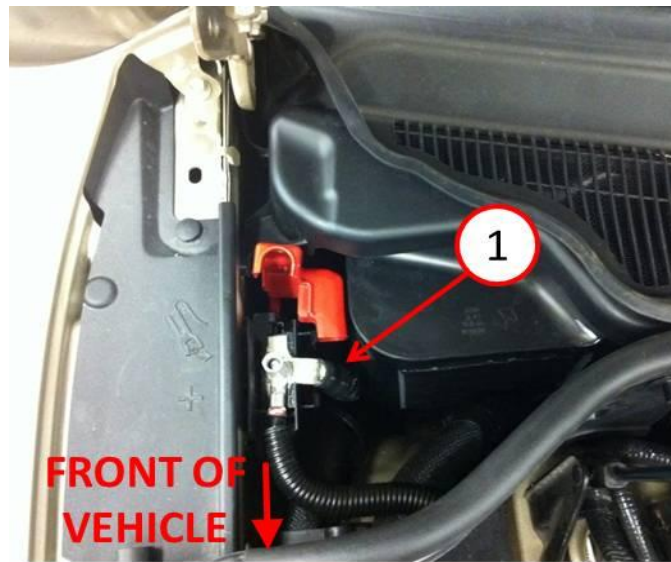
Fig. 2 Battery Positive Jumper Post

The vehicles 150 Amp TIPM Battery Feed Fuse is located under the Battery (+) Jumper Post Cover (Fig. 2). The fuse can be blown during attempts to jump start the vehicle when the positive jumper cable is connected to the TIPM Battery (+) Terminal (Fig. 3) instead of the Battery (+) Jumper Post.

1 - Battery (+) Jumper Post with the cover removed

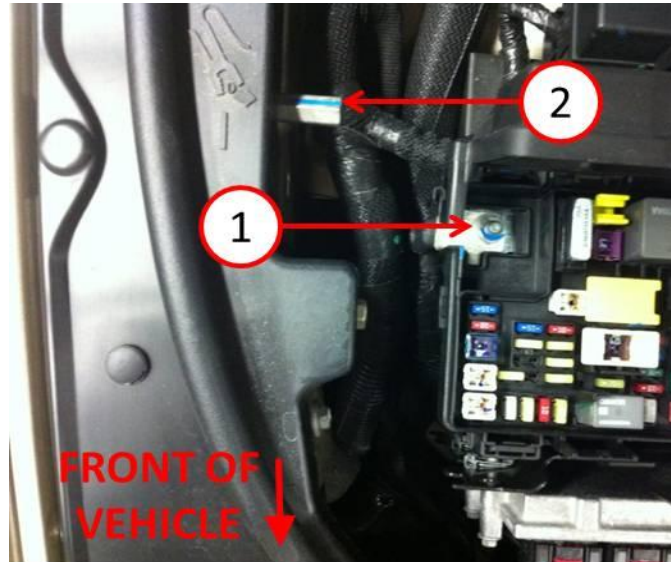
Fig. 3 TIPM Power Feed

When servicing the TIPM, the battery must first be disconnected. Contact between the Battery (-) Jumper Post and the TIPM Battery (+) Terminal (Fig. 3), without the battery being disconnected, may cause damage to the vehicles 150 Amp TIPM Battery Feed Fuse. The vehicles 150 Amp TIPM Battery Feed Fuse is located under the Battery (+) jumper cover (Fig. 2).

- 1 - TIPM Battery (+) Terminal
- 2 - Battery (-) Jumper Post
