NUMBER:	08-025-17
GROUP:	Electrical

Headlamp Condensation And Fogging

This bulletin involves installing updated vent caps on the headlamp housing.

Jeep Grand Cherokee

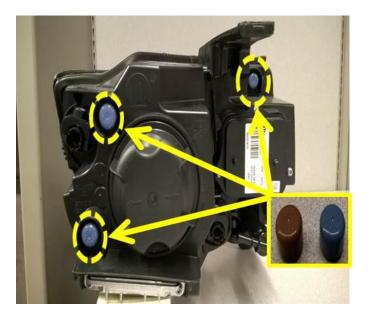
Fig. 3 Location Of Headlamp Vents

Blue vent caps are the old style. Updated vent caps are brown in color.

- 2. Remove the 3 blue vent caps by sliding them rearward from the headlamp assembly, see (Fig. 3).
- 3. Install the new (brown) vent caps by pressing them on the bosses of the housing.
