NUMBER: 08-028-13

RA2 Paired Phone List Is Deleted After Ignition Cycle

This bulletin involves upgrading the software on the RA2 Radio.

2014 (WK) Grand Cherokee

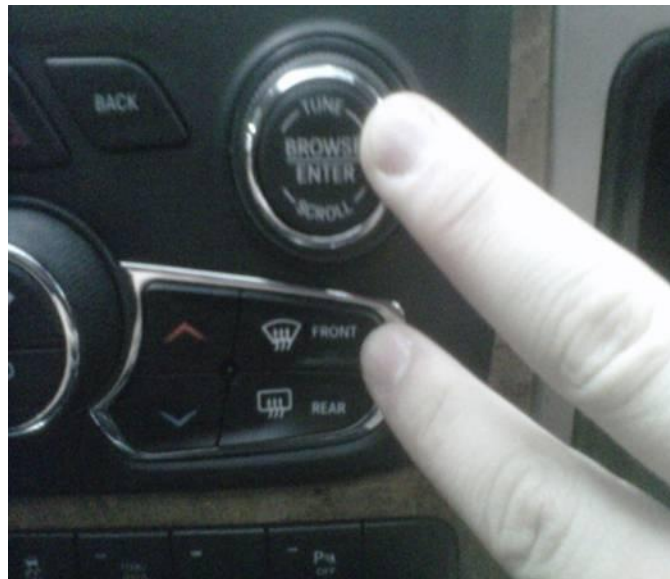
Fig. 1 Take Vehicle Out Of Ship Mode

1 - Press and hold these buttons, to put the vehicle in and out of ship mode.

3. Turn the engine on and check if the vehicle is still in ship mode. This will be displayed in the Electronic Vehicle Information Center (EVIC).
4. The vehicle must be in Customer Mode to update the radio. Is the vehicle in Ship Mode?
 - a. Yes >>> Proceed to [Step #5](#)
 - b. No >>> Proceed to [Step #6](#)
5. Press and hold the 'Enter/Browse' button and the 'Front Defrost' (about 5 seconds) until "Ship Mode" is no longer displayed on the instrument cluster, see ([Fig. 1](#)).
