NUMBER: 08-028-17 REV. B

GROUP: 08 - Electrical

DATE: September 8, 2017

RA3 and RA4 Radio Over The Air Software Updates

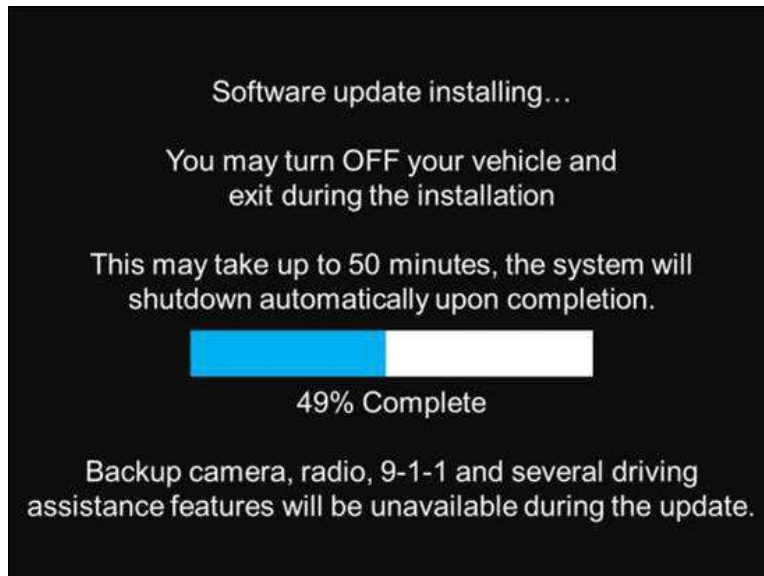
Fig. 4
Second Phase

NOTE: The second phase screen will show the completion bar go to 49% quickly and will then stay at that percentage for a longer period of time. The install is not broken/ frozen.

4. Once the update has reached the second phase, the message on the touchscreen will tell you that you may turn off the vehicle, exit and let the process complete on its own (Fig. 4) .

NOTE: The second phase may take up to 50 minutes to complete.
