NUMBER: 08-035-17

3.6L Engine Wiring Harness Retainer Clip Replacement

2016 - 2017	(WD)	Dodge Durango
2016 - 2017	(WK)	Jeep Grand Cherokee

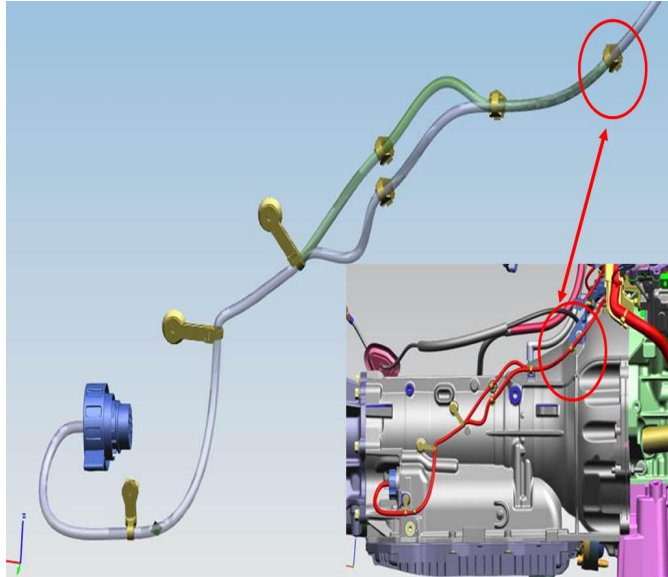
Fig. 1 Retainer To Be Replaced

1. Lift and support the vehicle. Refer to the detailed service procedures available in DealerCONNECT> TechCONNECT under: Service Info> 04 - Vehicle Quick Reference> Hoisting> Standard Procedure.
2. Remove the forward retainer clip (Fig. 1) and (Fig. 2).

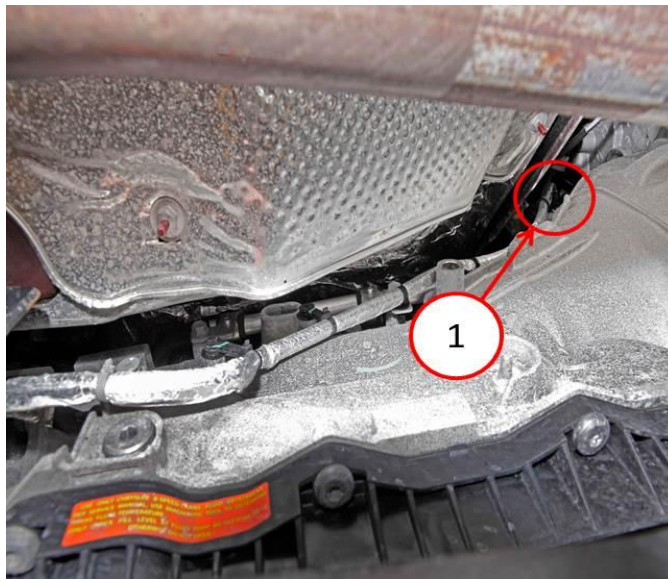
1 - Location of Wiring Harness Retainer Clip

Fig. 2 TCM Wiring Harness

3. Inspect wiring harness for wear from chaffing from contact with heat shield.
4. Is there any wiring damage found?
 - a. YES>>> Repair the damaged wiring. Refer to the detailed service procedures available in DealerCONNECT> TechCONNECT under: Service Info 29 - Non-DTC Diagnostics/Circuit Testing Procedures/Standard Procedure. Continue with [Step #5](#).
 - b. NO>>> Continue with the Repair Procedure [Step #5](#).
5. Replace the retainer clip with new part (P/N is 68078700AE). Place the new clip 108 mm (4.25 in.) from split ([Fig. 3](#)).

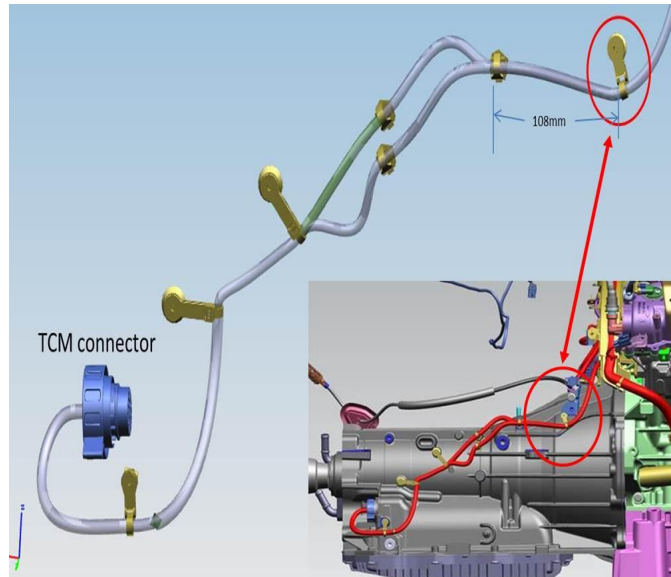
Fig. 3 Retainer After Replacement
