NUMBER: 08-041-15

Front Heated Seats Improvements

This bulletin involves updating the Heated Seat Module (HSM) and replacing both front cushion, heater elements.

2013-2015	(WK)	Jeep Grand Cherokee
2013-2015	(WD)	Dodge Durango

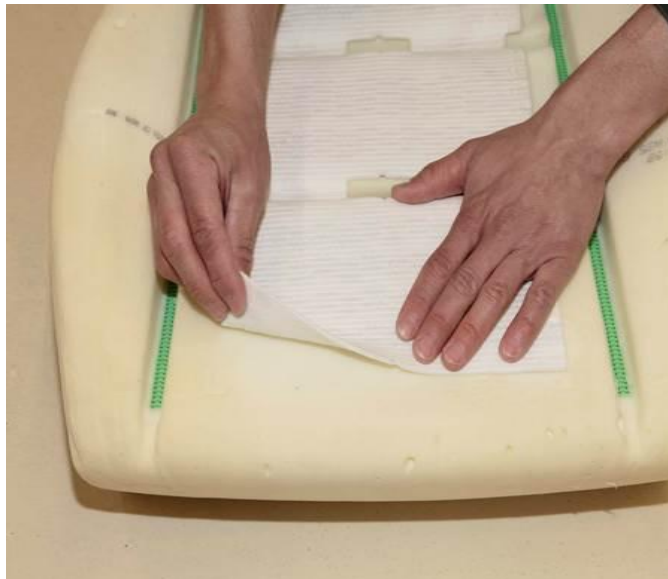
Fig. 1 Remove Heater Element

CAUTION: Be very careful when pulling the old heating element off the cushions, so not to damage the foam cushion.

2. Replace both front heated seat elements on the cushions. Follow procedure in TechConnect, 08 - Electrical/8G - Heated/Cooled Systems/Heated Seats/PAD, Heater/Removal/Installation.

Slowly peel off one section at a time.

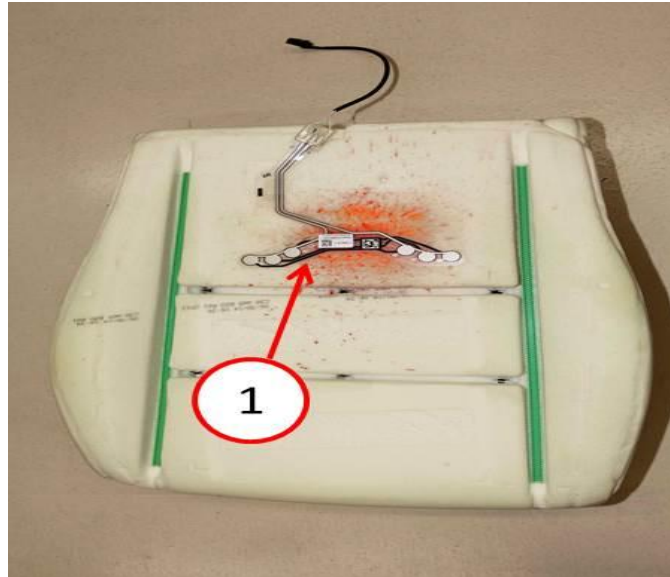
Fig. 2 Occupant Detection Sensor (ODS)

NOTE: On some vehicles the Occupant Detection Sensor (ODS) is part of the passenger seat cushion and shouldn't need to be replaced.

1 - Location of ODS

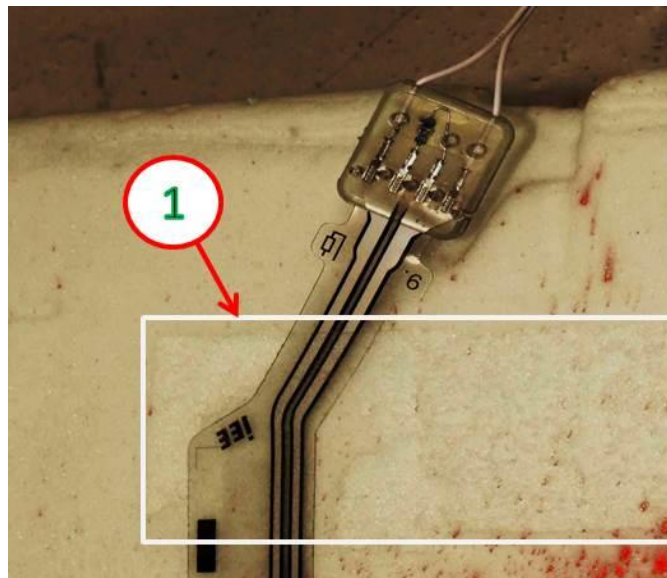
Fig. 3 Heater Element Adhesion Area

1 - Element is adhered to the sensor/cushion in this area. Hold ODS when peeling off element.
