NUMBER: 08-043-18

Transmission Control Module (TCM) Harness Damaged from Heat Shield

2015 - 2017 (WK) Jeep Grand Cherokee

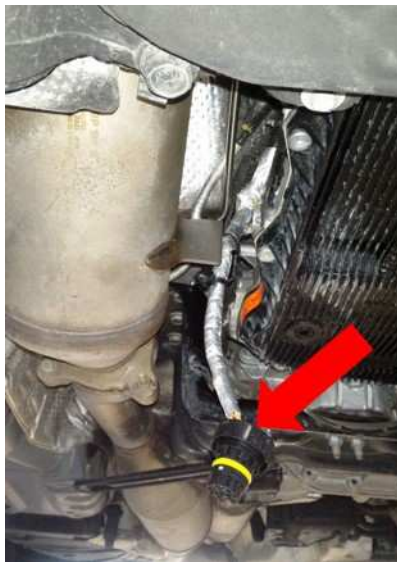
Fig. 1

TCM Wiring Harness - Disconnected

1. Raise and support the vehicle. Refer to the detailed service procedures available in DealerCONNECT> TechCONNECT under: Service Info> 04 - Vehicle Quick Reference> Hoisting> Standard Procedure.
2. Remove the transmission skid plate. Refer to the detailed service procedures available in DealerCONNECT> TechCONNECT under: Service Info>13 - Frame and Bumpers/Under Body Protection/Plate, Skid, Transmission/Removal.
3. Support the transmission with a suitable jack.
4. Remove the two transmission crossmember mount nuts.
5. Remove the six transmission crossmember bolts.
6. Remove the transmission crossmember.
7. Remove the TCM connector from the rear of the transmission assembly (Fig. 1) .

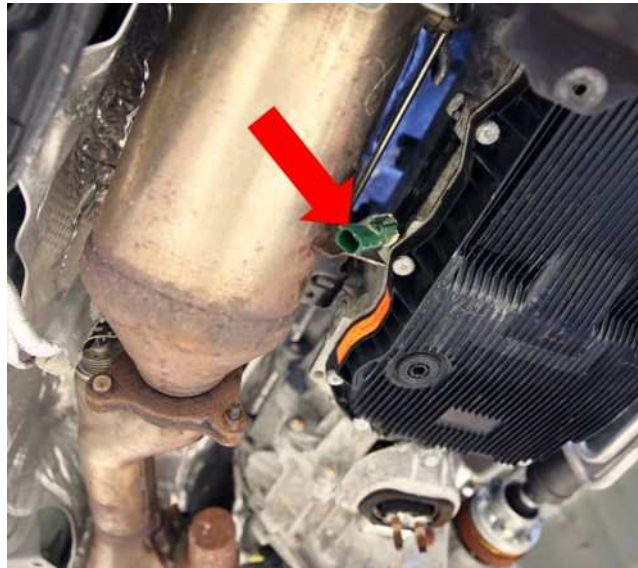
Fig. 2
Green EGT Connector

8. Disconnect the green Diesel Particulate Filter (DPF) Exhaust Gas Temperature (EGT) sensor connector (Fig. 2) .

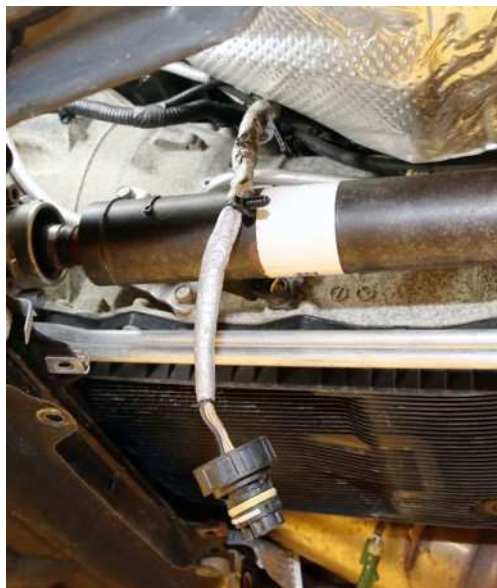
Fig. 3
TCM Wiring Harness On Left Side Of Transmission

9. Disconnect the TCM wiring harness from two fasteners.
10. Reposition the TCM wiring harness up and over the transmission assembly to the left side of the vehicle in order to allow adequate room to perform the repair (Fig. 3) .

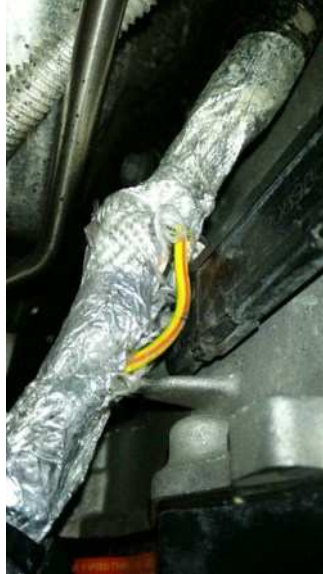
Fig. 4
TCM Wiring Harness Damage

11. Is the TCM wiring harness damaged from contact with the heat shield (Fig. 4) ?
- YES>>> Repair the wiring harness. Refer to the detailed service procedures available in DealerCONNECT> TechCONNECT under: Service Info>29 - Non-DTC Diagnostics/Circuit Testing Procedures/Standard Procedure. Then proceed to [Step 12](#).
 - NO>>> Proceed to [Step 12](#).

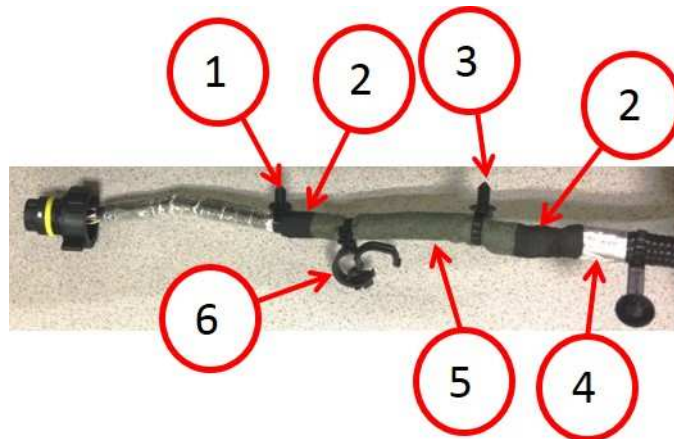
Fig. 5
TCM Wiring Harness Final Assembly

- 1 - Do Not Cover This Fastener With Reflective Tape
- 2 - Ends To Wrap With Reflective Tape
- 3 - #20098 Fastener To Cut Off And Discard - (If Equipped)
- 4 - End Of Loom
- 5 - Twist Tube
- 6 - C-Clip To Remove And Save

12. Remove and discard fastener #20098 (If Equipped) (Fig. 5) .

13. Cut the C-clip zip tie that holds the C-clip to the wiring harness (Fig. 5) . Save the C-clip to re-use.
14. Starting from where the wire loom ends, slide the Twist Tube over the original reflective tape on the wiring harness (Fig. 5) .

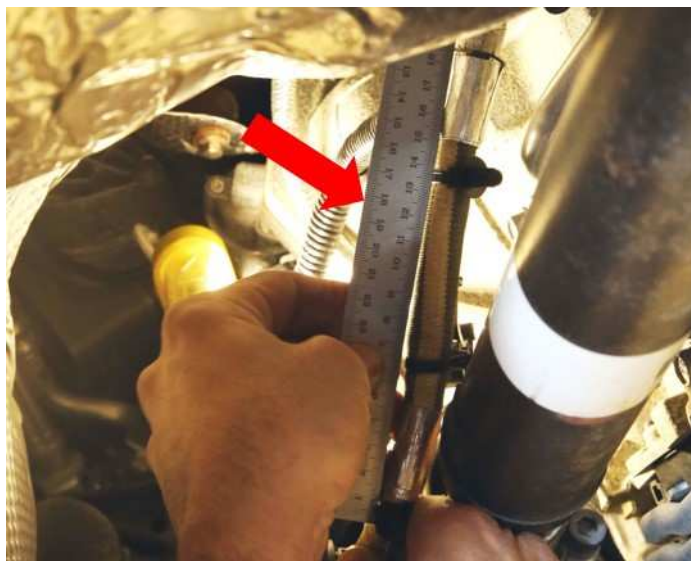
Fig. 6
Spacing For Fasteners

15. Install the C-clip from [Step 13](#), 80 mm (3.1 in.) from the fastener closest to the wiring harness connector with a new zip tie on the wiring harness ([Fig. 6](#)) . Make sure the C-clip is positioned 90° from the other two fasteners ([Fig. 5](#)) .

16. **NOTE:** If the wiring harness did not have a fastener with zip tie cut and discarded in [Step 12](#) a new fastener with zip tie must still be installed to help secure the twist tube to the wiring harness.
Install new fastener #20098 on wiring harness 50 mm (1.9 in.) ([Fig. 6](#)) from the fastener closest to the wiring harness connector to the replaced fastener cut and discarded in [Step 12](#). Make sure the fastener is 180° from the offset clip ([Fig. 5](#)) .
17. Using reflective tape, wrap tape to cover the twist tube at each end ([Fig. 7](#)) . **DO NOT** cover any fasteners with tape.

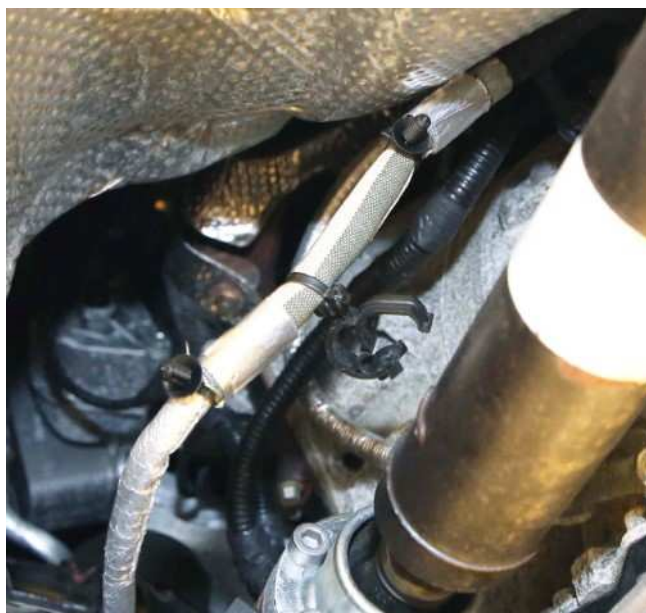
Fig. 7
Correct And Final assembly
