NUMBER: 08-045-18 REV. A

GROUP: 08 - Electrical

DATE: June 8, 2018

Flash: RA3 and RA4 Radio Enhancements

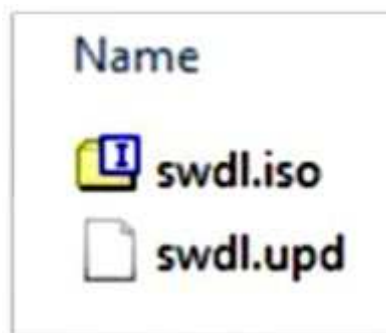
Fig. 1
Two USB Files

NOTE: Two files will be loaded onto the USB flash drive (Fig. 1) .

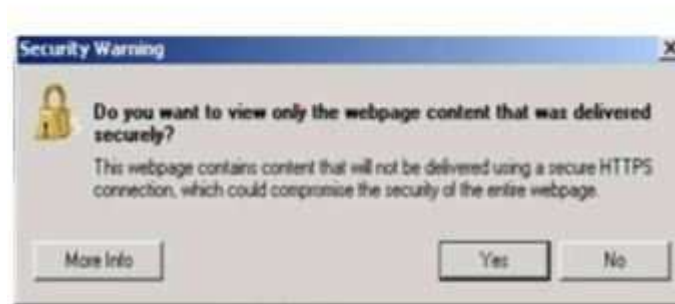
Fig. 2
Pop-up Security Message

3. If a security message appears “Do you want to view only the web page content that was delivered securely? (Fig. 2) Press No to continue.

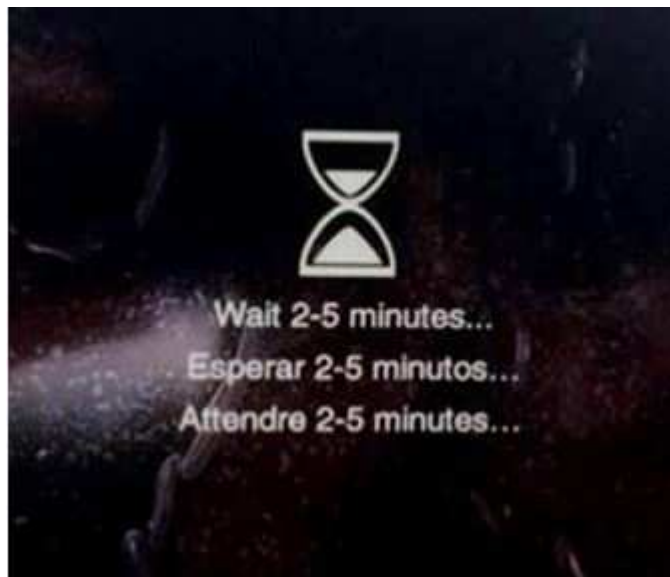
Fig. 3
Hourglass Screen

NOTE: During the update process you will see multiple hourglass and “Please Insert Update USB” screens for extended periods of time (several minutes)(Fig. 3) or (Fig. 4) . DO NOT remove the USB flash drive at this time. Only remove the USB flash drive when the update has completed, when the screen displays the software levels again. The screen will say “Software updated successfully”.

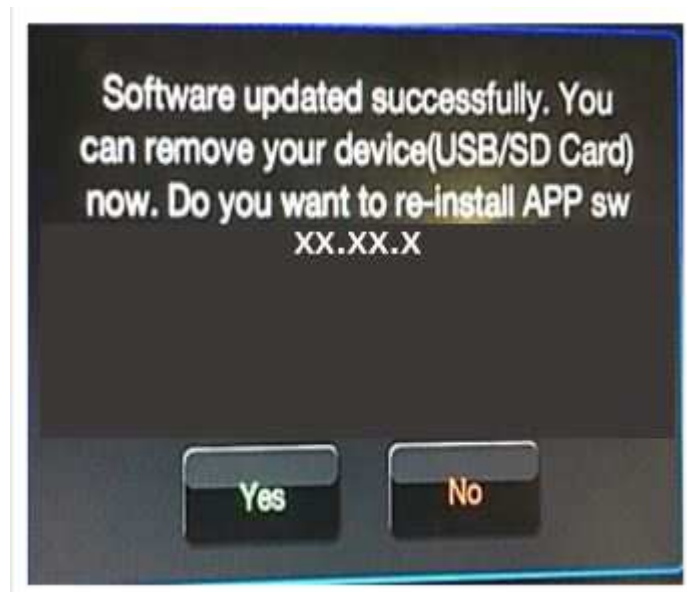
Fig. 5
Software Updated Successfully

10. After the update is done the screen will display the software levels again and will prompt to remove USB (Fig. 5) .
