NUMBER: 08-046-12

Navigation Losing Satellite Signal

This bulletin involves relocating the Global Position System (GPS) antenna.

2011 - 2012 (WK) Grand Cherokee (International Only)

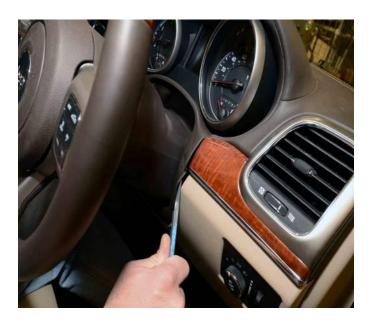
Fig. 1 Removing column seal with trim stick

NOTE: This is the seal in step 3 of the removal procedure. The clips need to be released and then position the steering column seal back. This gives more clearance to aid in the removal of the cluster.(Fig. 1)

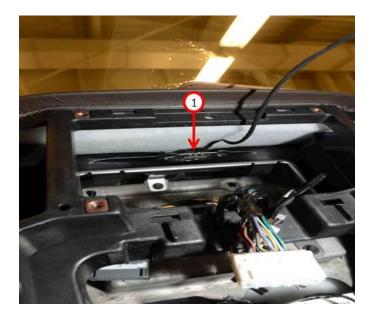
Fig. 2 Factory installed GPS antenna location

1 - Location of factory installed GPS antenna

6. The GPS antenna is located above the radio, mounted just under the white dash insulator (Fig. 2).

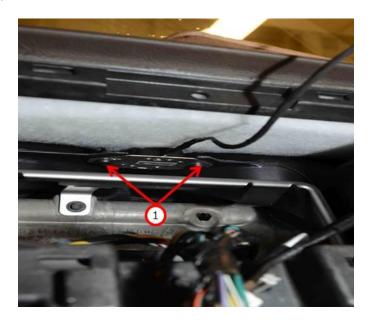
Fig. 3 Remove plastic push pins that hold antenna

1 - Plastic push pins location, remove and discard.

7. Remove the two push pins that holds the old GPS antenna, remove and discard the antenna (Fig. 3).

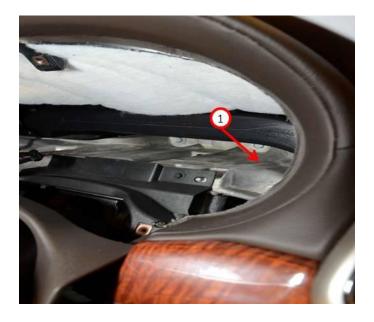
Fig. 4 Location for new GPS antenna

1 - Location where to install the new GPS antenna.

8. The new GPS mounting location is on the outboard side of the cast metal support brace for the cluster (Fig. 4).

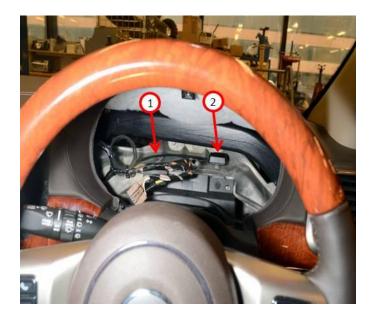
Fig. 5 GPS antenna installed and wire routing

- 1 Coax cable routing.
- 2 Antenna and coax pointed towards the radio.

- 9. Clean the support bracket with the alcohol wipe that is in the parts kit.
- 10. Remove the seal off the double sided tape that is located on the antenna mounting bracket.
- 11. Install the new antenna on the support bracket making sure the coax lead points toward the left side of the vehicle (Fig. 5).

NOTE: For left hand drive vehicles the coax lead points toward the right side of the vehicle (toward the radio).

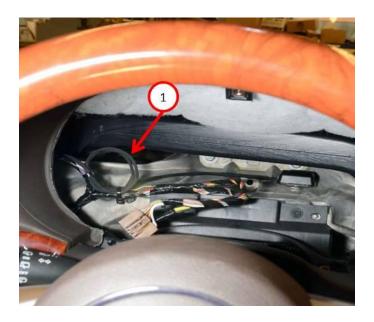
Fig. 6 Extra cable coiled and zip tied

1 - Proper location to coil extra coax.

- 12. Route the coax along the wire harness. Secure the coax to the harness with wire ties and make sure the connector is positioned so the connection can be made at the rear of the radio.
- 13. Coil excess coax cable and secure to the wire harness as shown in (Fig. 6).
