NUMBER: 08-059-18 REV. A

Water Intrusion at Electronic Limited Slip Differential (ELSD) Connectors

2018 (WK) Jeep Grand Cherokee

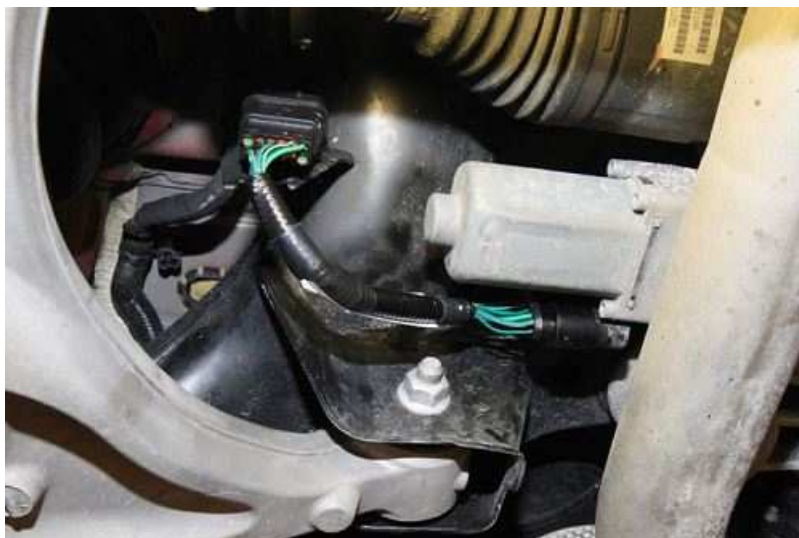
Fig. 1
ELSD Jumper Harness

1. Raise the vehicle on hoist. Refer to the detailed service procedures available in DealerConnect> TechCONNECT under: Service Info> 04 - Vehicle Quick Reference> Hoisting> Standard Procedure.
2. Inspect the in-line connectors of both the Underbody harness and the ELSD jumper harness (Fig. 1) to ensure the dummy cavity plugs are present and they are correctly installed. Disconnect the connector and verify there is no corrosion or water present. Verify the cable seals are present and installed under-flush in both in-line connectors.

3. Was any water or corrosion found?
 - YES>>> Proceed to [Step 1](#) of Repair Procedure 2.
 - NO>>> Proceed to [Step 4](#).
4. Replace dummy cavity plugs ([Fig. 2](#)) with MOPAR Part number 68425656AA of the ELSD jumper.

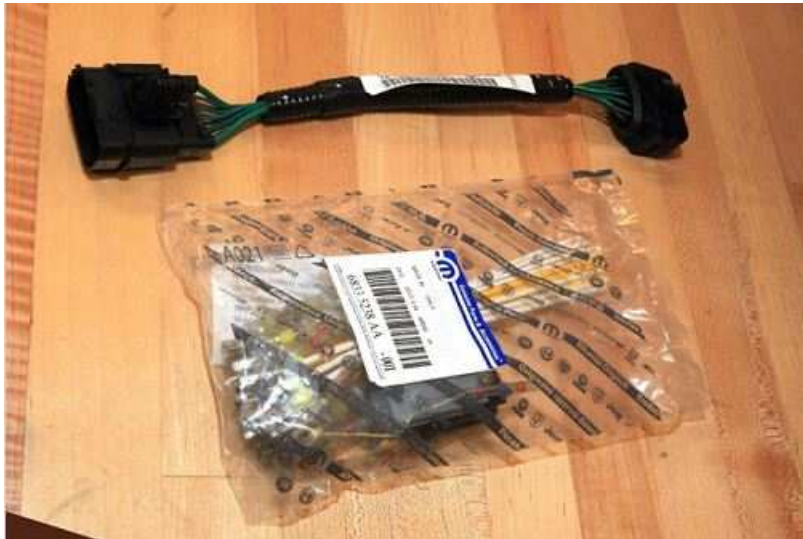
Fig. 3
Connector Terminal Repair Kit and ELSD Jumper Harness

1. Remove all water from connector. Spray connector with electrical contact cleaner (05018045AA or equivalent) to assist with the removal of any water and/or corrosion. Use a small, soft, plastic brush to gently clean the terminals.
2. Was corrosion of the terminals able to be cleaned and terminal cavities/pins undamaged?
 - YES>>> Proceed to [Step 3](#).
 - NO>>> A new ELSD jumper harness must be installed ([Fig. 3](#)) . Proceed to [Step 1](#) of Repair Procedure 3.

1. Install new ELSD jumper harness (P/N 05035575AA).
2. Was the underbody harness connector damaged or corrosion was unable to be removed?
 - YES>>> Proceed to [Step 3](#).
 - NO>>> Proceed to [Step 4](#).
3. Repair the connector with the underbody wiring harness connector repair kit (P/N 68335238AA) ([Fig. 3](#)) .
4. Apply dielectric grease (J8126688AB or equivalent) to each female terminal along with the face of the connector with female terminals.
5. Make the connection, and continue to reassemble the vehicle.
6. Lower the vehicle.
7. Clear all DTCs that may have been set. Use LOP (08-90-97-92) to close the active RRT.
