NUMBER: 08-068-18

DATE: May 11, 2018

RA3 and RA4 Radio Enhancements

This bulletin involves inspecting and if required, updating the radio to software level 17.43.01.

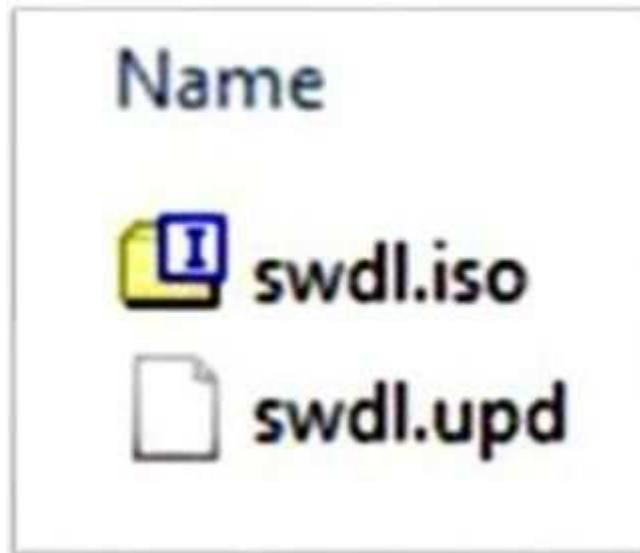
Fig. 1
Two USB Files.

Two files will be loaded onto the USB flash drive ([Fig. 1](#)).

2. Go to DealerCONNECT> Service> UCONNECT Information & Utilities> Uconnect Dealer software downloads to download the files.
3.
 - Acquire a blank USB flash drive with at least 4GB of space.
 - Download the software update file to your local PC's desktop.
 - Be sure to extract the file before copying it to the blank USB flash drive.
 - A blank USB flash drive will be needed one for each radio update. Both updates can not be on the same USB flash drive.
 - Once the file is saved to the USB flash drive, it is recommended that the USB flash drive be physically labeled with the bulletin number and radio sales code.

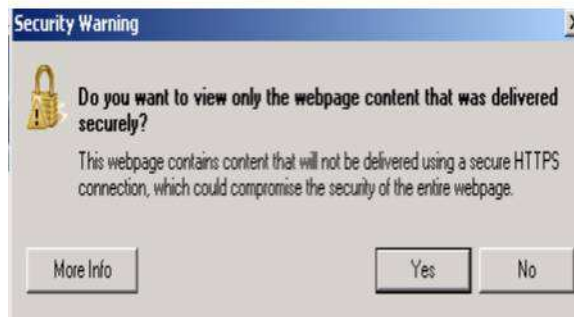
Fig. 2
Pop-up Security Message

4. If a security message appears “Do you want to view only the web page content that was delivered securely?” press “NO” to continue, see (Fig. 2) .

If this Pop-up appears, select “NO” to continue.

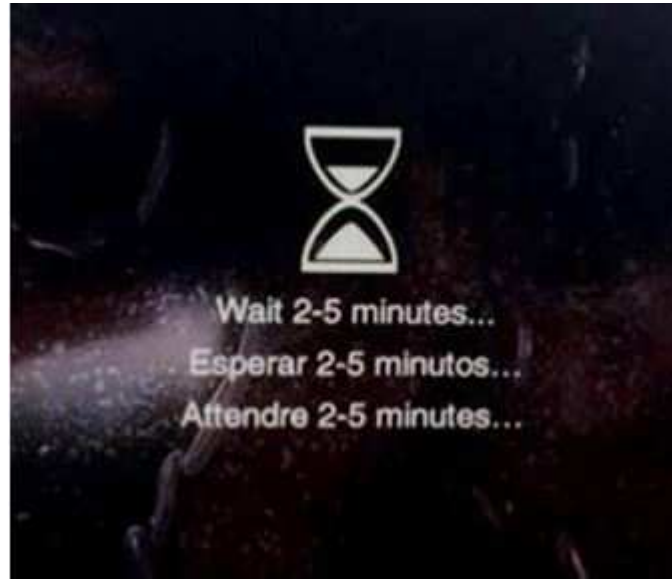
Fig. 3
Hourglass Screen

NOTE: During the update process you will see multiple hourglass and “Please Insert Update USB” screens for extended periods of time (several minutes)(Fig. 3) or (Fig. 4) . DO NOT remove the USB flash drive at this time. Only remove the USB flash drive when the update has completed, when the screen displays the software levels again. The screen will say “Software updated successfully”.

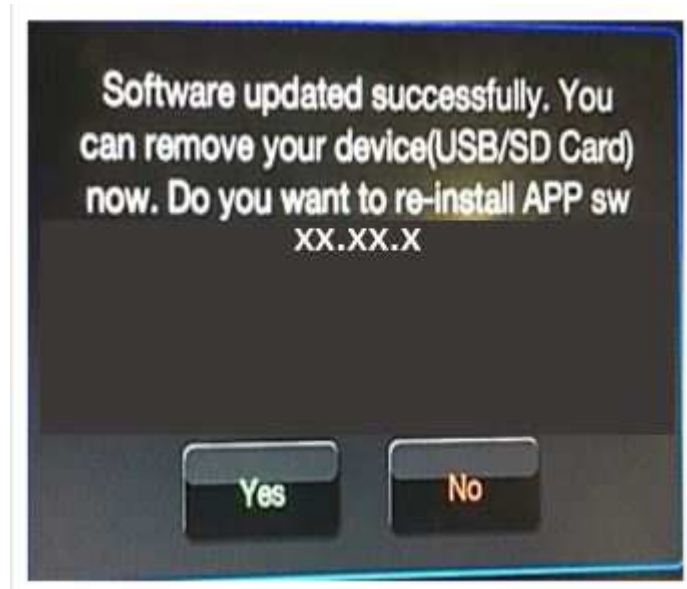
Fig. 5
Software Updated Successfully

10. After the update is done, the screen will display the software levels again, see (Fig. 5) .

NOTE: DO NOT remove the USB at any point of the update process until the final software levels match.
