NUMBER: 08-081-15

GROUP: Electrical

DATE: August 22, 2015

Unable To Register With Uconnect

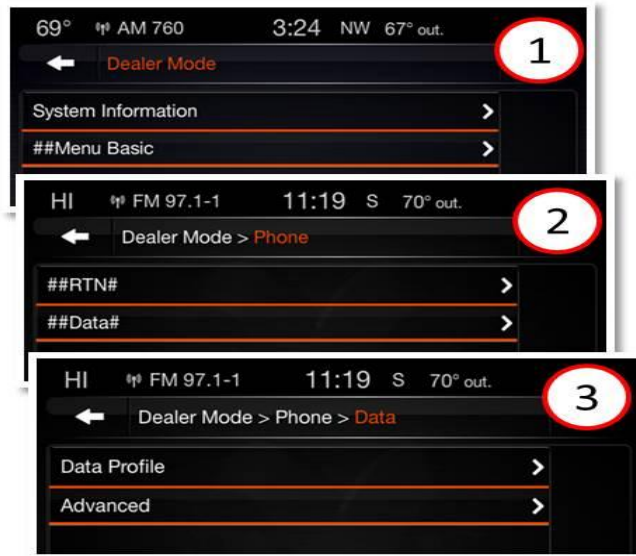
Fig. 1 Select The Following

- 1 - Select ##Menu Basic
 - 2 - Select ##RTN#
 - 3 - Select Advanced
-

1. Before creating a Star case, retrieve the MDN and MEID numbers from the radio. The radio must be in Dealer Mode to access these numbers.
2. Enter dealer mode by pressing and holding the temp up, temp down and front defrost all at the same time. If the vehicle has dual temp, use the drive side temp controls.
3. Once in dealer mode select the following:
 - a. Select “##Menu Basic “
 - b. Select “##Data#”
 - c. Select “Advanced”

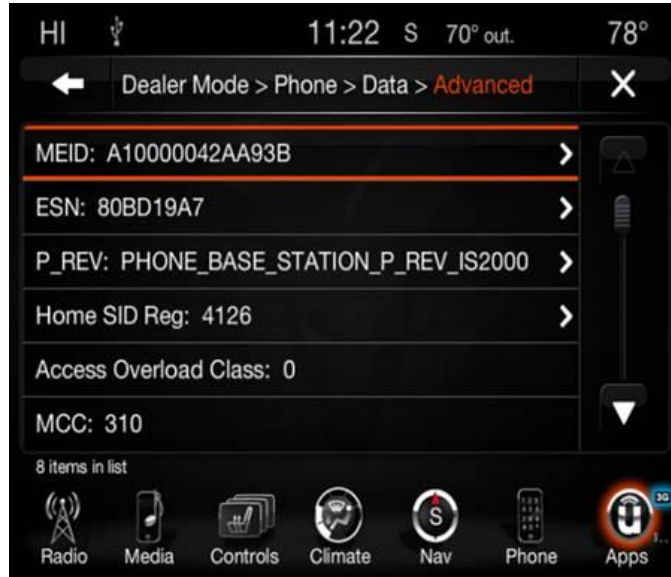
Fig. 2 MEID Number

- Record the MEID number for the STAR case.

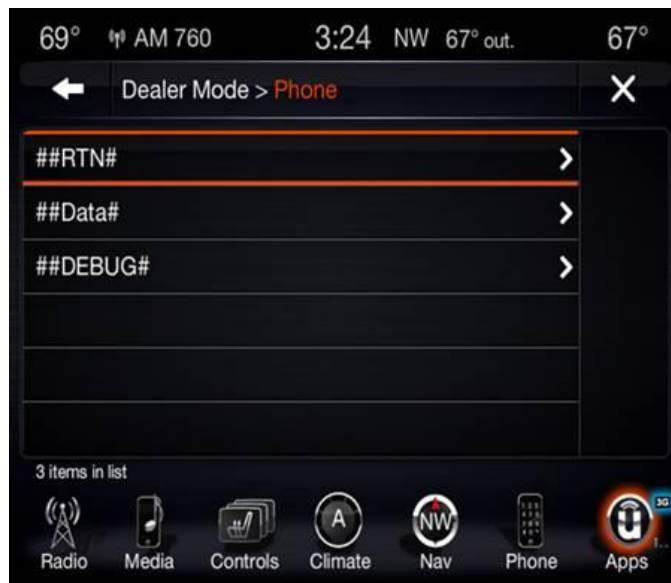
Fig. 3 Back Up Two Screen

Select ##RTN#

-
- Go back two screens by pressing the back arrow and select “##RTN#”.

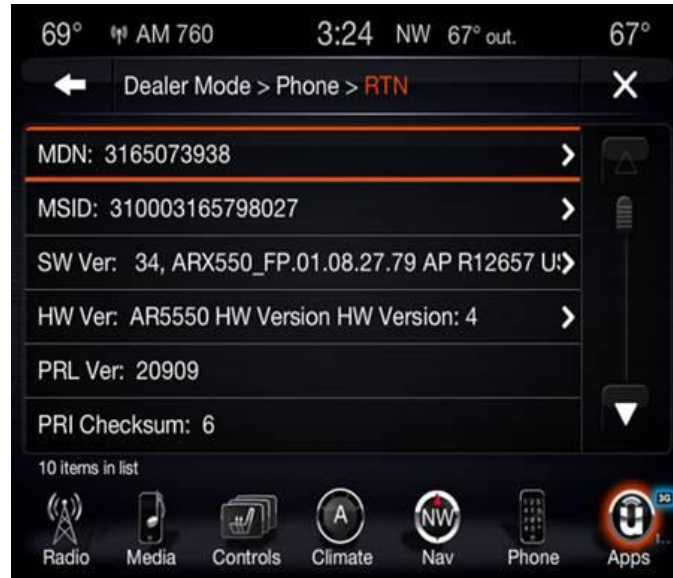
Fig. 4 MDN Number

6. Record the MDN number for the STAR case.

NOTE: At times when going into the ##RTN# screen the MDN number might remain listed as “NULL”. If this occurs, back out of the screen, re-enter the ##RTN# screen and it will populate the MDN number.

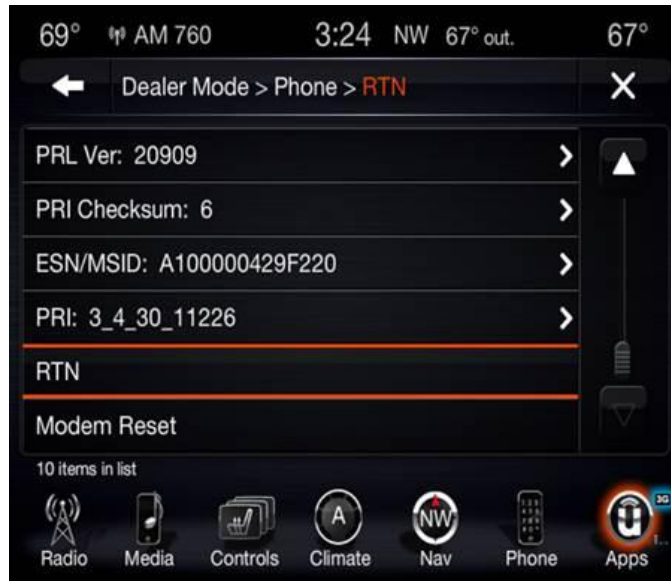
Fig. 5 RTN number

9. Then select ##Menu Basic and ##RTN#, scroll to the bottom of the menu and select RTN,

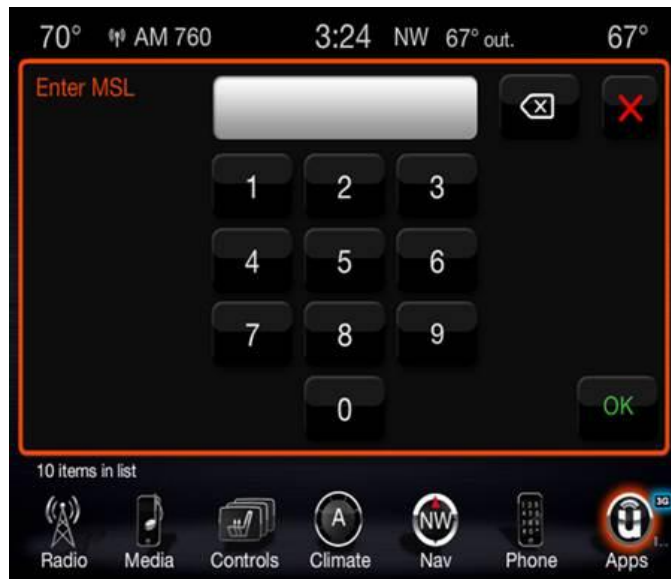
Fig. 6 Enter MSL Code

-
10. Enter the MSL code and press OK.

-
11. The next screen will display “Clear all Settings?” press Yes.
 12. At this point the radio will attempt to connect with the Uconnect App website.

NOTE: If a “Fail” message is displayed, enter the MSL number again, press OK and repeat steps 11, 12, 13.
