**NUMBER:** 08-103-15

**GROUP:** Electrical

**DATE:** October 30, 2015

RG3 RG4 RJ3 RJ4 Radio Enhancements

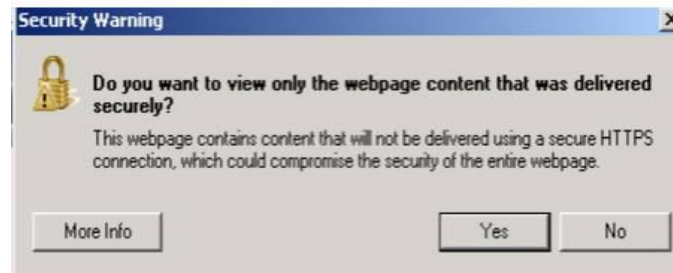
***Fig. 1 Pop-up Security Message***

If this Pop-up appears, select "NO" to continue.
