NUMBER: 08-113-18

GROUP: 08 - Electrical

DATE: September 6, 2018

UAS, UAQ, UCS and UCQ Radio Enhancements

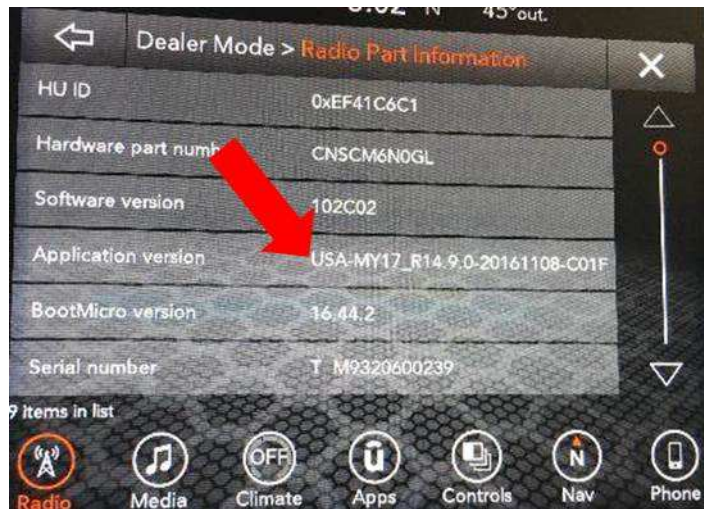
Fig. 1
Radio Software Level Screen

1. Verify the radio software version. Radio must be in Dealer Mode to verify by following these steps:
 - a. Push and hold the Front Defrost, Driver Temperature Up and Temperature Down buttons simultaneously until the Dealer Mode screen appears (approximately seven seconds). Release buttons.
 - b. Select "Radio Part Information". The software version will be listed next to "Application Version".
2. Is the radio currently at software level 21.9 or higher (Fig. 1) ?
 - YES >>> The radio software is already up to date. This bulletin has been completed, use inspect LOP (18-60-02-VK) to close the active RRT.
 - NO >>> The radio software needs to be updated. Back out of Dealer Mode and proceed to [Step 1](#) of the Repair Procedure.

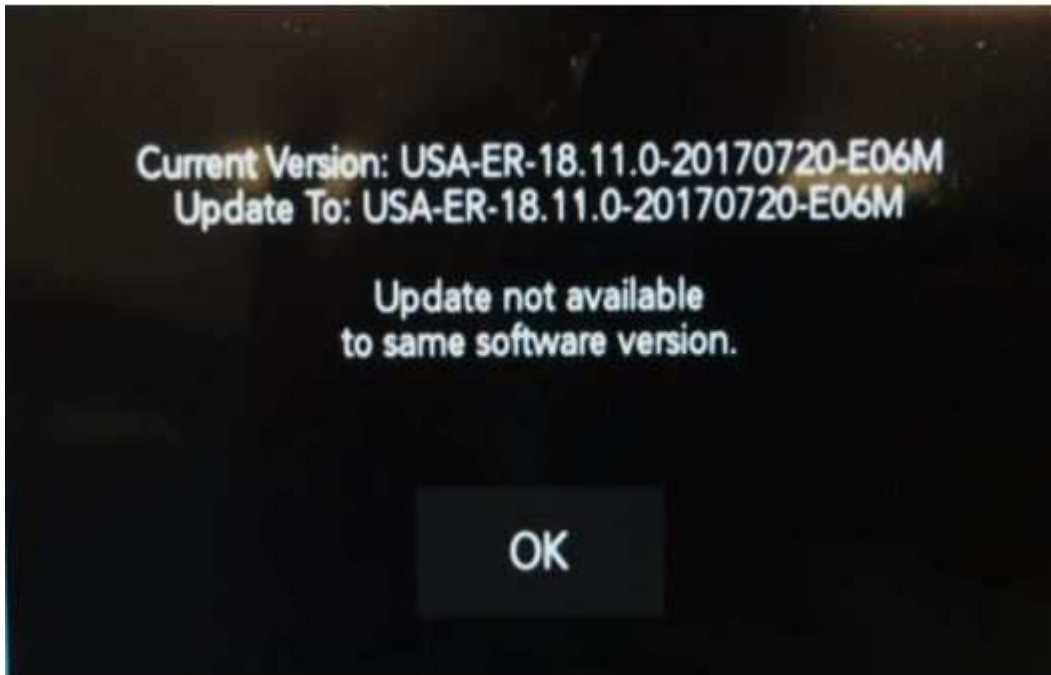
Fig. 5

Screen Displayed When Radio Software Is Up To Date, Version 21.9

11. If the radio software is up to date, the screen in (Fig. 5) will be displayed. Press “OK” and remove the USB flash drive.
