**NUMBER:** 08-135-18

**GROUP:** 08 - Electrical

**DATE:** October 16, 2018

ULQ Radio Enhancements

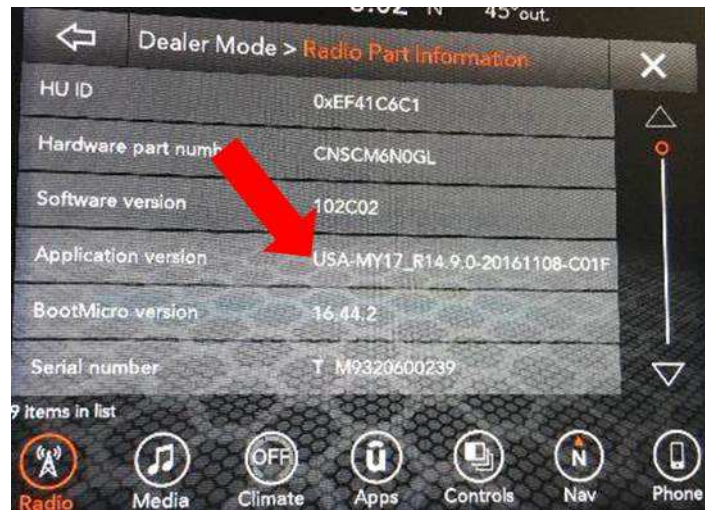
**Fig. 1****Radio Software Level Screen**

1. Verify the radio software version. Radio must be in Dealer Mode to verify by following these steps:
  - a. Push and hold the front defrost, driver temperature up and temperature down buttons simultaneously until the 'Dealer Mode' screen appears (approximately seven seconds). Release buttons.
  - b. Select "Radio Part Information". The software version will be listed next to "Application Version" (Fig. 1) .

2. Is the radio software level (Application Version) at or higher than 21.8?
  - YES>>> The radio software is already up to date. Normal diagnostic should be performed.
  - NO>>> Proceed to [Step 1](#) of the Repair Procedure.

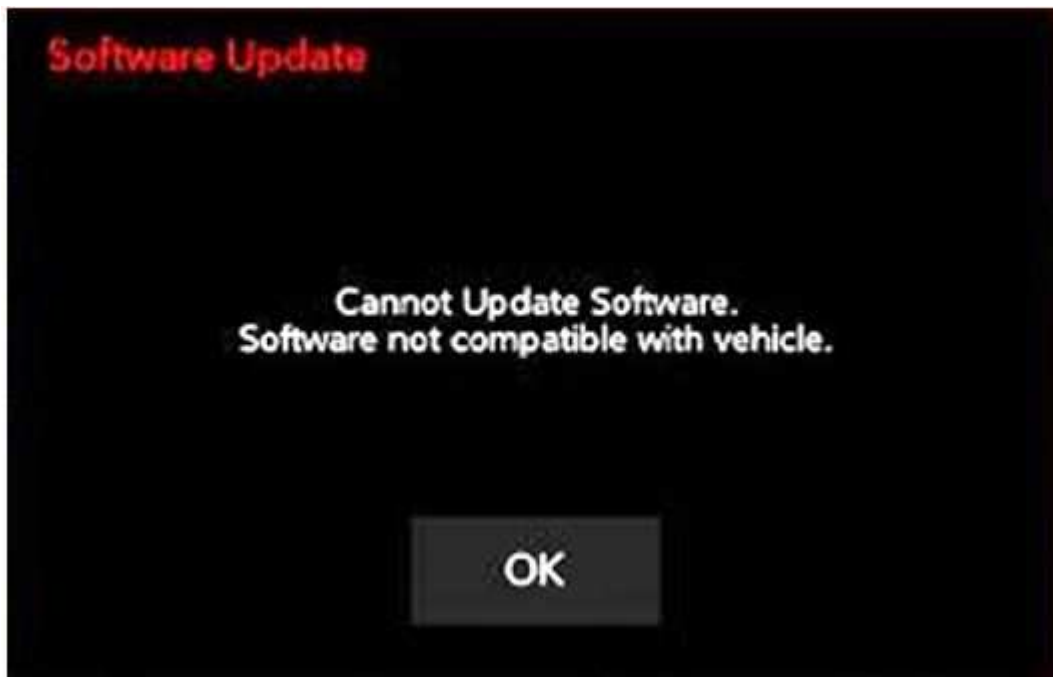
Fig. 2  
Software Not Compatible

2. If the screen in (Fig. 2) is displayed, the USB flash drive was not set up correctly. Use a top name brand USB flash drive and create a new USB flash drive. Start the update again.

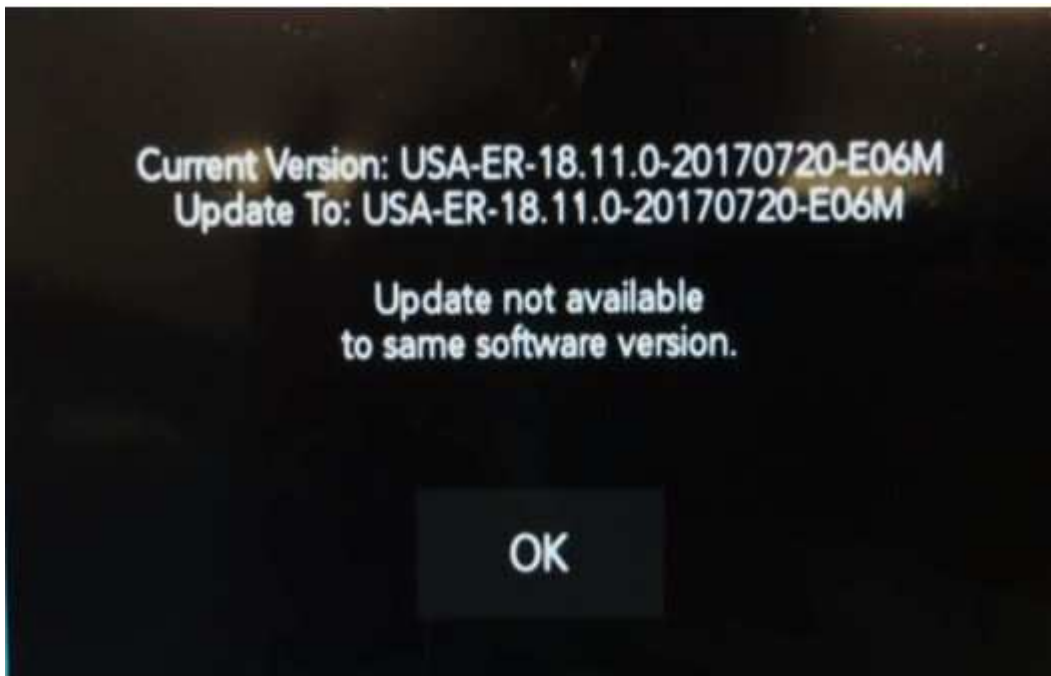
Fig. 3

Screen Displayed When Radio Software Level Is Up To Date

3. If the radio software is up to date, the screen in (Fig. 3) will be displayed. Press “OK” and remove the USB flash drive.

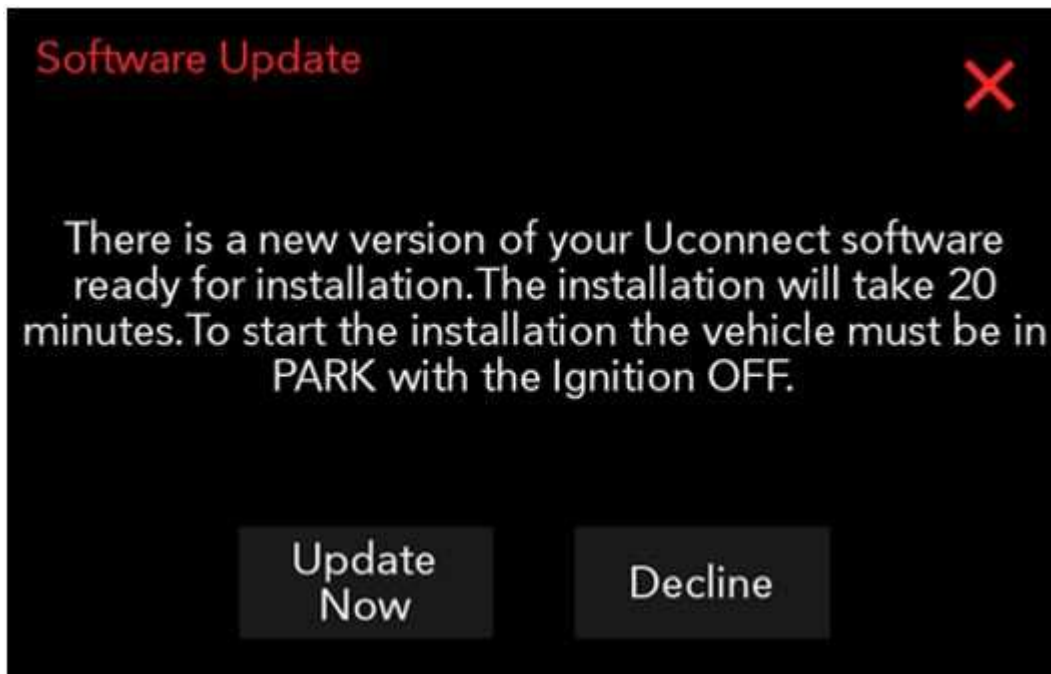
Fig. 4

Software Update Is Available

**NOTE:** The ignition must be turned off before the two minute timer has expired, as seen in (Fig. 4) .

4. Once the system has verified there is an available update, press the “Update Now” button. Make sure the vehicle is in park. **Turn off the ignition at this point,**(Fig. 4) .

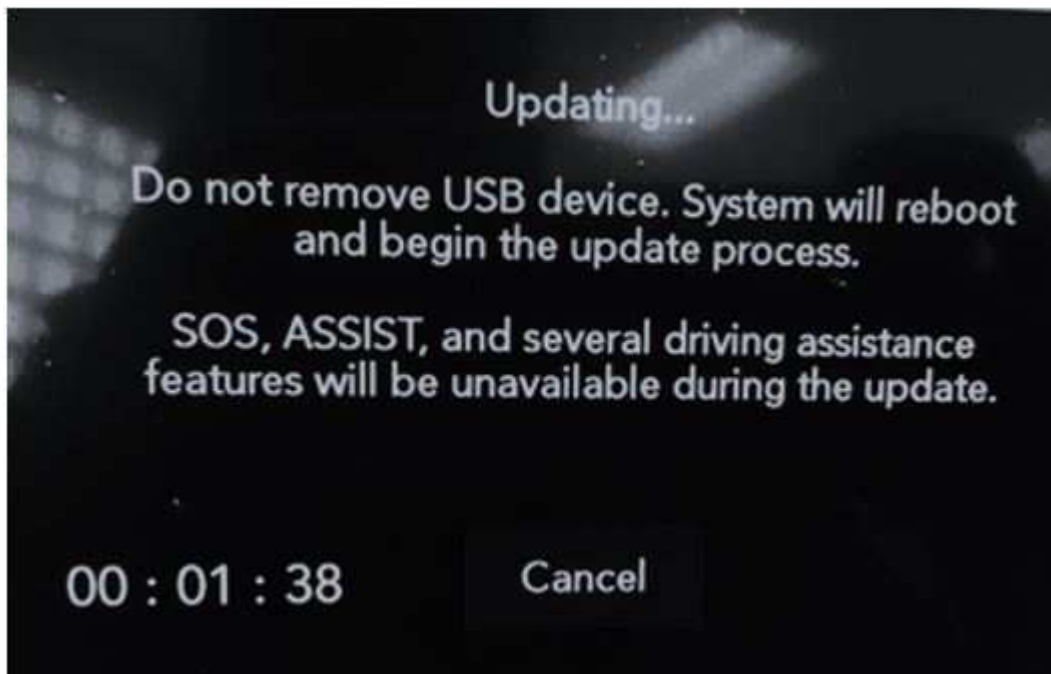
Fig. 5  
Radio Update Process Begins

5. When the radio starts updating, the screen in (Fig. 5) will be displayed.

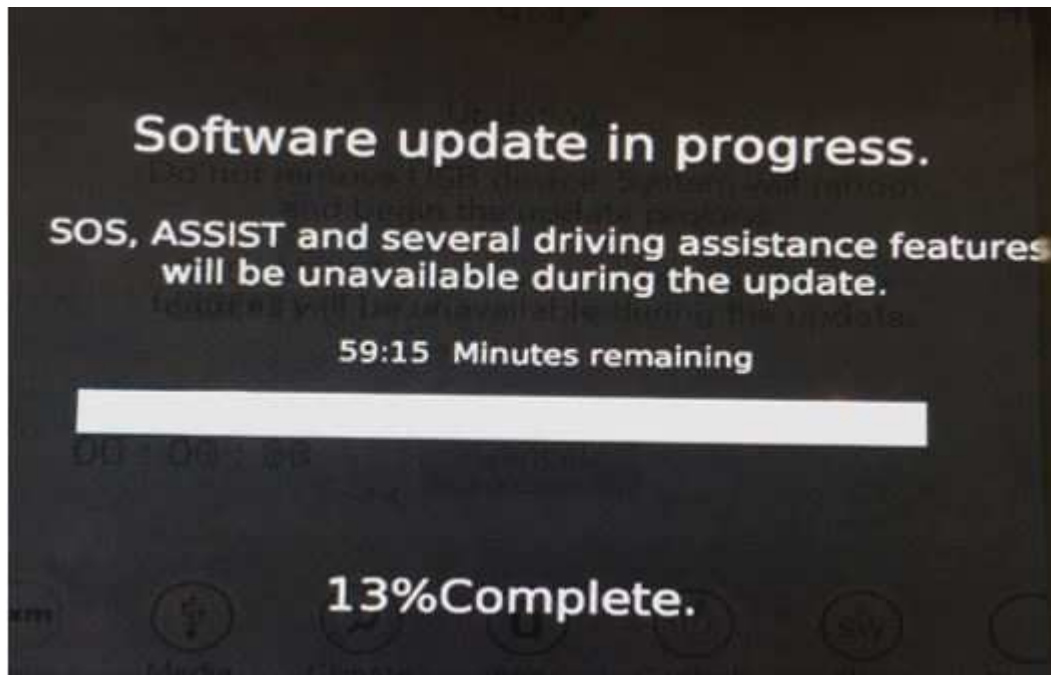
Fig. 6  
Software Update In Progress

6. The radio will reboot and the update will begin. The update should only take 50 minutes, the timer on the screen may display the incorrect time remaining, (Fig. 6) .

**NOTE:** The completion indicator may not reach 100%, even though the software update has been completed. Once the software update has finished, the radio and display screen will turn off.

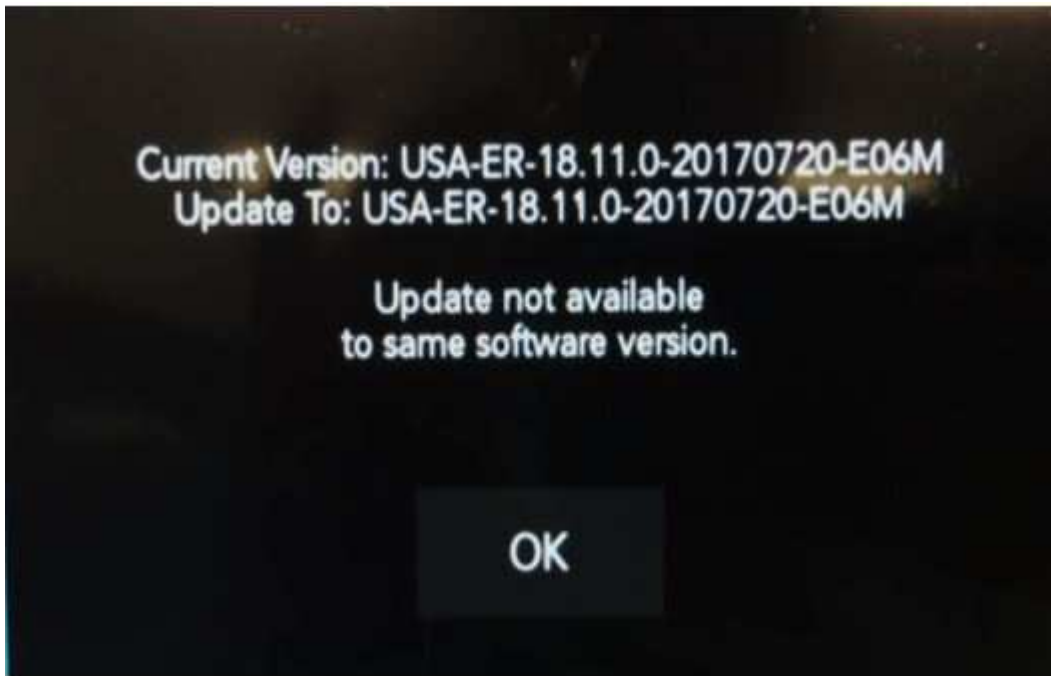
**Fig. 7**  
**Radio Software Has Been Updated.**

7. After the update has completed, the radio will shut down. With the USB flash drive still inserted in the USB port, turn the ignition back to the run position. If the radio has been updated

correctly, the screen in (Fig. 7) will be displayed. Press “OK” and remove the USB flash drive.
