NUMBER: 09-004-18

6.2L Knock Sensor Heat Shield Loose/Missing

This bulletin involves inspecting and if necessary, replacing the knock sensor connector back cover and installing a new heat shield.

2018 (WK) Jeep Grand Cherokee (Trackhawk)

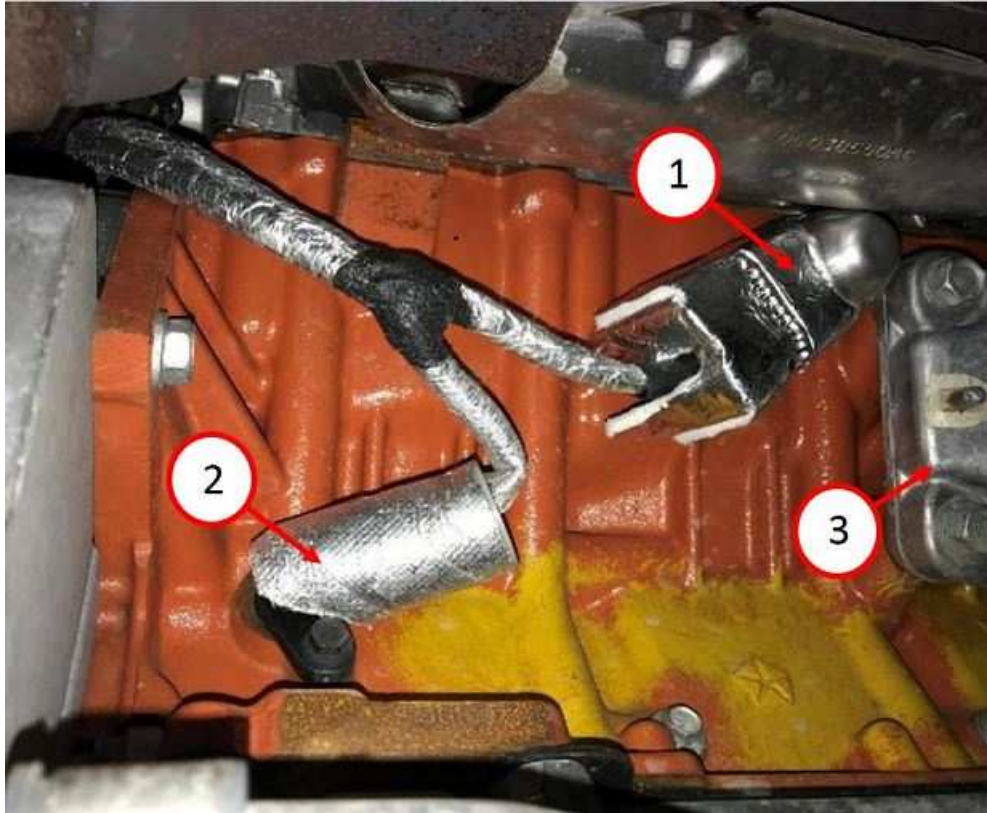
Fig. 1
Sensor Locations

Some customers may experience a Malfunction Indicator Lamp (MIL) illumination due to damage to the knock sensor from exposure to high heat conditions. Upon further investigation, a technician may find one of the following Diagnostic Trouble Code (DTCs):

3. Was the knock sensor heat shield (Fig. 1) loose, missing or is there any damage to the harness connector back cover?
 - YES>>> Continue to the Repair Procedure. Proceed to [Step 1](#) of the Repair Procedure.
 - NO>>> This bulletin has been completed. Use inspection LOP (25-01-85-93) to close the active RRT.
