**NUMBER:** 11-001-13

**GROUP:** Exhaust System

Exhaust Tip Contacting Hitch Causing Buzz, Squeak Or Rattle (BSR)

2013 (WK) Cherokee

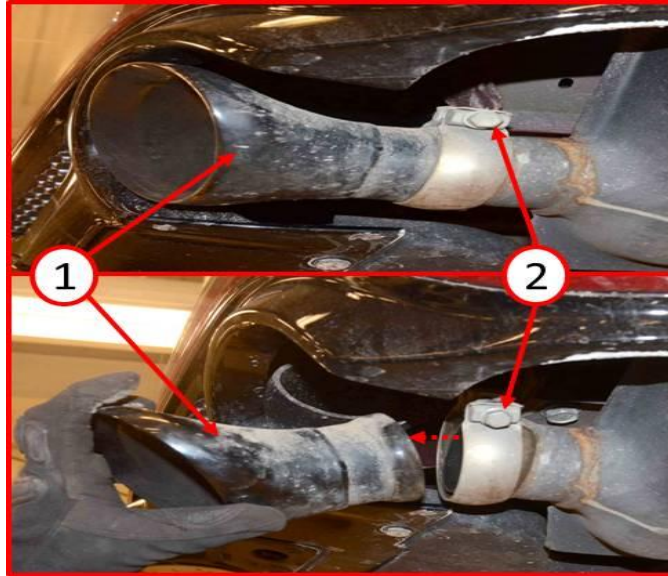
**Fig. 1 Remove Old Exhaust Tips**

- 1 - Old Exhaust Tip
  - 2 - Exhaust Clamp Bolt
-

1. Raise the vehicle on a suitable hoist. Refer to the detailed service procedures available in DealerCONNECT> TechCONNECT under: Service Info> 04- Vehicle Quick Reference> Hoisting> Standard Procedure> Hoisting.
2. Remove the right and left side exhaust tips (1) from the vehicle by loosening the bolt (2) on each of the exhaust clamps (Fig. 1).

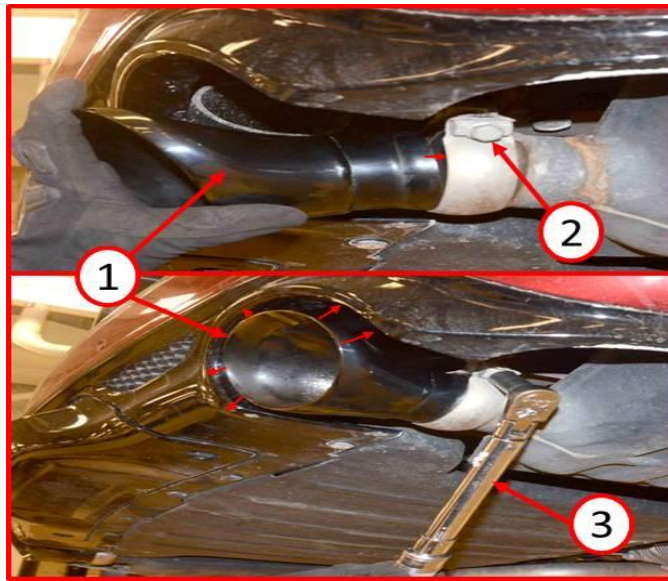
**Fig. 2 Install New Exhaust Tips**

- 1 - New Exhaust Tip
- 2 - Exhaust Clamp Bolt
- 3 - Torque Wrench

3. Install the new exhaust tip P/N 05181770AB (1) on the left and right side muffler outlets and snug the exhaust clamp bolts (2) so that the exhaust tip can still be adjusted (Fig. 2).
4. Center the exhaust tip (1) in the rear fascia opening and tighten the exhaust clamp bolt (2) using a torque wrench (3) to 22ft/lbs.(30NM)(Fig. 2).
