NUMBER: 11-003-14

Rattle Or Squeak Noise Under Vehicle

2014 WK Grand Cherokee

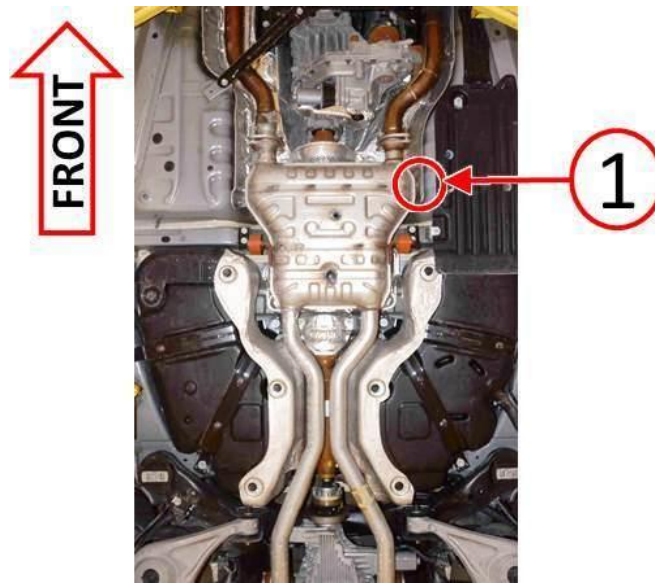
Fig. 1 Area Of Missing Fastener Nut

1 - Missing Nut

3. Install the nut specified in the PARTS REQUIRED section of this bulletin to the toe pan heat shield, and tighten the nut to 7 N·m (62 in. lbs.).
4. Ensure proper alignment and sufficient gap between the toe pan heat shield and other components.

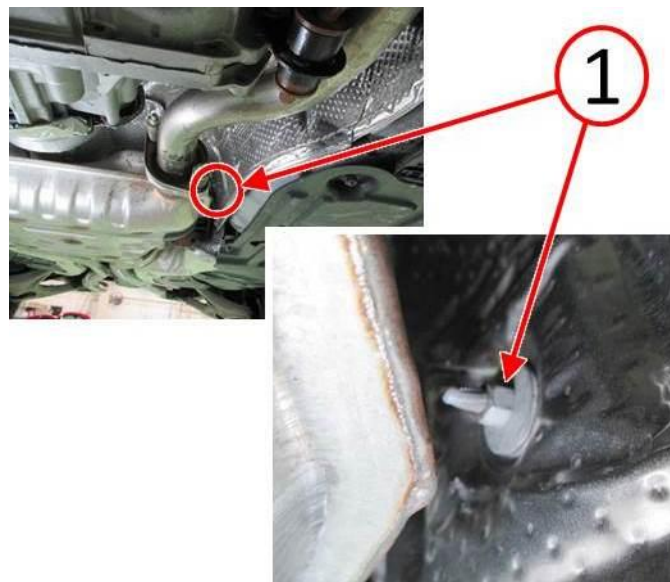
1. Lift the vehicle. Refer to the detailed repair procedures available in: DealerCONNECT> TechCONNECT under: Service Info> 04 - Vehicle Quick Reference> Hoisting> Standard Procedure.
2. Inspect for a missing fastener nut securing the rear lower corner of the toe pan heat shield to the left underside of the vehicle body as shown in (Fig. 1) and (Fig. 2). Is the fastener nut missing?
 - a. Yes, the fastener nut is missing >>> Continue with [Step #3](#).
 - b. No, the fastener nut is not missing >>> This bulletin does not apply.

Fig. 2 Inspect For Missing Fastener Nut

1 - Missing Nut
