NUMBER: 17-001-11

GROUP: Rear Suspension

Rear Shock Buzz / Squeak / Rattle

2011 (WK) Grand Cherokee

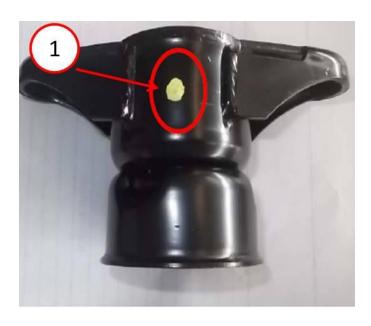
Fig. 1 Yellow Paint Mark

NOTE: Part stock should have yellow paint marks (Fig. 1) and/or include a September or later build date code (Fig. 2).

NOTE: Make sure the replacement mounts meet the requirements described in (Fig. 1) and (Fig. 2) above.

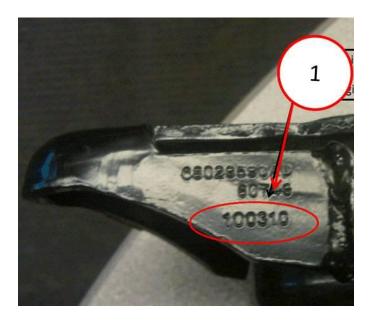
Fig. 2 Date Code

1 - Date Code — Example (100310 / 10 = 2010 / 03 = March / 10 = Day)

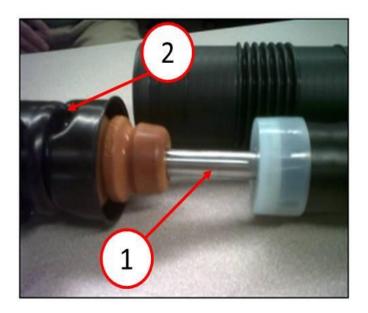
Fig. 5 Shock Rod

NOTE: Do not use any tools on the shock rod assembly other than what is specified in Step #4 (Fig. 5). Pursuing any other methods could damage the shock rod and result in shock leaks.
