NUMBER: 17-001-17

GROUP: Rear Suspension

Rear Lower Control Arm Spring Alignment Slot In The Wrong Location

2017 (WK) Jeep Grand Cherokee

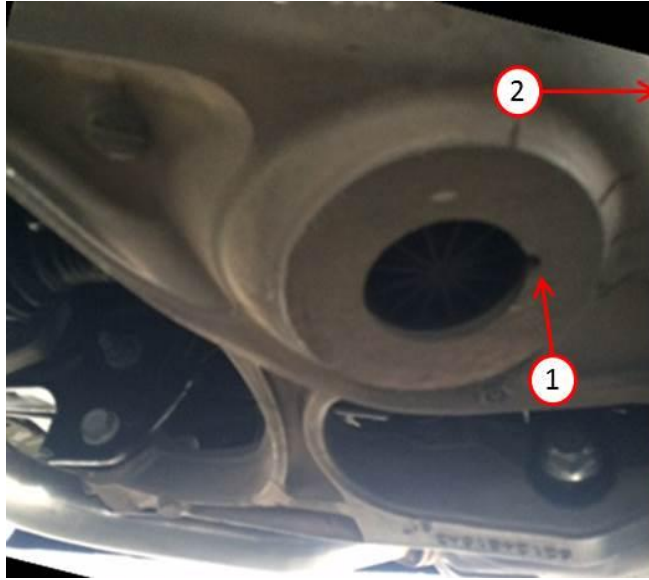
Fig. 1 Correct Spring Alignment Slot Location

1. Raise the vehicle on a hoist.
2. Inspect both rear lower control arms for proper location of the air spring alignment slot. If the alignment slot is in the correct location, the slot will be next to the tire/wheel, see (Fig. 1).

- 1 - Air spring alignment slot.
- 2 - Location of the tire and wheel.

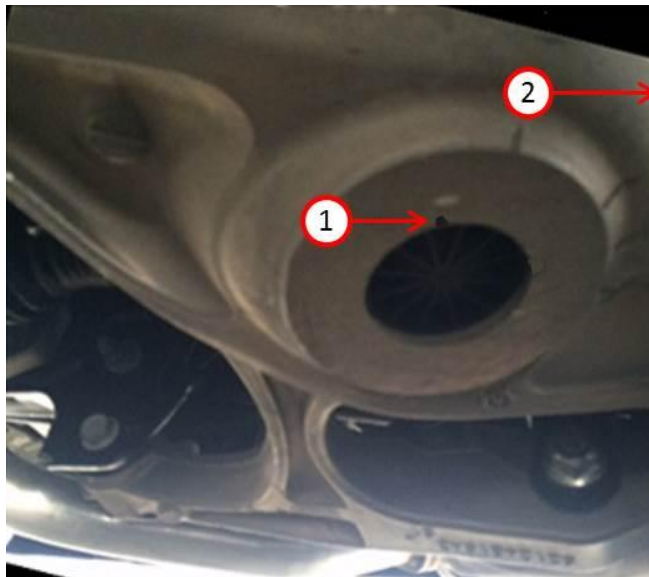
Fig. 2 Incorrect Spring Alignment Slot Location

Rear lower control arms with the air spring alignment slot in the wrong location may have been installed at the factory.

-
3. If the alignment slot is not in the correct location, the slot will be 90 degrees away from the side of the tire/wheel, see (Fig. 2).

- 1 - Air spring alignment slot.
 - 2 - Location of the tire and wheel.
-

- 4. Is the alignment slot in the correct location?
 - a. Yes>>> This bulletin has been completed. Use inspection LOP (02-04-06-91) to close the active RRT.
 - b. No>>> Proceed to the repair procedure, [Step #1](#).

- 1. Using wiTech, perform the following routines under the ASCM:
 - a. Disable the air suspension system.
 - b. Run the routine, Spring Deflate To Reservoir, on the side that the control arm needs to be replaced.
- 2. Remove the rear lower control arm. Refer to the detailed service procedures available in DealerCONNECT> TechCONNECT under: 17 - Rear Suspension/Arm, Lower Control/Removal.
- 3. Inspect the air spring alignment tab on the bottom of the spring. Check if the alignment tab is broken or cracked. Review below image for location of air spring tab, ([Fig. 3](#)).
