**NUMBER:** 17-002-10 REV. A

**GROUP:** Rear Suspension

Rear Shock Buzz / Squeak / Rattle

2011 (WK) Grand Cherokee

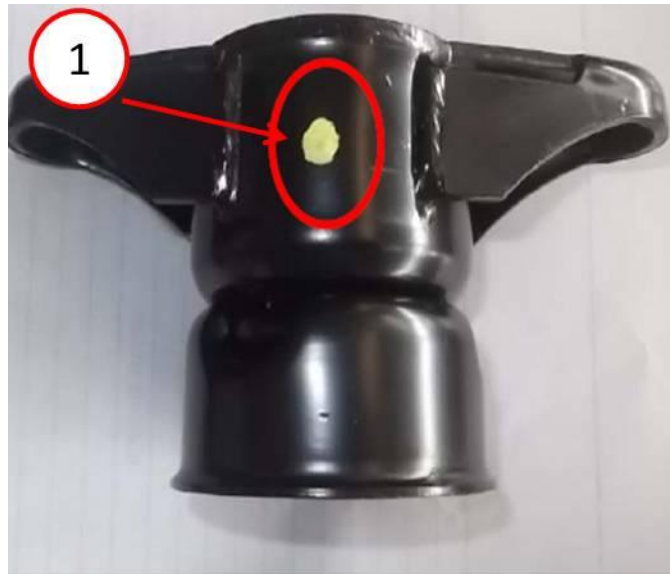
**Fig. 1 Yellow Paint Mark**

**NOTE: Modified part stock will have yellow paint marks (Figure 1) or include a September or later date code (Figure 2).**

1 - Yellow Paint Mark

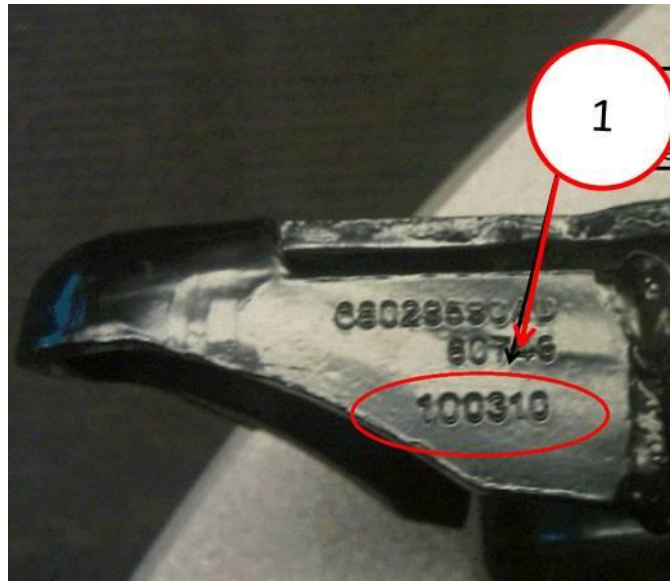
**Fig. 2 Date Code**

1 - Date Code — Example (100310 / 10 = 2010 / 03 = March / 10 = Day)
