**NUMBER:** 19-001-17

**GROUP:** Steering

Electric Power Steering (EPS) Module Connector Security

2015 - 2017	(LA)	Dodge Challenger
2015 - 2017	(LD)	Dodge Charger
2015 - 2017	(LX)	Chrysler 300
2016 - 2017	(WD)	Dodge Durango
2016 - 2017	(WK)	Jeep Grand Cherokee
2017	(RU)	Chrysler Pacifica
2014 - 2017	(KL)	Jeep Cherokee
2015 - 2017	(UF)	Chrysler 200
2012 - 2016	(PF)	Dodge Dart

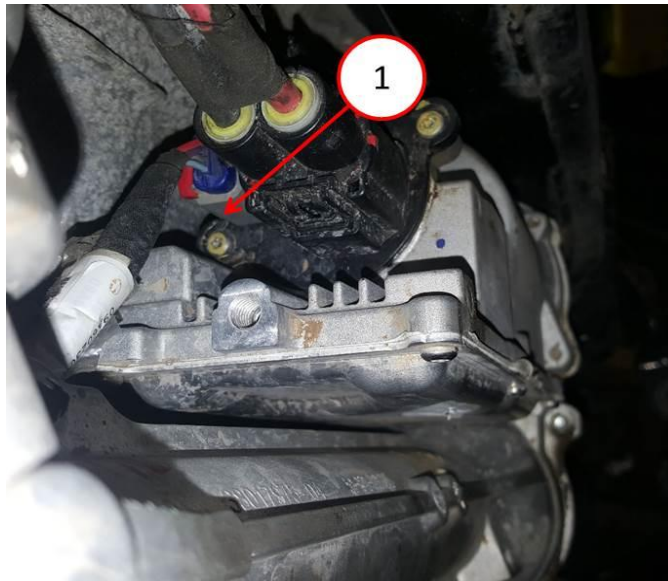
**Fig. 1 LA LD and LX EPS Module Connector**

During EPS module electrical diagnosis and verification, DO NOT disconnect the (gray) EPS torque sensor connector on the EPS module.

1 - EPS Torque Sensor Connector

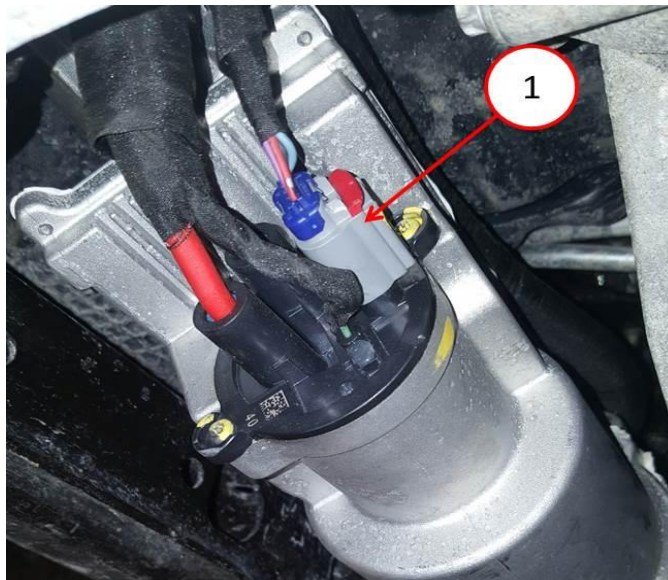
**Fig. 2 WD and WK EPS Module Connector**

1 - EPS Torque Sensor Connector

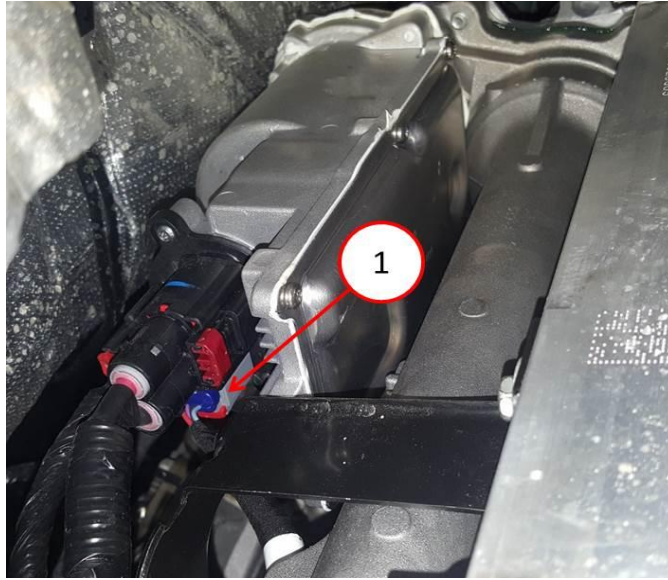
**Fig. 3 RU EPS Module Connector**

1 - EPS Torque Sensor Connector

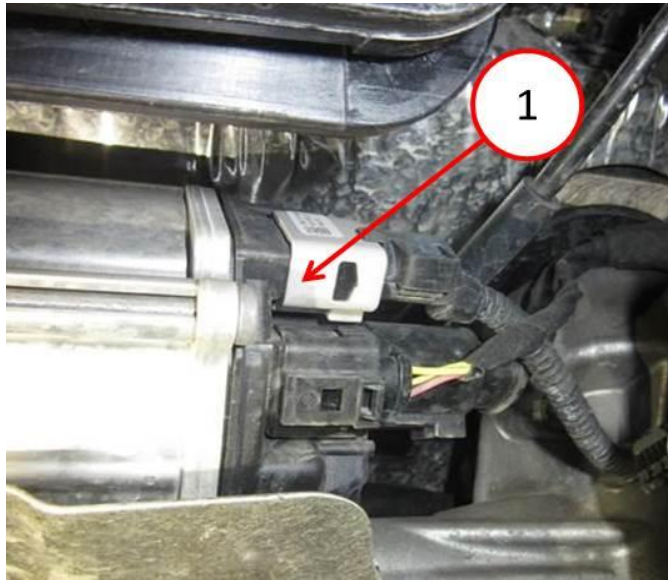
**Fig. 4 KL UF and PF EPS Muodule Connector**

1 - EPS Torque Sensor Connector
