NUMBER: 19-003-14

GROUP: Steering

Clunk And/Or Bump Felt Through The Steering Wheel Under Moderate Braking And/Or Driving Over Rough Roads

2011-2012	(WD)	Durango
2011-2012	(WK)	Grand Cherokee

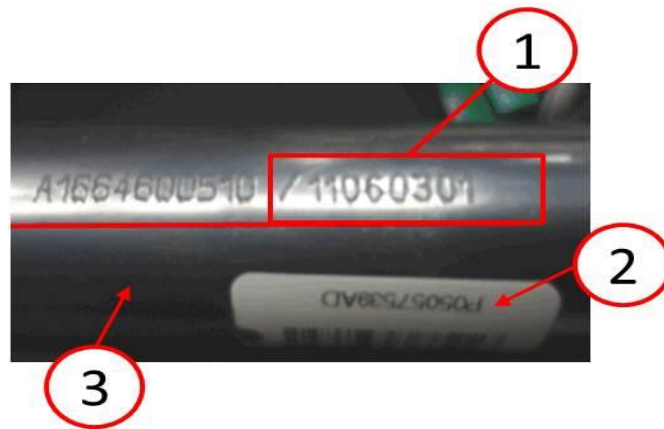
Fig. 1 Lower Intermediate Shaft

NOTE: **The new lower intermediate shaft must have a julian date greater than August 01, 2011 and is located near I-Shaft barcode label (Fig. 1). The julian date has a series of eight digits coded as follows, YY=Year MM=Month DD=Date SS=Shift. For example, the julian date in (Fig. 1) is 11060301, decoded the intermediate shaft was manufactured Year=2011, Month=June, Date=03 Shift=01.******
