NUMBER: 19-006-10

GROUP: Steering

Moan Like Sound During Parking Lot Maneuvers And/Or Fluid Weeping At Rack And Pinion

2011 WK Grand Cherokee

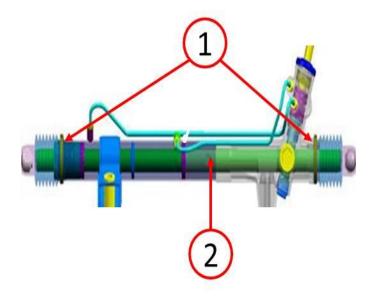
Fig. 1 Rack and Pinion

- 1. Test drive the vehicle and verify moan like sound during parking lot maneuvers. Was there any moan noise?
 - a. Yes>>> Proceed to Step #3.
 - b. No>>> Proceed to Step #2.
- 2. Raise the vehicle on a suitable hoist. Refer to the detailed service procedures available in DealerCONNECT> TechCONNECT under: Service Info> 04- Vehicle Quick Reference> Hoisting> Standard Procedure> Hoisting.
- 3. Inspect the rack and pinion for any signs of power steering fluid weeping at the bellows (Fig. 1). Was there any power steering fluid weeping?

- 1 Bellows
- 2 Rack and Pinion
 - a. Yes>>> Proceed to Step #4
 - b. No>>> This bulletin does not apply continue further diagnosis.
- 4. Remove and replace the rack and pinion. Refer to the detailed service procedures available in DealerCONNECT> TechCONNECT under: Service Info> 19- Steering> Gear> Removal/Installation> 3.6L/5.7L.
- 5. Return the vehicle to the customer or dealer inventory.
