NUMBER: 23-001-19 REV. A

GROUP: 23 - Body

Dash and Door Appliques Delaminating - X77 Warranty Extension

2012 - 2017 (WK) Jeep Grand Cherokee (SRT Only)

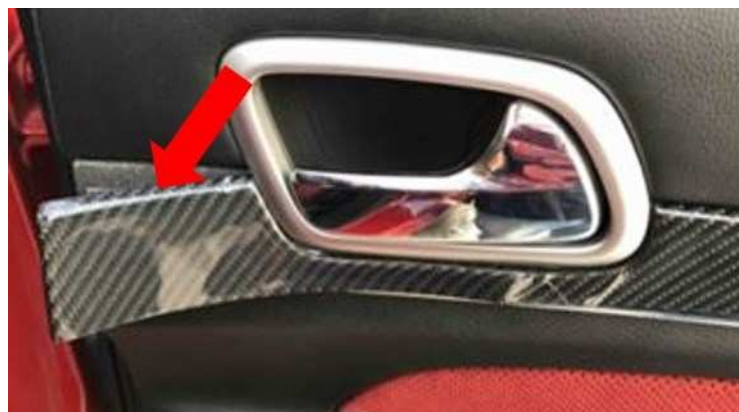
Fig. 1
Applique Delaminating Example

Some customers may comment on one of the following (Fig. 1) :

- The inner doors and instrument panel appliques are delaminating.
- The outer layer of an applique is separating from the inner layer.

If the customer describes the symptom/condition listed, perform the Repair Procedure.

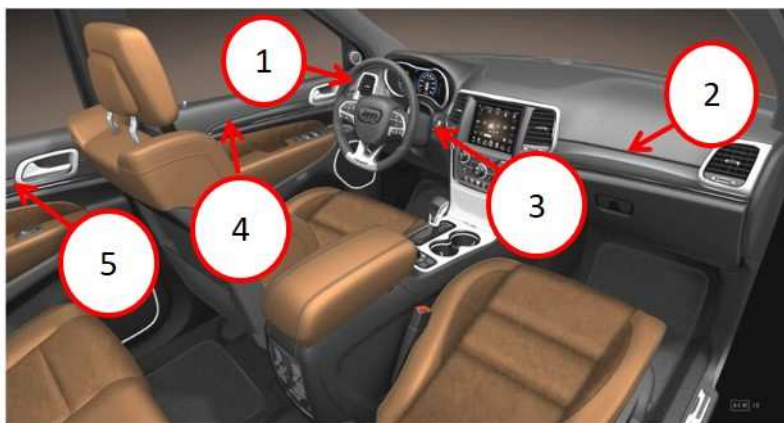
Fig. 2
Appliques

- 1 - Driver Inboard Applique
- 2 - Passenger Applique
- 3 - Driver Outboard Applique
- 4 - Front Door Applique
- 5 - Rear Passenger Door Applique

NOTE: This service bulletin does not cover replacement of all trim pieces (Fig. 2) . Only replace the trim pieces showing delamination issues.

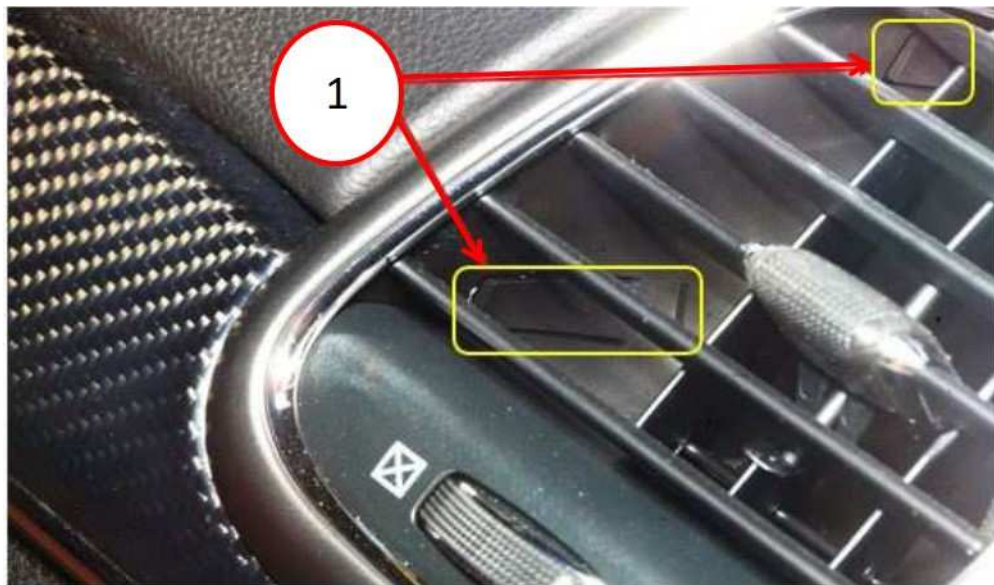
Fig. 5
Retaining Clip Location Inside Vent

1 - Outboard Clips

- Using a hook tool or small screw driver, disengage the outboard clips. Access the clips by going through the air vent (Fig. 4) and (Fig. 5) .

NOTE: To disengage the retainers that are located in the vent, pull out on the applique a small amount while disengaging the clips.

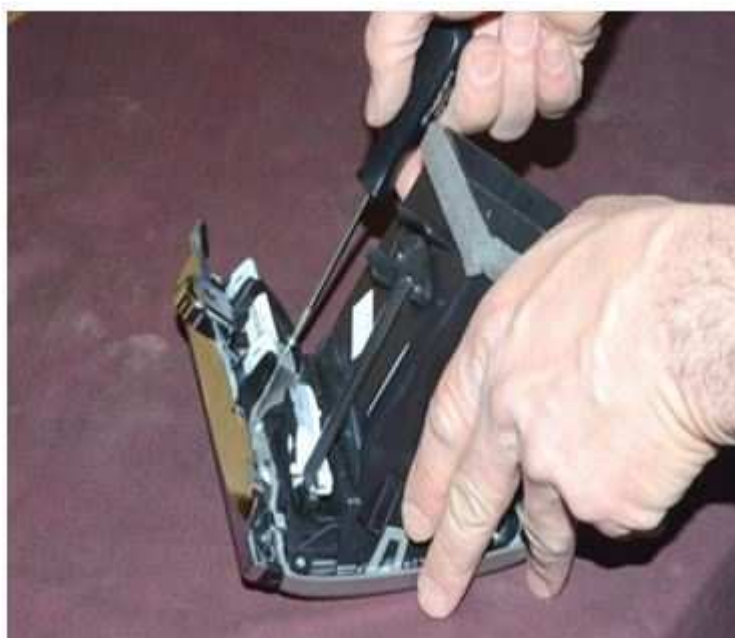
Fig. 6

Retaining Screws for the Air Vents

6. Using a T-10 Torx, remove the two screws that hold the air vent to the applique (Fig. 6) . Discard applique.

7. Using a T-10 Torx, install the air vent to the new applique with two screws.
8. Install the applique assembly to the IP by applying light pressure to the applique to engage the clips.
9. Install the one inboard screw using a 7 mm socket.
10. Install the IP end cap and door seal.
11. Install the center IP bezel. Refer to the detailed procedures available in DealerCONNECT > Service Library/TechCONNECT> under: 23 - Body/IP/Bezel, Instrument Panel, Center/ Installation.

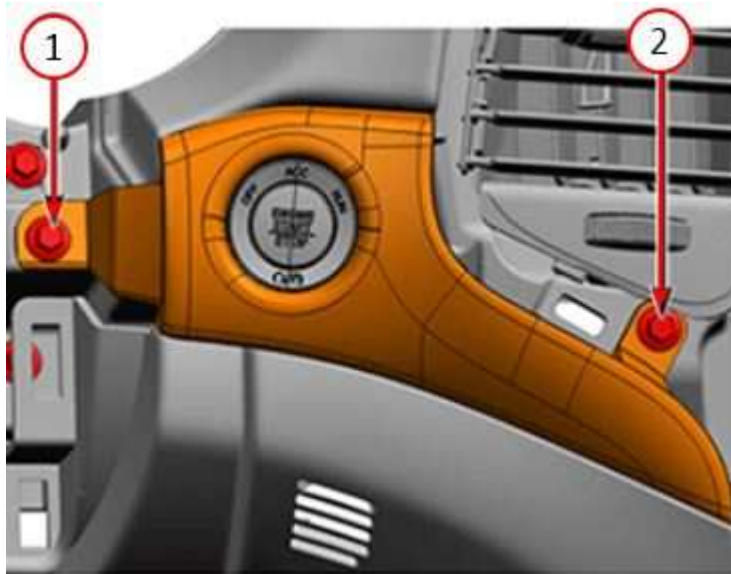
Fig. 7
7 mm Retaining Screws

- Retaining Screw
- Retaining Screw

- Using a 7 mm socket, remove the two screws holding the applique to the IP (Fig. 7) .

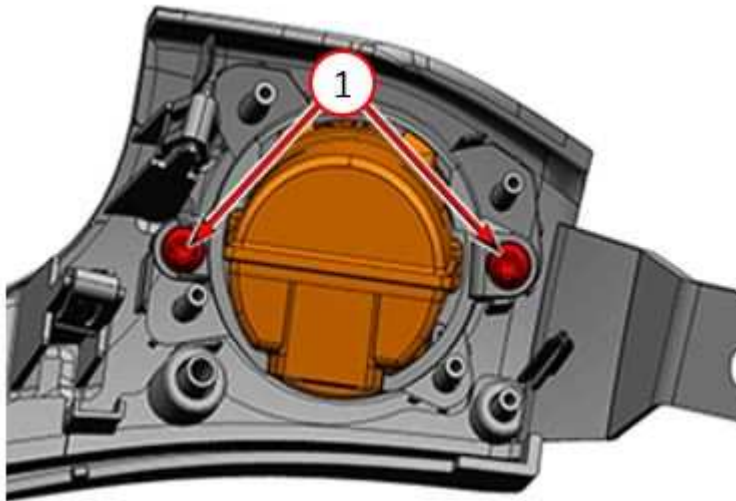
Fig. 8
KIN Trim Retaining Screws

- Torx Screws

- Disengage the remaining clips and remove the applique.
- Disengage the connector for the Keyless Ignition Node (KIN).
- Using a T-10 Torx, remove the two screws that hold the KIN to the applique (Fig. 8) . Discard applique.

- Install the KIN on the new applique with two screws.
- Reconnect the KIN connector to the back of the KIN.
- Install the new applique to the IP by pushing the applique to engage the clips.
- Using a 7 mm socket, install the two screws (Fig. 8) .
