NUMBER: 23-001-19 REV. B

Dash and Door Appliques Delaminating - X77 Warranty Extension

2012 - 2017 (WK) Jeep Grand Cherokee (SRT Only)

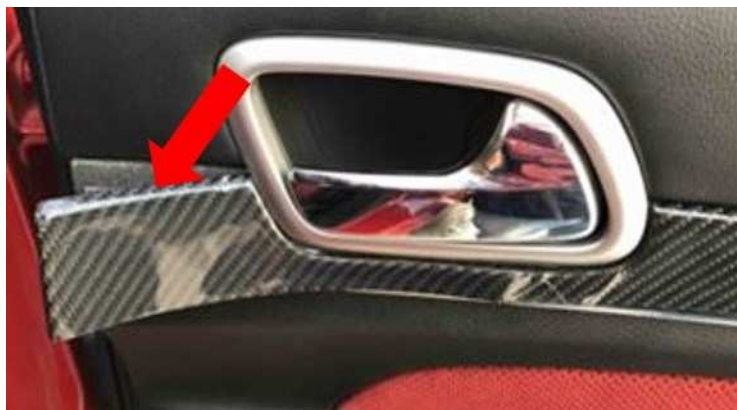
- The carbon fiber inner doors and instrument panel appliques are delaminating.
- The outer layer of a carbon fiber applique is separating from the inner layer.

Fig. 1
Carbon Fiber Applique Delaminating Example

If the customer describes the symptom/condition listed, perform the Repair Procedure.

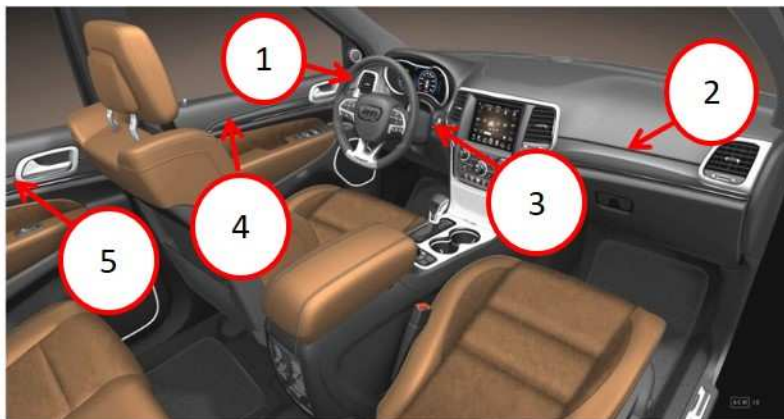
Fig. 2

NOTE: **This service bulletin does not cover replacement of all trim pieces (Fig. 2) and only the listed parts and subsequent superseded Part No's. are covered. Only replace the trim pieces showing delamination issues and on the above parts list.**

Covered Carbon Fiber Appliques

- 1 - Driver Outboard Applique
- 2 - Passenger Applique
- 3 - Driver Inboard Applique
- 4 - Front Door Applique
- 5 - Rear Passenger Door Applique
