NUMBER: 23-006-18

Click, Creak or Groaning Sound Near C-Pillar, Dual Pane Sunroof

2016 - ****2018**** (WK) Jeep Grand Cherokee

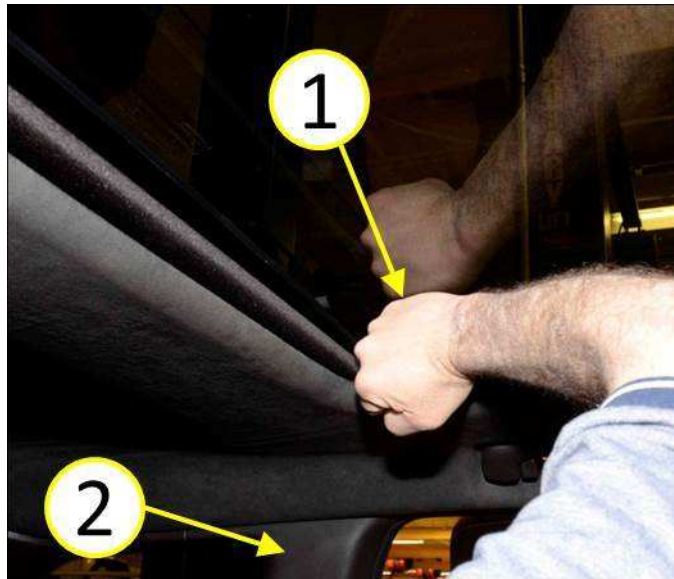
Fig. 1

1. Test drive the vehicle over uneven road surfaces or where the customer advises the noise can be duplicated. Attempt to duplicate the noise by pushing upward on the dual pane sunroof rear panel at the rear corner with increasing pressure, then release while listening for a creak/groan noise. Also try tapping with fist on the dual pane sunroof rear panel at the rear corner while listening for a click/tick noise (Fig. 1) .

Push And Tap On Sunroof Glass Panel

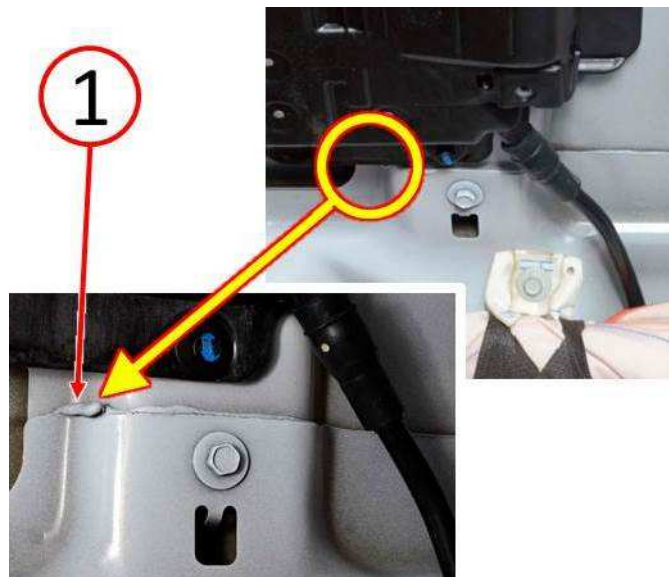
Fig. 2
Visually Inspect For Adhesive

3. Visually inspect for adhesive filling the space between the sheet metal structural components at C-pillar nearest rear corner of sunroof module where the noise was heard. Can adhesive be seen filling the space identified in (Fig. 2) ?

- YES>>> Repeat the diagnostic test of pushing upward on the dual pane sunroof rear panel at the rear corner with increasing pressure and then releasing while listening for creak/groan noise as performed in Step 1. Ensure that the noise is coming from the area identified in (Fig. 2) before proceeding to Step 4. If noise is not coming from this structural joint, this bulletin does not apply and further diagnosis is required.

- NO>>> Adhesive was not observed filling the identified area. Continue to Step 4.
