NUMBER: 23-010-14

Click, Creak, Or Groaning Sound Near C-Pillar, Dual Pane Sunroof (Sales Code GWJ)

2013 - 2014 WK Grand Cherokee

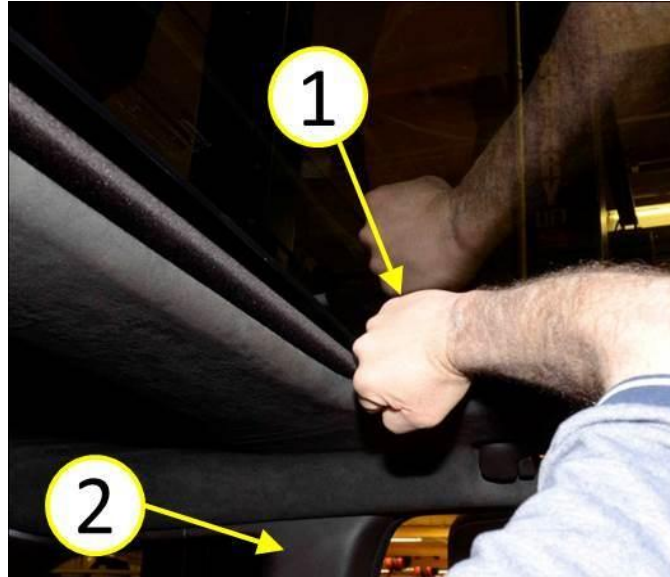
1. Test drive the vehicle over uneven road surfaces or where the customer advises the noise can be duplicated. Attempt to duplicate the noise by pushing upward on the dual pane sunroof rear panel at the rear corner with increasing pressure then release while listening for a creak/groan noise. Also try tapping with fist on the dual pane sunroof rear panel at the rear corner while listening for a click/tick noise (Fig. 1). If the suspect noise is duplicated, proceed to [Step #2](#) .

Fig. 1 Push And Tap On Sunroof Glass Panel

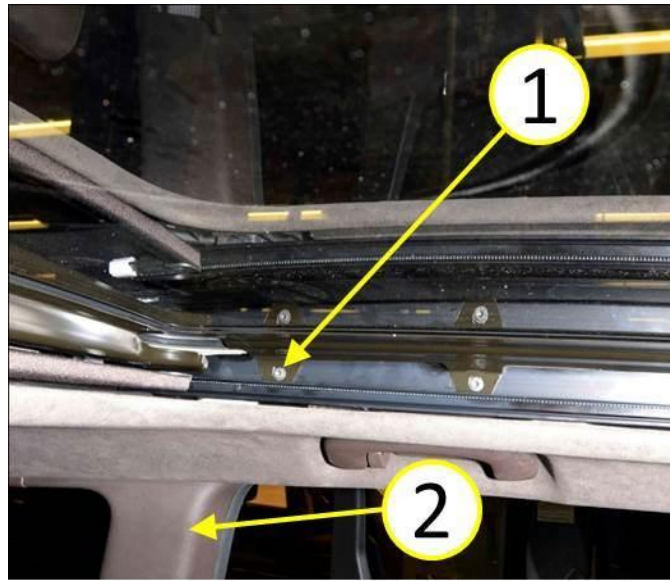
Fig. 2 Sunroof Glass Panel Screw

3. Remove the rear sunroof pane rear attaching screw on the side where the noise is heard (Fig. 2).

-
4. Repeat the test by tapping with a fist on the dual pane sunroof rear panel at the rear corner while listening for the click/tick noise as was done in [Step #1](#) to verify if removing the screw turns off the sound. Was the click/tick sound eliminated?
 - a. Yes>>> Proceed to [Step #5](#).
 - b. No>>> This bulletin does not apply, continue with further diagnosis.
 5. Replace the rear sunroof panel. Refer to the detailed repair procedures available in: DealerCONNECT> TechCONNECT under: Service Info> 23- Body> Sunroof, Dual Pane> GLASS, Sunroof, Rear> Removal/Installation.
 6. Confirm the issue has been resolved then, return the vehicle to the customer.

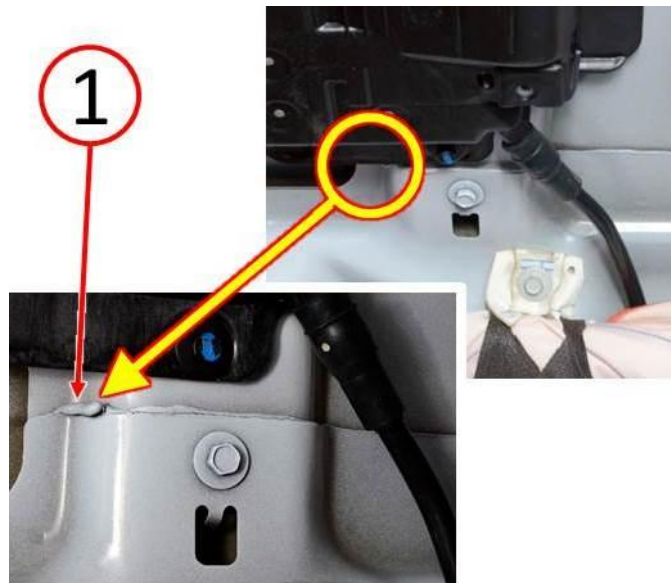
8. Visually inspect for adhesive filling the space between the sheet metal structural components at C-pillar nearest rear corner of sunroof module where the noise was heard. Can adhesive be seen filling the space identified in ([Fig. 3](#))?

- a. Yes>>> Repeat the diagnostic test of pushing upward on the dual pane sunroof rear panel at the rear corner with increasing pressure then release while listening for creak/groan noise as was done in [Step #1](#) to ensure that the noise is actually coming from the area identified in ([Fig. 3](#)) before proceeding to [Step #9](#). If noise is not coming from this structural joint, than this bulletin does not apply and further diagnosis is required.

- b. No>>> Adhesive was not observed filling the identified area. Continue to [Step #9](#).

Fig. 3 Visually Inspect For Adhesive

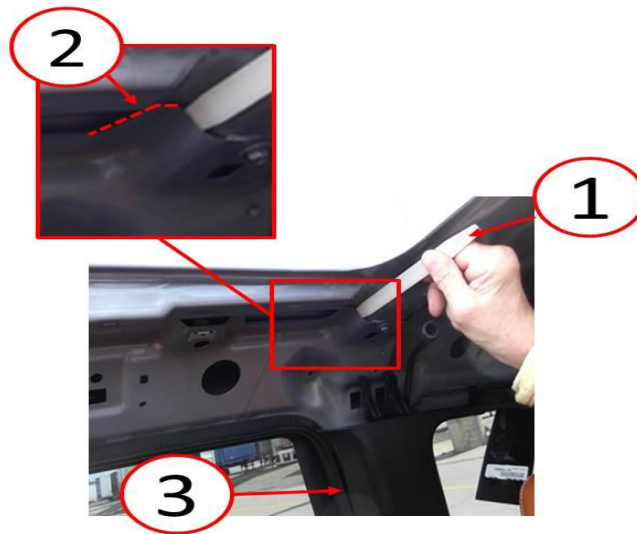
Fig. 4 Dual Pane Sunroof Reinforcement

-
9. Remove the dual pane sunroof module for access to the sheet metal flange. Refer to the detailed repair procedures available in: DealerConnect> TechCONNECT under: Service Info> 23 - Body> Sunroof, Dual Pane> Removal
 10. Insert trim stick C-4755 (1) at the location shown in (Fig. 4). Can the metal be easily moved by moving the trim stick left to right?
 - a. Yes>>> Proceed to [Step #11](#).
 - b. No>>> This bulletin does not apply, continue with further diagnosis.
 11. Clean and prepare the sheet metal flange (2) identified in (Fig. 4) for application of structural adhesive per the adhesive manufacturer's recommendations.
 12. Apply Lord Fusor 112B structural adhesive or equivalent at the sheet metal flange, location (2) identified by the dashed line in (Fig. 4).

-
13. Allow the adhesive to cure per the adhesive manufacturer's recommendations.
 14. Install the dual pane sunroof module. Refer to the detailed repair procedures available in: DealerConnect> TechCONNECT under: Service Info> 23 - Body> Sunroof, Dual Pane> Installation.
 15. Install the headliner. Refer to the detailed procedures available in DealerCONNECT> TechCONNECT>: Service Info> 23 -Body> Interior > Headliner> Installation.
 16. Confirm the issue has been resolved, then return the vehicle to the customer.
