NUMBER: 23-015-11

DATE: April 20, 2011

Loose And/Or Squeaking Front Seat Cushion

Grand Cherokee

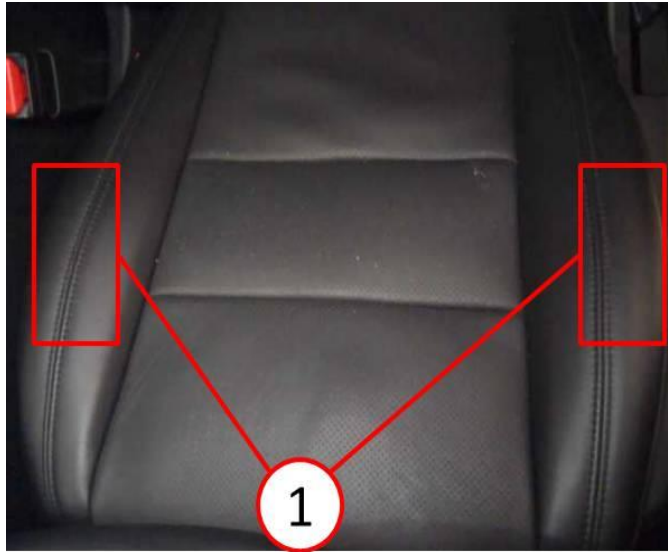
Fig. 1 Front Seat Cushion Bottom

1. Grab either side of the seat bottom ([Fig. 1](#)) and attempt to move side to side. Inspect for side to side movement and/or squeaking. Was there any excessive side to side movement and/or squeaking?
