NUMBER: 23-022-12 REV. A

Knocking Sound From Instrument Panel Area Near The A-Pillar

2011 - 2012	(WD)	Durango
2011 - 2012	(WK)	Grand Cherokee

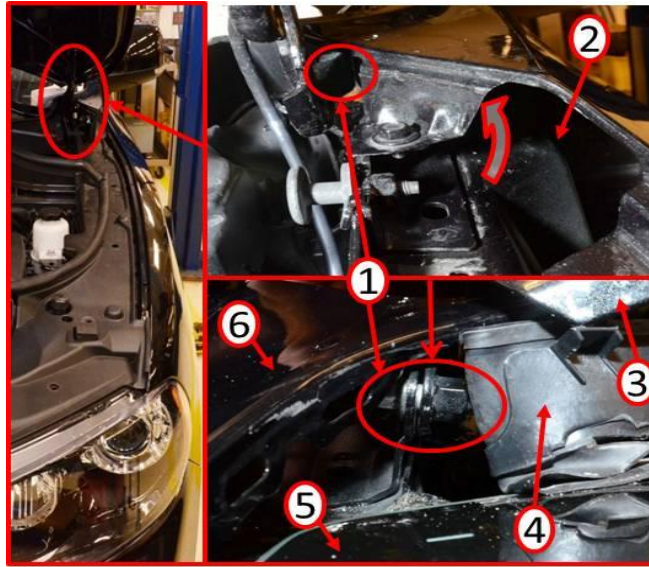
Fig. 3 Hood Hinge Pivot Bolt Removal

An audible buzz, squeak, or rattle (BSR) or knocking sound may appear to be coming from the instrument panel (I/P) area at or near the front leading edge of the A-pillar. The noise may actually be caused by an improperly adjusted hood hinge. The hood hinge can be checked in the closed position by grasping the hood near the rear corners at the hinge and lifting up and down. If excessive motion and/or a knocking sound is produced or the customer describes the symptom, perform the Repair Procedure.

9. Remove and replace the driver side hood hinge pivot bolt ([Fig. 3](#)).

NOTE: The front fender does not need to be removed in order to replace the hood hinge pivot bolt which can be accessed through the hood hinge pivot bolt access area (2) shown in ([Fig. 3](#)).

NOTE: Torque the new hood hinge pivot bolt to 13ft/lbs(17nm).
