NUMBER: 23-033-11

DATE: August 25, 2011

Waterleak Diagnosis Procedures

2011 WK Grand Cherokee

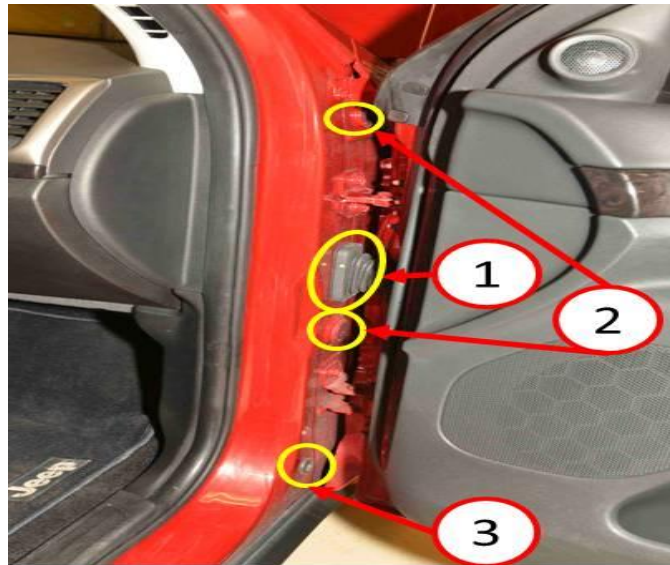
Fig. 1 Inspect A-Pillar Body Side Grommets

- 1 - Door Wire Harness Seal
 - 2 - Body Plugs
 - 3 - Body Grommet
-

1. Check plugs and grommets in body side at door hinge area for proper installation by pushing down around perimeter of grommet to ensure they are fully seated (Fig. 1).

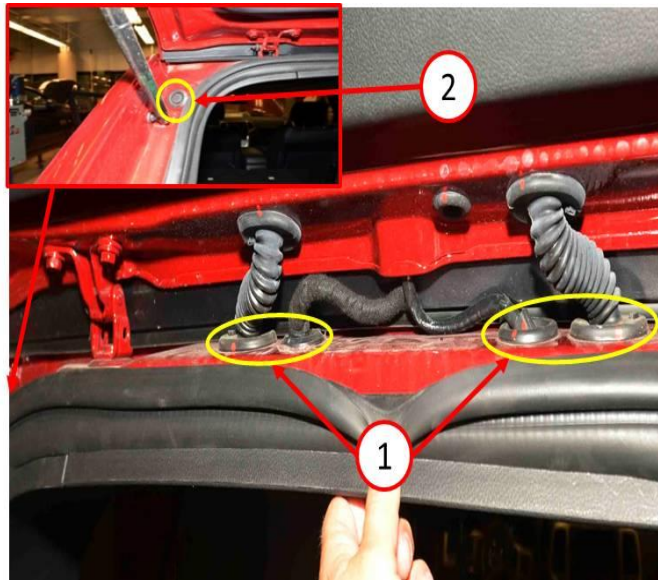
Fig. 2 Inspect Rear Liftgate Body Grommets

- 1 - Liftgate Body Side Grommets
- 2 - Body Grommet (Driver Side)

NOTE: Raise and lower liftgate to verify wiring is not pulling grommet out of hole in sheet metal.

2. Open rear liftgate and verify liftgate wiring grommets to body are fully seated to body sheet metal by pushing down around perimeter of grommet (Fig. 2).

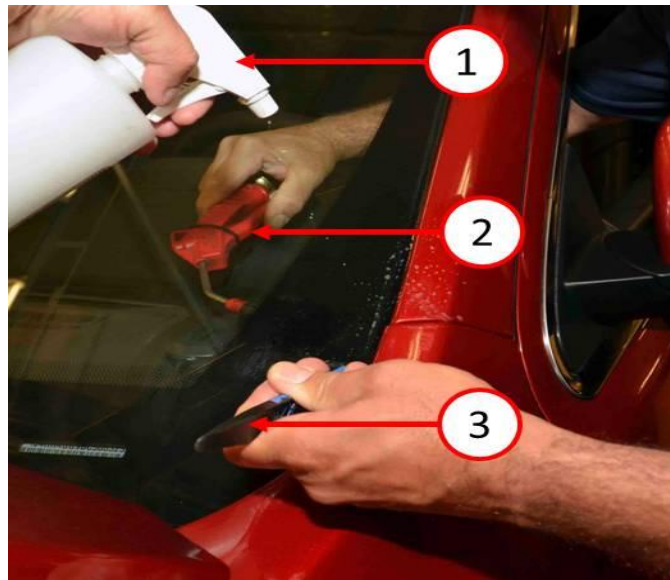
Fig. 3 Leak Check Lower Windshield Seal

NOTE: Lift up the rubber windshield molding with a trim stick (3) for a visual of possible bubbles ([Fig. 3](#)).

- 1 - Soapy Water Solution
 - 2 - Blow Gun (Compressed Air)
 - 3 - Trim Stick
-

5. Did water enter the vehicle interior down the front of the dash panel area or through the side cowl area?
 - a. Cowl Side Area Leak >>> Proceed to [Step #6](#).
 - b. Dash Panel Area Leak >>> Proceed to [Step #11](#).
6. Determine if the water leak is originating from the lower corners of the windshield.
7. Lift up rubber windshield molding with trim stick (3) and spray foamy glass cleaner or soapy water solution (1) against the windshield urethane surface ([Fig. 3](#)).
8. Apply shop air using blow gun (2) from the interior of the vehicle at the bottom corner of the windshield and inspect for air bubbles on exterior windshield urethane surface ([Fig. 3](#)).

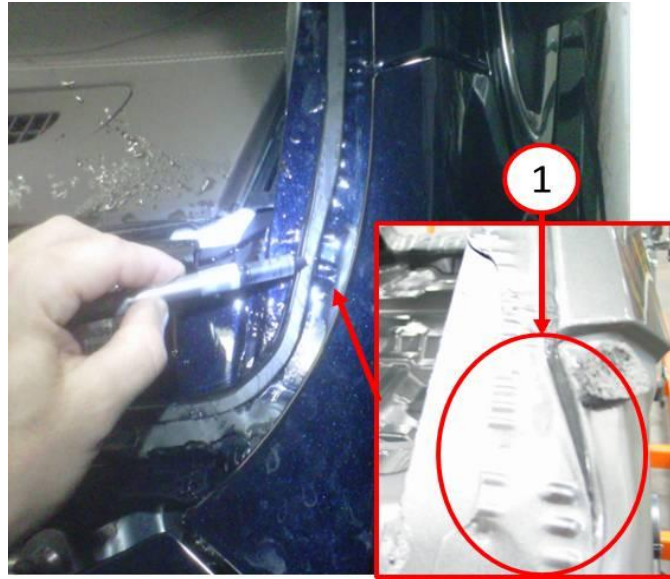
Fig. 4 Windshield Resealing

1 - Take-Up Beads

NOTE: Use larger urethane bead at lower corner to ensure sealing around the sheet metal take-up beads (1) (Fig. 4).

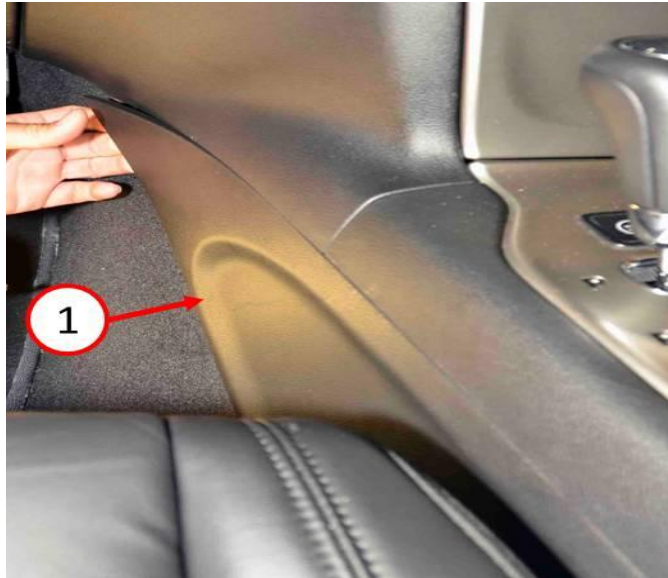
Fig. 5 Console Side Cover Removal

1 - Side Cover

11. Inspect the HVAC A/C condensate drain grommet to ensure that it is fully seated.
Refer to the detailed procedures available in DealerConnect>TechCONNECT> under:
Service Info> 23 - Body> Interior> BEZEL, Shifter> Removal .
12. Using a trim stick or equivalent, release the clip fasteners and separate the driver side console side cover (Fig. 5).

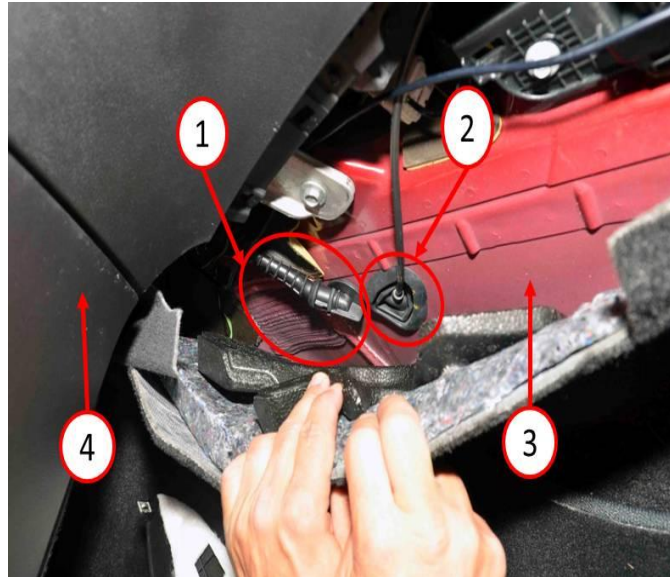
Fig. 6 Inspect HVAC Drain Tube

NOTE: If HVAC Grommet Seal is not seated (1), A/C condensate can leak onto floor panel. Grommet must be fully seated (Fig. 6).

- 1 - HVAC Drain Tube Grommet
 - 2 - Shifter Cable Grommet
 - 3 - Driver's Side of Transmission Tunnel
 - 4 - Instrument Panel
-

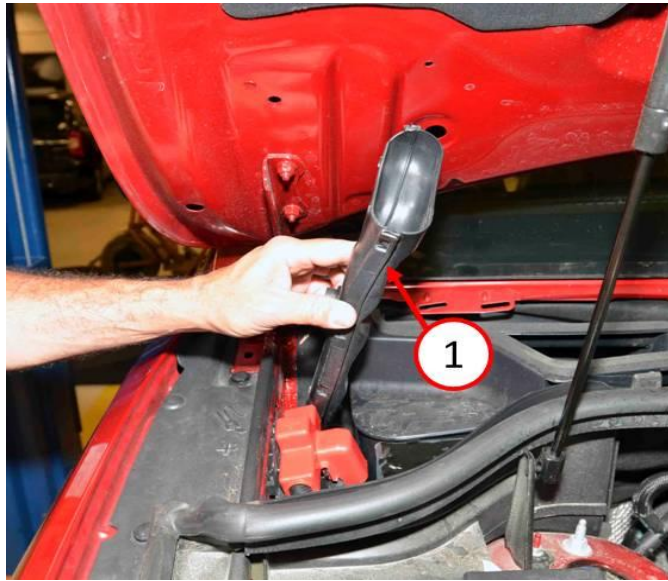
Fig. 7 Cowl Drain Trough Removal

1 - Cowl Drain Trough

NOTE: Sunroof drain tube grommets must be fully seated to dash panel with drain tubes properly protruding out of dash panel or water may leak into the interior floor panels.

13. Using a trim stick or equivalent, remove the right and left cowl drain troughs (1) to inspect the right and left sunroof drain tube grommets (Fig. 7).

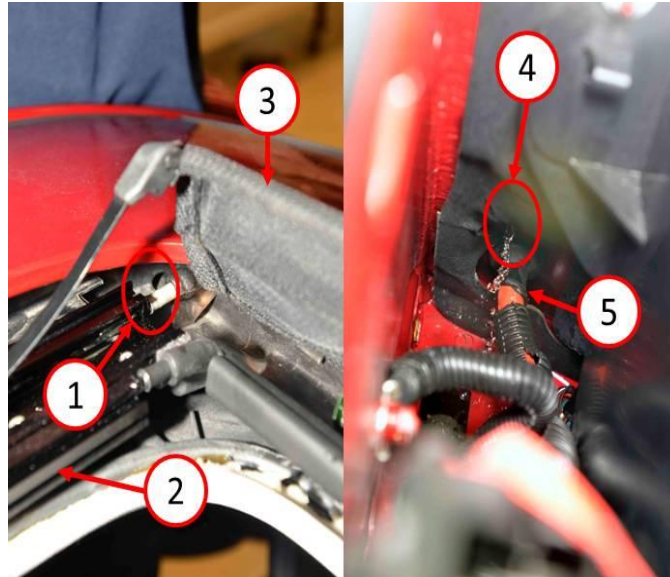
Fig. 8 Inspect Sunroof Drain Tubes

- 1 - Sunroof Drain Tube Port
- 2 - Sunroof Module
- 3 - Wind Stop
- 4 - Drain Tube Grommet (Under hood)
- 5 - Dash Panel Pass-Through Grommet

NOTE: Make sure the dash panel pass-through grommet (5) (located below passenger side drain tube grommet) is fully seated in the dash panel. Water from the sunroof drain tube (4) could leak into the vehicle interior unless grommet is fully seated.(Fig. 8).

14. Water flow test the sunroof drain tubes using approximately 16 ounces (500mL) of water to verify possible obstructions and/or leaks (Fig. 8).

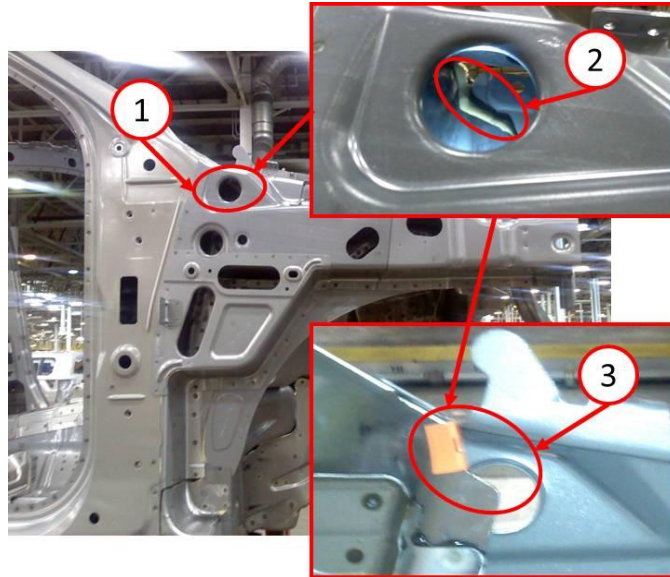
Fig. 9 Body Knife Edge Sealing

- 1 - Body Reinforcement Panel
 - 2 - Urethane “Knife Edge” Seam
 - 3 - Inside View of “Knife Edge” Seam Location
-

15. Was the vehicle built prior to January 5, 2011?
 - a. Yes >>> Proceed to [Step #16](#).
 - b. No >>> Proceed to [Step #20](#).
16. Remove the front fenders. Refer to the detailed procedures available in DealerConnect>TechCONNECT> under: Service Info> 23 - Body> Exterior> FENDER, Front> Removal.
17. Access and reseal (2) the “knife edge joint” (3) between the body side Inner and body side reinforcement using Kent P10200 High-Tech Clear seam sealer or equivalent.
