NUMBER: 23-046-16

DATE: September 28, 2016

Incorrect Gap Tolerance Between The Liftgate And Left Tail Lamp

2017	(WK)	Jeep Grand Cherokee
2017	(WD)	Dodge Durango

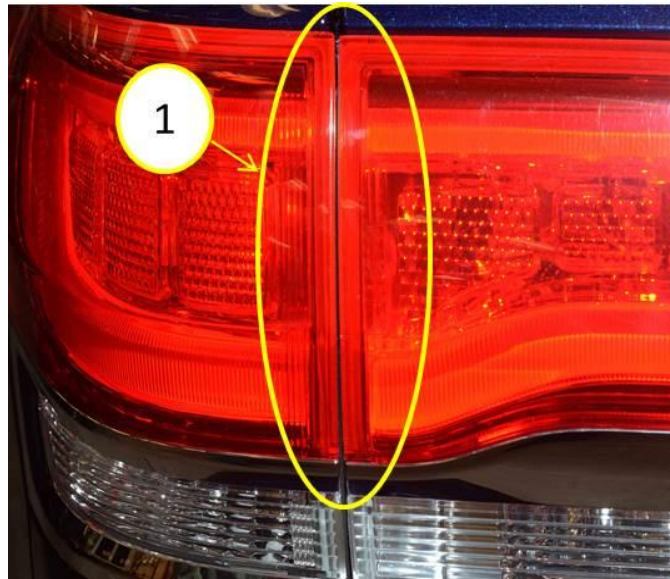
Fig. 1 Too Close Of Gap Clearance

This bulletin involves removing excess sealant from the body behind the tail lamp to open the gap clearance between the left tail lamp and the liftgate.

Customers may notice that the left rear tail lamp has too tight of a gap (Fig. 1) compared to the right rear tail lamp (Fig. 2).

1 - Gap Clearance Too Close (Left Side)

1. Remove the left tail lamp assembly. Refer to the detailed service procedures available in DealerCONNECT> TechCONNECT under: Service Info> 08 - Electrical/8L - Lamps and Lighting/Lamps/Lighting - Exterior/Lamp, Tail Stop Turn/Removal.
2. Remove sealant using scraper tool (Fig. 3). Sealant should be removed from these areas (Fig. 4).

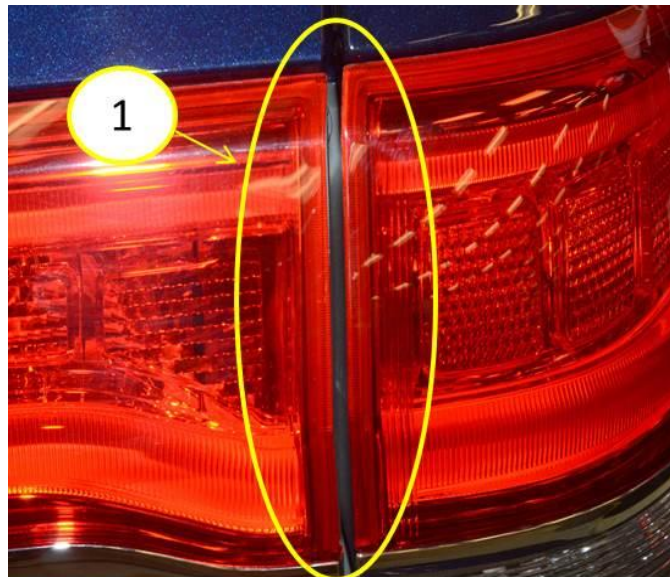
Fig. 2 Proper Gap Clearance

1 - Proper Gap Clearance (Right Side)

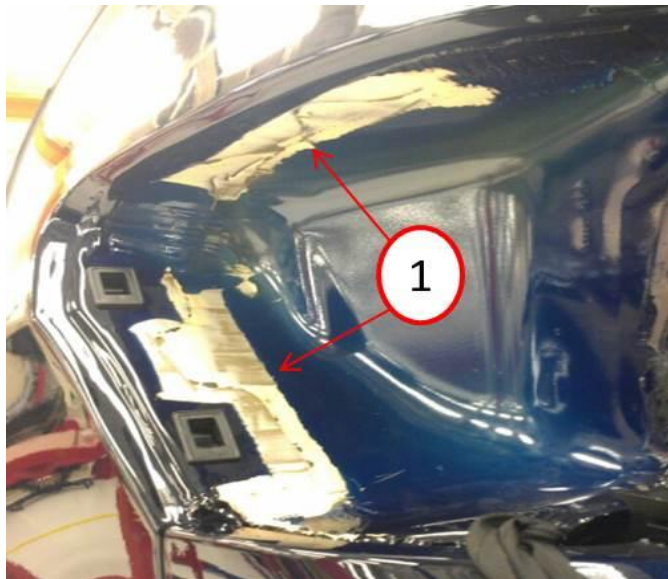
Fig. 4 Area To Be Removed And Reapplied Sealant

1 - Areas To Be Removed And Reapplied With New Sealant

5. Clean and prepare application area as needed before applying sealer per the manufacturer's directions (Fig. 4).
6. Apply clear air dry sealant (Kent High-Tech Seam Sealer). Using a brush, seal the seam completely from top to bottom and allow to fully dry per the manufacturer's directions.

7. Smooth out flat the newly applied sealer with wood applicator or equivalent (Fig. 4).
8. Install the left tail lamp assembly. Refer to the detailed service procedures available in DealerCONNECT> TechCONNECT under: Service Info> 08 - Electrical/8L - Lamps and Lighting/Lamps/Lighting - Exterior/Lamp, Tail Stop Turn/Installation.
