**NUMBER:** 31-001-19

**GROUP:** 31 - Collision Bulletins

**DATE:** July 31, 2019

Aluminum Body Panel Corrosion Repair

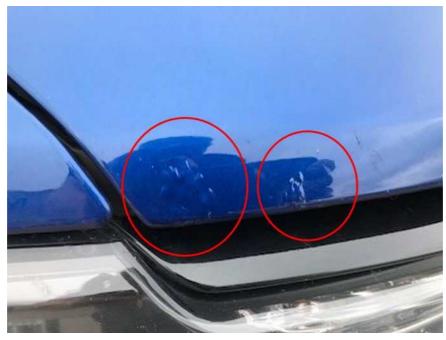
Aluminum corrosion along the leading edge of hood or other exterior surface areas of the doors, fenders or liftgates (Fig. 1).

Fig. 1
Examples of Corrosion Along Leading Edges

Is corrosion evident on the aluminum panel surface (Fig. 1)?

- YES>>> Must receive authorization from vehicle digital imaging and/or Regional Office. Once approval is received from digital imaging or Regional Office, Proceed to Step 1 of the diagnosis procedure.
- NO>>> Submit the vehicle digital image for further analysis.
- 1. Remove blistered paint from the panel surface with 80 grit grinding disc.
- 2. After digital imaging or Regional Office approval and removing the initial blistered paint from the panel surface with 80 grit grinding disc, is severe pitting exhibited that cannot be removed with

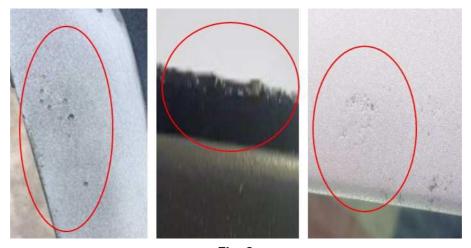
sandpaper, 3M Clean and Strip Disc or equivalent (Fig. 2)?

Fig. 2
Corrosion Examples

- YES>>> Replace the panel.
- NO>>> Proceed to Step 1 of the repair procedure.
