**NUMBER:** 03-002-18

Front Differential Bolt Not Torqued To Cradle

This bulletin involves tightening the front differential mounting bolt to specification.

2018	(WD)	Dodge Durango
2018	(WK)	Jeep Grand Cherokee

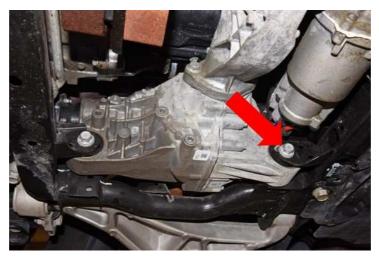
Fig. 1 Mounting Bolt

- 1. Remove the front skid plate. Refer to the detailed service procedures available in DealerConnect> TechCONNECT under: Service Info>13 Frame and Bumpers / Under Body Protection / Plate, Skid, Front Suspension/Removal.
- 2. Is the front differential mounting bolt to cradle missing (Fig. 1)?
  - YES>>> Install a new bolt and tighten to 118 N·m (87 ft. lbs.). Proceed to Step 4.
  - NO>>> Proceed to Step 3.

- 3. Tighten the front differential mounting bolt to 118 N·m (87 ft. lbs.).
- 4. Install the front skid plate. Refer to the detailed service procedures available in DealerConnect> TechCONNECT under: Service Info>13 Frame and Bumpers / Under Body Protection / Plate, Skid, Front Suspension/Installation.
