NUMBER: 09-009-18

Oil Filter Adapter (OFA) - Pressure Relief Valve Replacement

This bulletin involves replacing the pressure relief valve in the OFA assembly.

NOTE: This bulletin applies to vehicles equipped with the 3.6L V6 24V VVT Engine (Sales Code ERB).

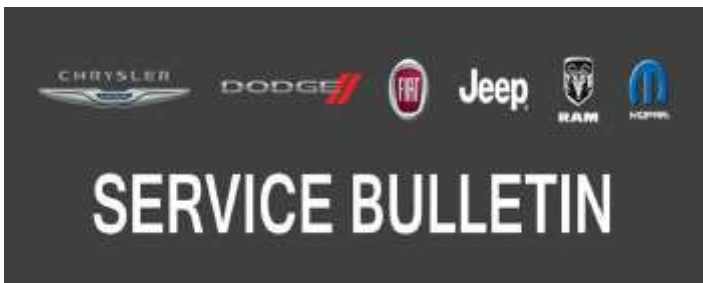
Missing Oil Pressure Relief Valve Spring

The technician may find when replacing an oil filter, the oil pressure relief valve is missing from the support stem of the OFA (Fig. 1) .

NOTE: Inspect the oil filter adapter for any damage. If the supports are broken the replacement oil pressure relief valve may come loose. If there is damage to the oil pressure relief valve support (**Fig. 1**), the entire oil filter adapter will need to be replaced under normal service procedure and warranty.

1. While performing an oil filter change, examine the OFA for a missing or broken oil pressure relief valve (**Fig. 1**). If the oil pressure relief valve is missing or broken, proceed to [Step 1](#).

1. If the oil pressure relief valve is missing install the new oil pressure relief valve. Refer to the detailed service procedures available in DealerCONNECT> TechCONNECT under: Service Info>09 - Engine, 3.6L/Lubrication/Valve, Oil Pressure Relief/Removal/Installation. (Fig. 2) .

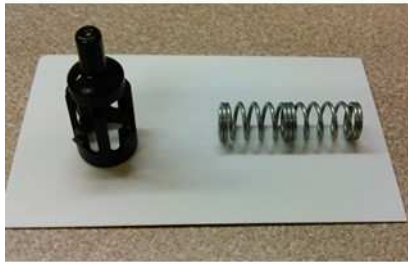
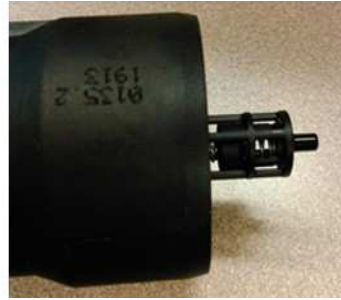
Fig. 2
New Oil Pressure Relief Valve

NOTE: The replacement kit will include a new spring and valve.
