**NUMBER:** 17-002-13

**GROUP:** Rear Suspension

Squeak And/Or Creak Noise Coming From Rear Of Vehicle

2011-2013 (WK) Grand Cherokee

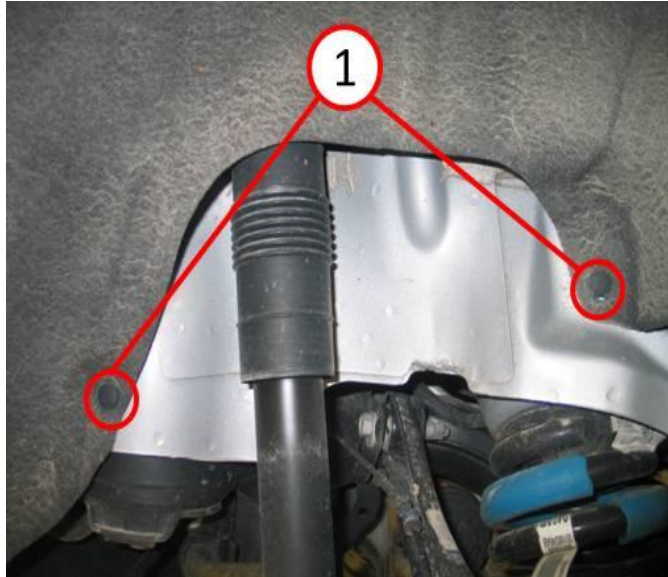
***Fig. 1 Wheel House Liner***

3. Raise the vehicle on a suitable hoist. Refer to the detailed procedures available in DealerCONNECT> TechCONNECT under: Service Info > 4 - Vehicle Quick Reference > Hoisting.
4. Remove the left and right rear wheel and tire assemblies.
5. Locate and remove the push pins from the inner wheel house and pull back the liner to fully access the rear strut assembly ([Fig. 1](#)).

1 - Push Pins

- 15. Reposition inner wheel house and install the two push pins (1) (Fig. 1).
- 16. Repeat the appropriate steps to the other side rear shock.
- 17. Install the left and right rear wheels and tires. Refer to the detailed removal procedures available in DealerCONNECT> TechCONNECT under: Service Info > 22 - Wheels and Tires> Wheels> Standard Procedure> Wheel Installation.

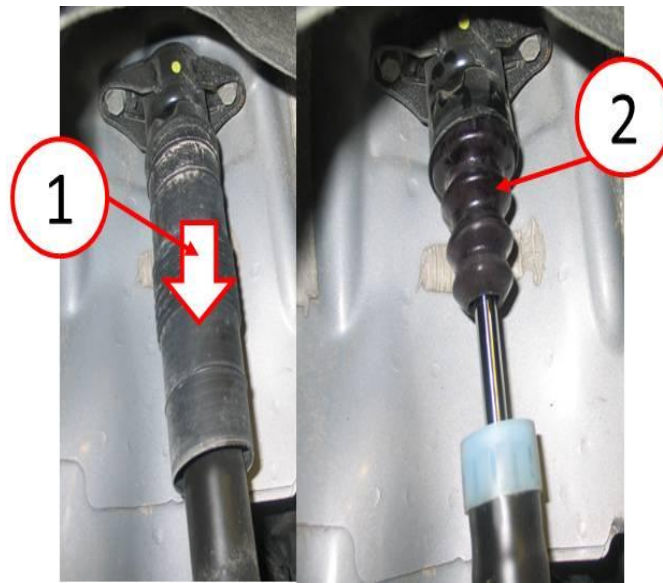
**Fig. 2 Dust Boot Removal**

- 
6. Pull the dust boot (1) downward from the top of the shock to expose the jounce bumper (2) ([Fig. 2](#)).

- 1 - Pull Downward
- 2 - Jounce Bumper

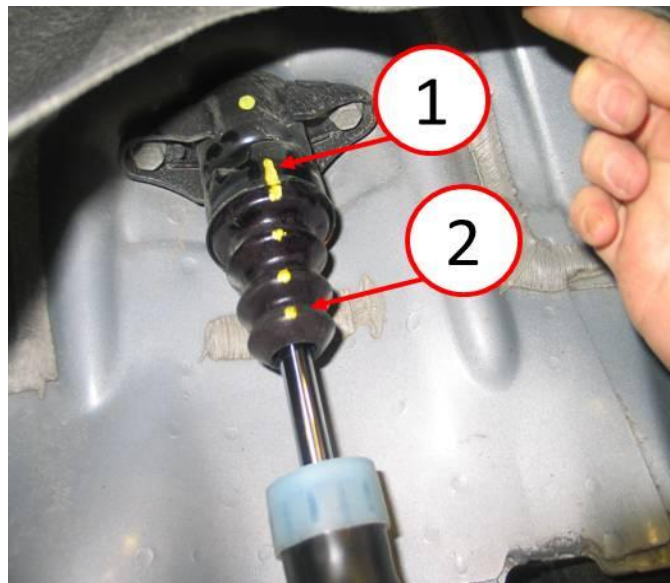
**Fig. 3 Jounce Bumper Alignment**

- 
7. Was the vehicle built prior to March 17, 2011?
    - a. Yes >>> Proceed to [Step #8](#).
    - b. No >>> Proceed to [Step #13](#).
  8. Mark the upper shock mount (1) and jounce bumper (2) as shown ([Fig. 3](#)), to assist in proper alignment during re-assembly.
  9. Pull the jounce bumper (2) downward from the upper mount (1) ([Fig. 3](#)) to expose the upper surface of the jounce bumper and thoroughly clean it with isopropyl alcohol.

- 1 - Upper Shock Mount Alignment Indicator
- 2 - Jounce Bumper Alignment Indicator

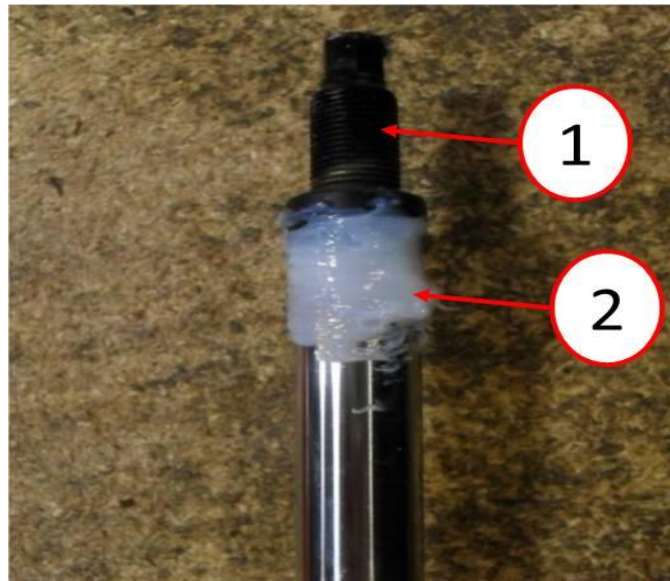
**Fig. 4 Grease Upper Shock Shaft At Mount**

10. Apply Nye Grease, P/N 05019061AA (2) to the upper end of the shock shaft (1) just below where it connects to the upper mount (Fig. 4).

**NOTE: Shock was removed for visual purposes to show the upper end of the shaft just below where it connects to the upper mount. The shock does not need to be removed to complete the repair.**

- 1 - Upper Shock Shaft Mounting Threads (Secures Shock Shaft to Upper Mount)
- 2 - Nye Grease Application (Upper End of Shock Shaft)

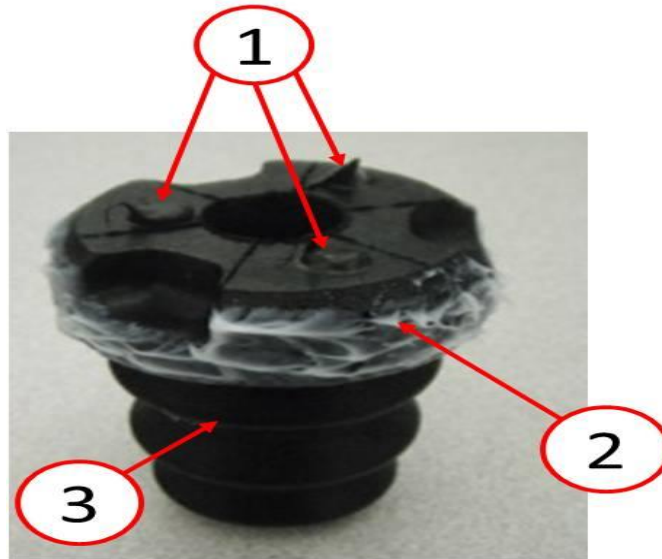
**Fig. 5 RTV and Nye Grease**

11. Apply a dab of RTV P/N 04883971 to the locators (1) and apply Nye Grease, P/N 05019061AA to the perimeter (2) of the jounce bumper as shown in (Fig. 5).

**NOTE: Jounce bumper was removed for visual purposes to show the upper locating nibs and does not need to be removed to perform the repair.**

**NOTE: Only apply the RTV on the locating nibs being careful not to contaminate the other surfaces with the RTV.**

- 1 - RTV Application Area
- 2 - Nye Grease Application
- 3 - Jounce Bumper

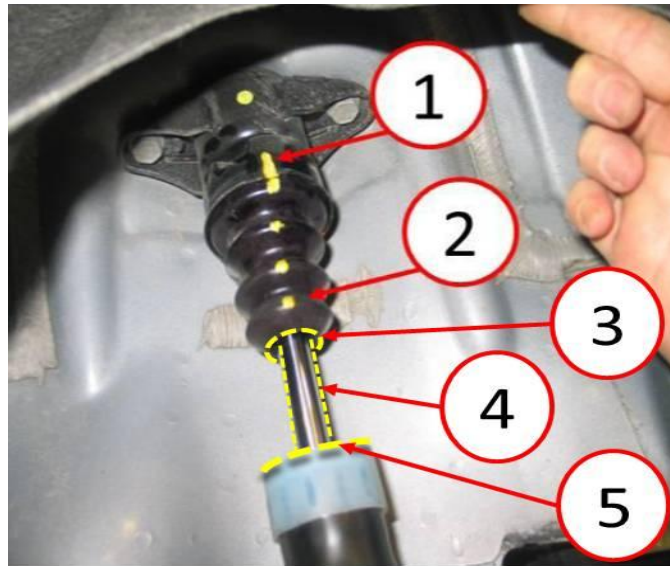
**Fig. 6 Apply Nye Grease**

12. Install the jounce bumper into the upper mount aligning the indicator marks of the upper shock mount and the jounce bumper (Fig. 6).

**NOTE: Ensure jounce bumper is correctly oriented into upper mount cup. Jounce bumper cut outs must line-up with upper mount cup formations. Incorrect installation will cause noise and/or harsh ride.**

13. Apply Nye Grease, P/N 05019061AA to the bottom/small end face of the jounce bumper (3), shock shaft (4) and top of the shock striker cap (5) (Fig. 6).

**NOTE: When applying grease to the bottom of the jounce bumper, the grease should be squeezed as best as possible up between the jounce bumper and the shock shaft. The goal is to get lubrication between the jounce bumper and shock shaft without removing the shock or pulling the jounce bumper down out of the mount.**

**NOTE: Vehicles built after March 17,2011 have the jounce bumper fixed to the upper shock mount. Trying to pull the jounce bumper out of the mount can result in damage to the jounce bumper if built after this date.**

- 1 - Upper Shock Mount
- 2 - Jounce Bumper
- 3 - Bottom of Jounce Bumper
- 4 - Shock Shaft (Visible Portion)
- 5 - Striker Cap (Top of Shock Body)

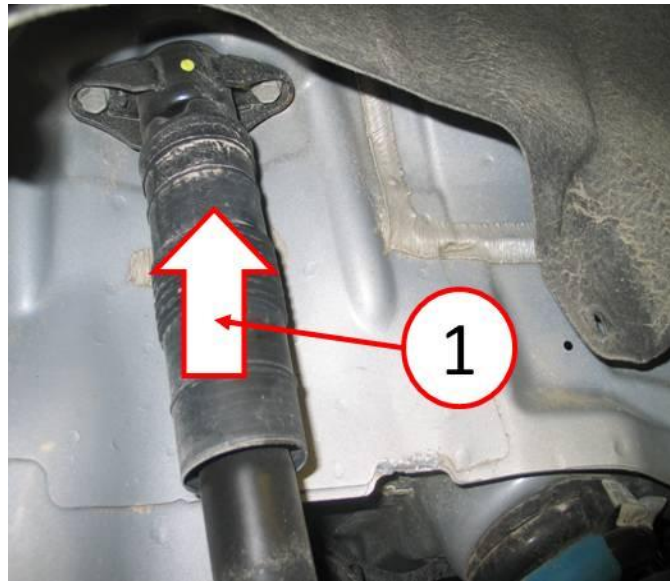
**Fig. 7 Dust Boot**

14. Install dust cover onto upper mount and jounce bumper assembly sliding upward as shown in (Fig. 7).

1 - Push Dust Boot Up
