NUMBER: 21-012-11

Chatter On Turns During Parking Lot Maneuvers

2012 WK Grand Cherokee SRT 8

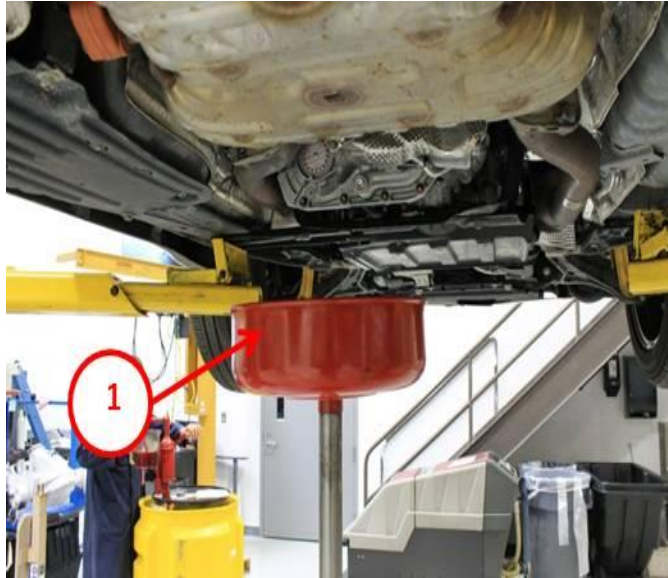
Fig. 1 Drain Transfer Case Fluid

1 - Drain Pan

2. Place oil drain pan (Fig. 1) under drain plug (Fig. 2).

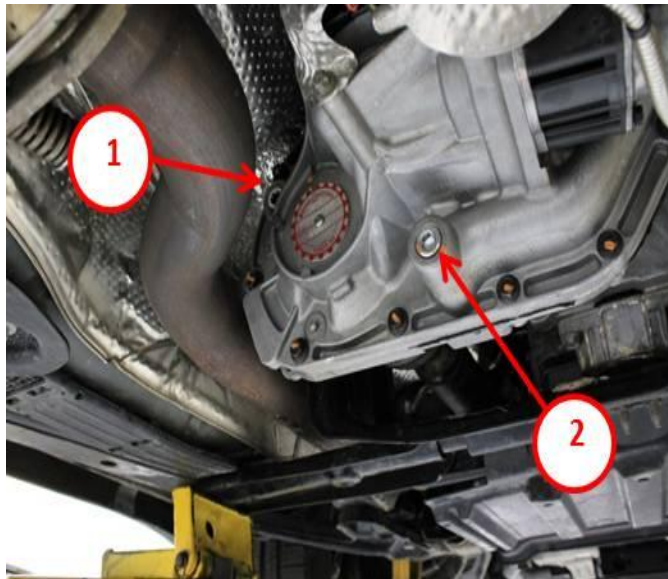
Fig. 2 Transfer Case Fill And Drain Plug Location

1 - Transfer Case Fill Plug
2 - Transfer Case Drain Plug

-
4. Drain the oil. Allow the oil to drain approximately 8-10 minutes to allow all of the oil to drain out.
 5. Re-install the drain plug. Tighten the drain plug to 15 - 22 ft. lbs. (20-34 Nm).
 6. Remove the fill plug (Fig. 2). Then, using a suction gun, fill the transfer case with 2 quarts (1.9 liters) of Mopar ATF+4 Transmission Fluid (p/n 05013457AA).

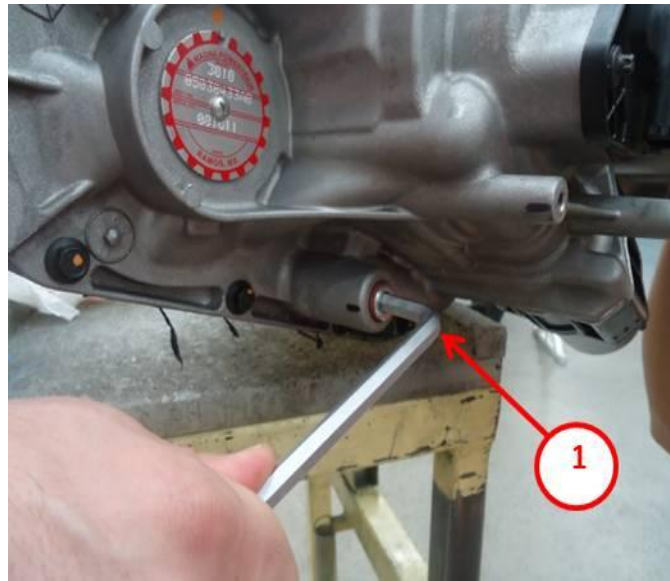
Fig. 3 Removing Transfer Case Drain Plug

1 - 8mm Allen Wrench

3. With an 8 mm Allen Wrench, remove drain plug (Fig. 3).

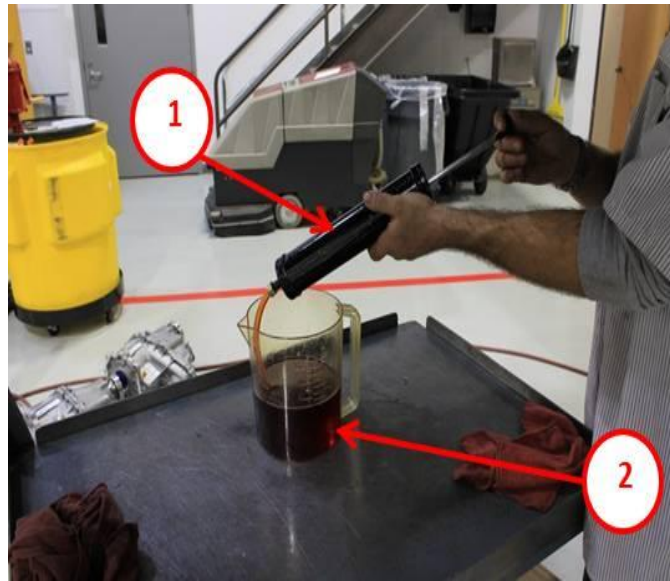
Fig. 4 Using Suction Gun To Fill Transfer Case

- 1 - Suction Gun
- 2 - Mopar ATF+4 Transmission Fluid
