**NUMBER:** 23-031-13

Second Row Headrest Creak And/Or Squeak

This bulletin involves inspecting and if necessary replacing the second row left and right headrest mechanism.

2013	WD	Durango
2013	WK	Grand Cherokee

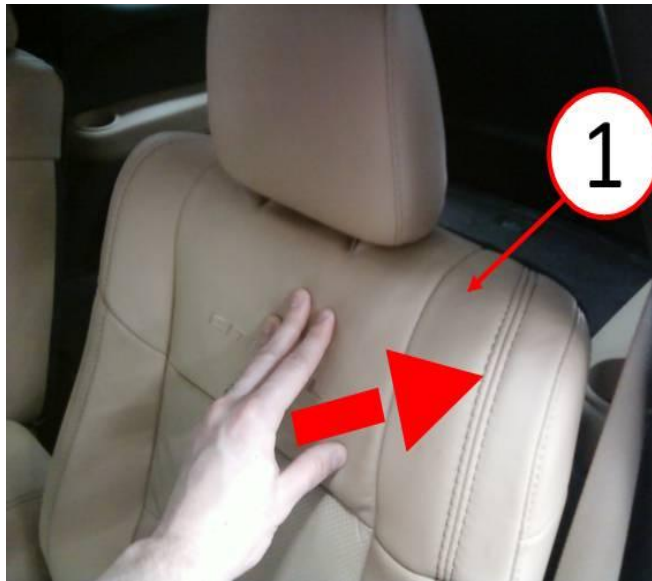
***Fig. 1 Inspection***

1. Push on the left and then right side of the 2nd row upper seat back just under the headrest as shown in (Fig. 1). Did a metal to metal squeak sound occur?
  - a. Yes>>> Proceed to [Step #2](#).
  - b. No>>> This bulletin does not apply, continue further diagnosis.

1 - Seat Back Cover

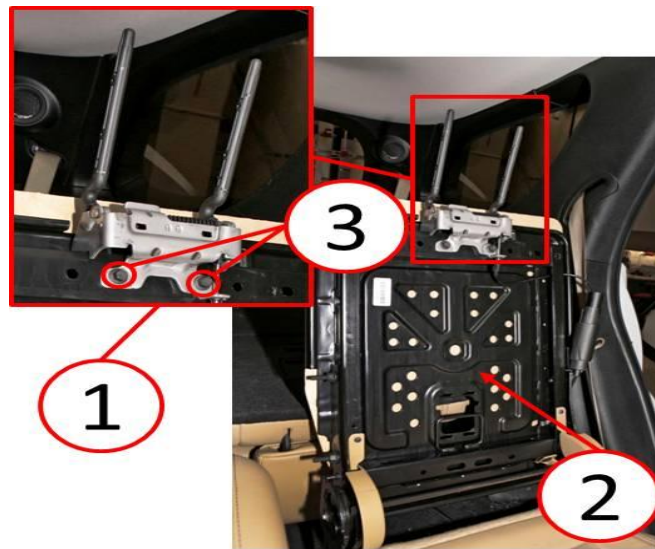
**Fig. 2 Headrest Mechanism**

- 1 - Headrest Mechanism
- 2 - Seat Back Frame
- 3 - Bolts

3. Remove the bolts shown in (Fig. 2) and discard the headrest mechanism.

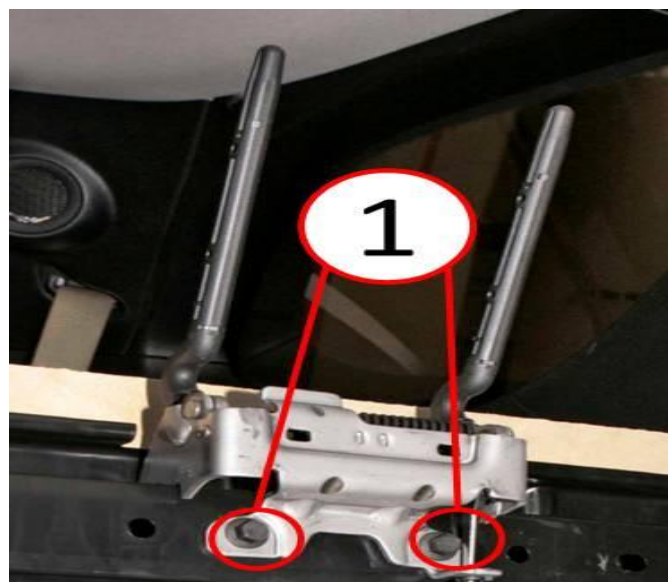
**Fig. 3 Headrest Mechanism**

- 1 - Torque to 21 N·m (15 ft. lbs.)
-

- 
4. Install the new headrest mechanism and torque the bolts shown in (Fig. 3) to 21N·m (15 ft. lbs.).
