April 2013

Dealer Service Instructions for:

Customer Satisfaction Notification N06 Instrument and Door Panel Applique Delamination

2012 (WK) Jeep® Grand Cherokee SRT8

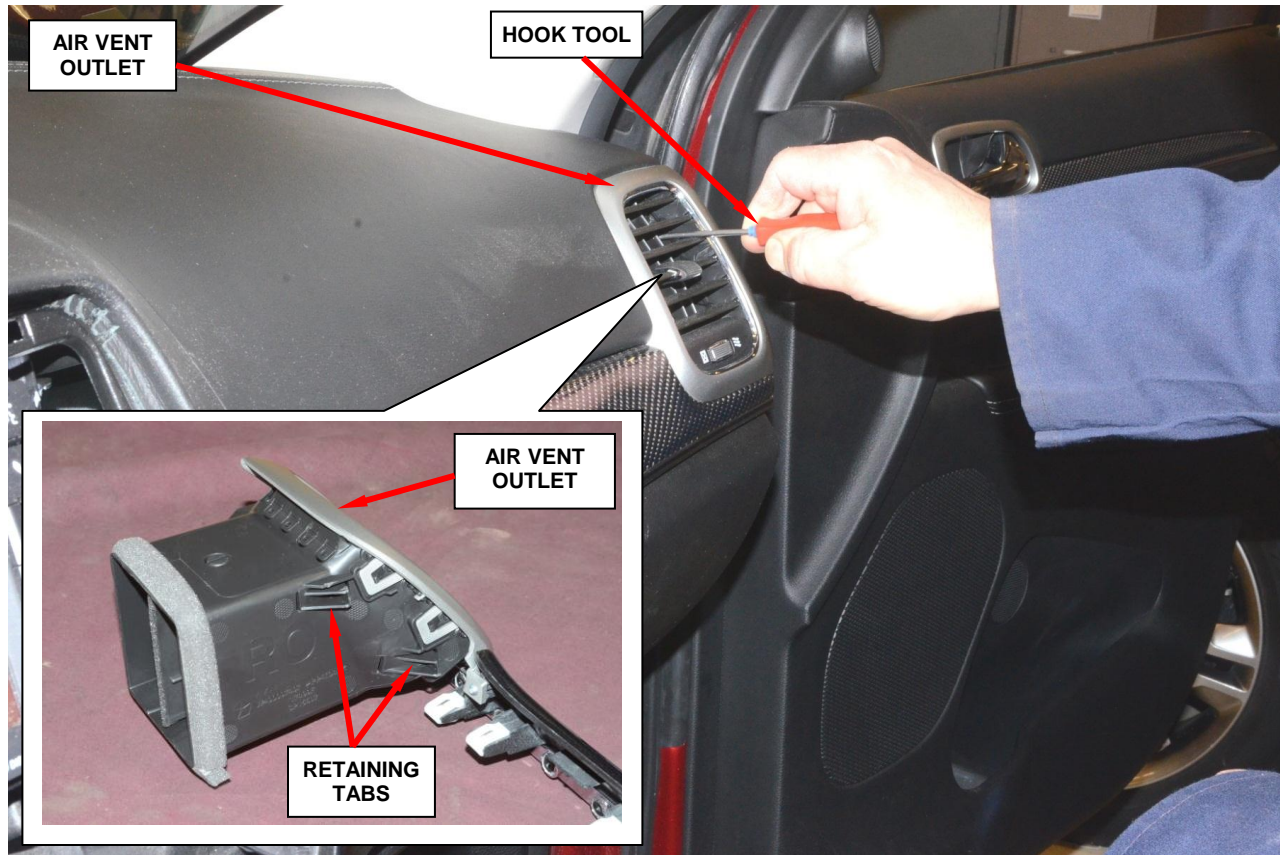
Figure 3 – Disengage the Air Vent Outlet Retaining Tabs (two per side)

CAUTION: The four air vent outlet retaining tabs are difficult to see and even more difficult to disengage. Extreme patience and perseverance is required to disengage the four air vent outlet retaining tabs.

4. Using a small hook tool, carefully disengage the four (4) right air vent outlet retaining tabs and remove the air vent outlet and carbon fiber bezel as an assembly (Figure 3).

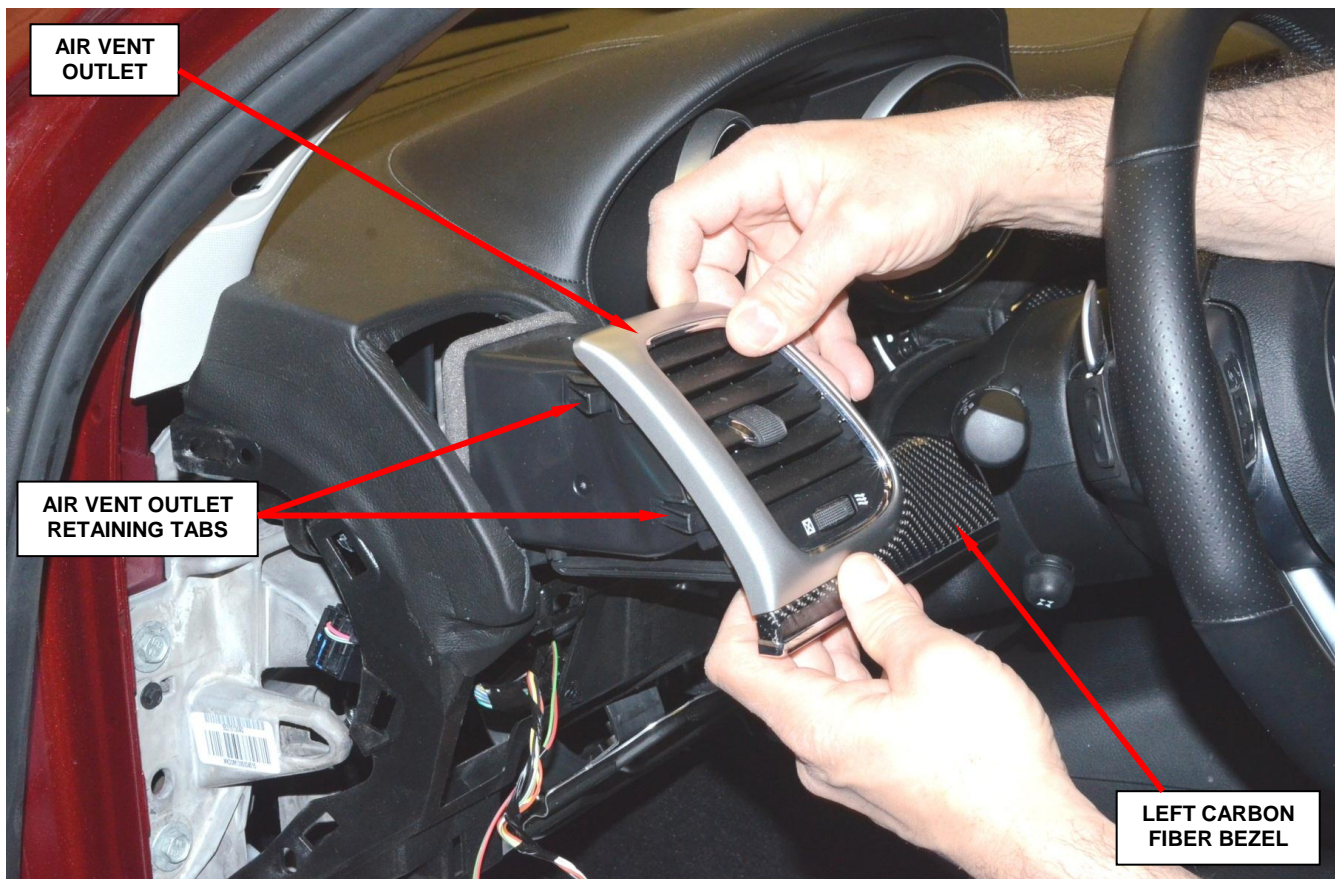
Figure 11 – Air Vent Outlet and Left Bezel Assembly

CAUTION: The four air vent outlet retaining tabs are difficult to see and even more difficult to disengage. Extreme patience and perseverance is required to disengage the four vent outlet retaining tabs.

21. Remove and save the left instrument panel carbon fiber bezel retaining screw (Figure 10).
22. Using a small hook tool, disengage the four (4) left air vent outlet retaining tabs and remove the air vent outlet and left instrument panel carbon fiber bezel as an assembly (Figure 11).

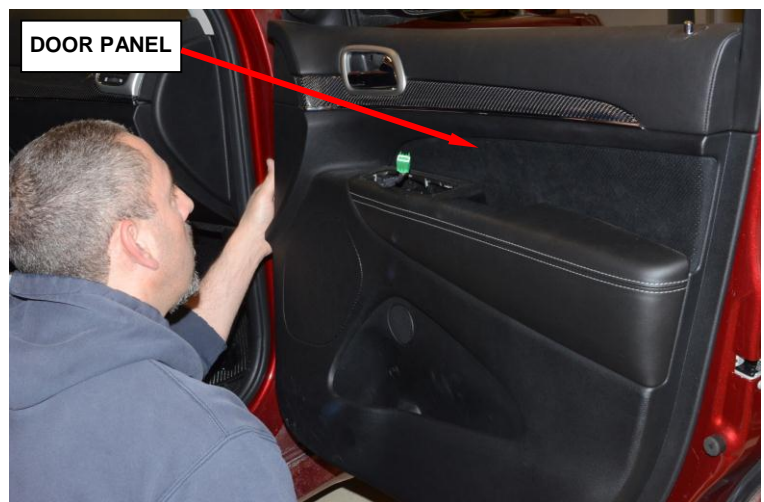
Figure 17 – Remove/Install Door Panel

CAUTION: Be sure that all door panel retaining clips are properly engaged.

7. Remove and discard the original carbon fiber door panel bezel.
8. Place the new carbon fiber door panel bezel into position on the door panel.
9. Install the seven (7) carbon fiber door panel bezel retaining screws. Tighten the screws securely.
10. Carefully install the door panel onto the door (Figure 17).
