Dealer Service Instructions for:

Safety Recall R71 / NHTSA 15V-879

Sun Visor Wiring

2011 – 2012 (WD) Dodge Durango

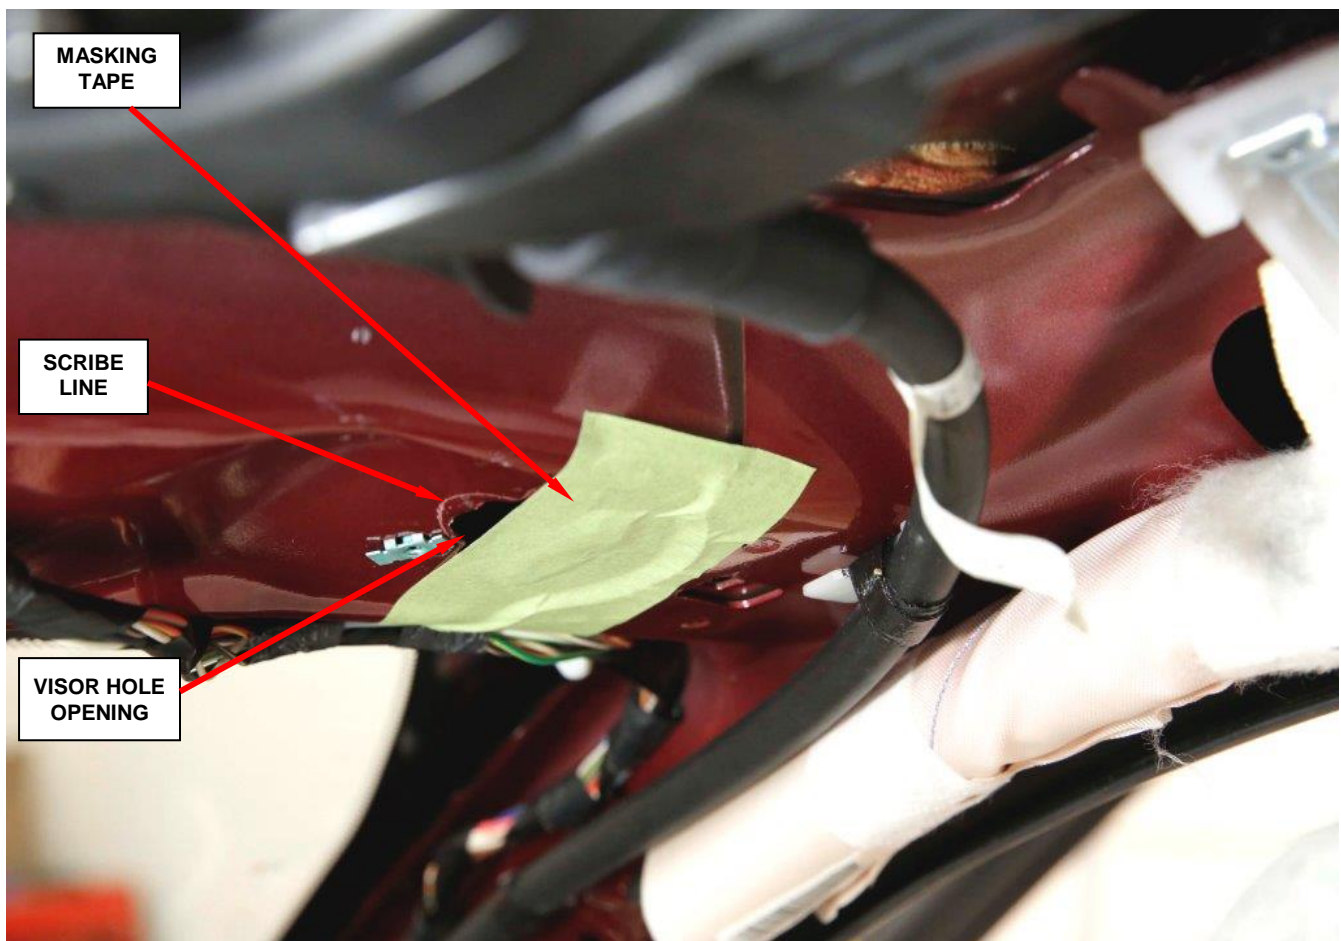
Figure 14 – Apply Masking Tape to Cover Majority of the Visor Hole Opening (right side shown)

NOTE: Covering the visor hole opening with masking tape will greatly decrease the potential for metal shaving being thrown about the interior of the vehicle during the grinding process.

35. Apply masking tape (or equivalent) over the right and left visor hole opening in the sheet metal panel as shown in Figure 14.

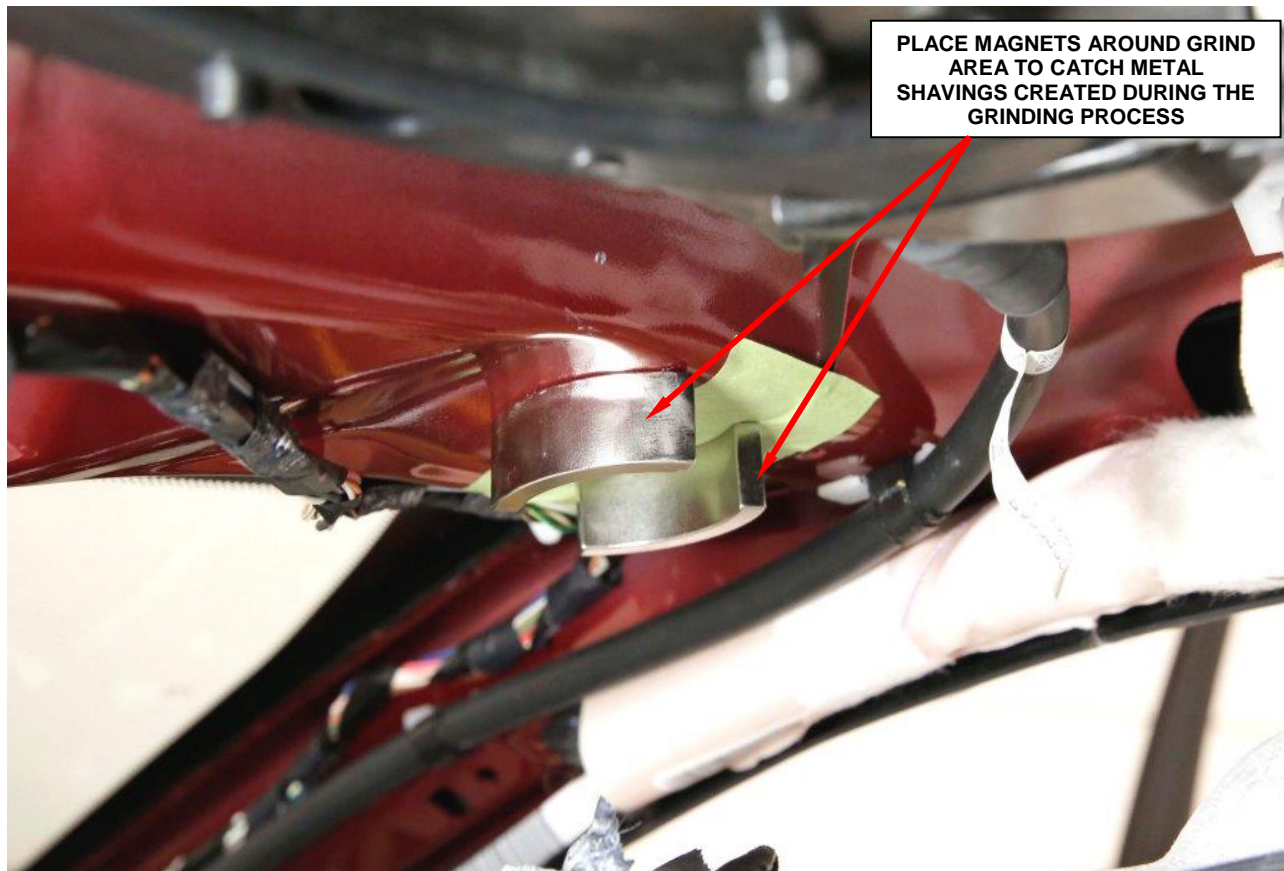
CAUTION: Failure to use magnets to catch the metal shavings will allow the shavings to fall throughout the interior of the vehicle and on the top of the headliner.

36. Place a fender cover or equivalent over the defroster vents on the instrument panel to prevent any metal shavings from entering the defroster vents.
37. Install the two supplied magnets around the left visor hole to catch any metal shavings created from the grinding process (Figure 15).

**Figure 15 – Install Magnets to Catch Metal Shavings
(right side shown)**
