NUMBER: 08-003-14 REV. A

Integrated Center Stack Missing Buttons

This bulletin involves replacing the integrated center stack (ICS) bezel.

2014 (WK) Jeep Grand Cherokee

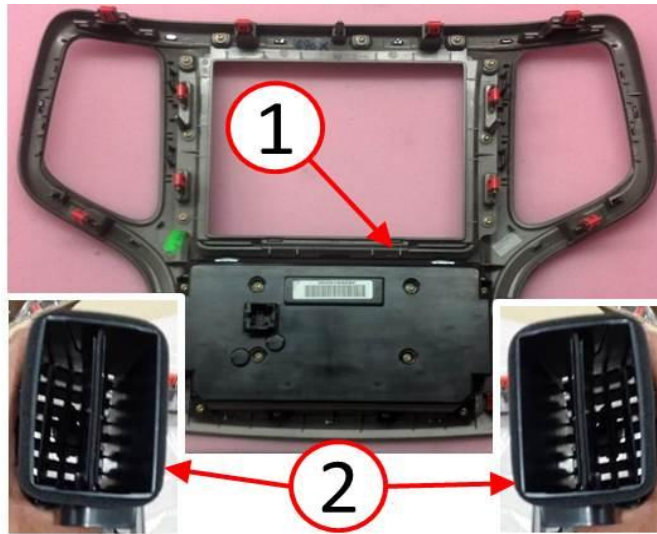
Fig. 2 New ICS Components

- 1 - ICS Bezel
- 2 - HVAC outlets

-
2. Unpack the NEW ICS bezel (1) and HVAC outlets (2). Place ICS bezel face down on a clean padded surface. Determine the proper location of the HVAC outlets. HVAC outlets are labeled LH and RH (Fig. 2).

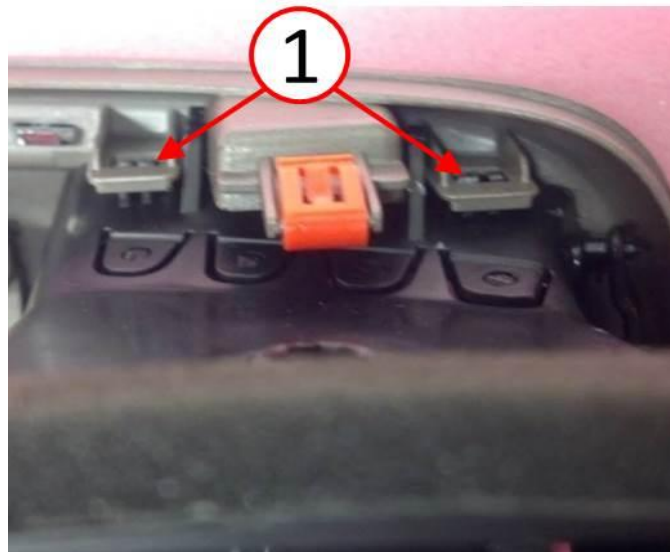
Fig. 3 HVAC Outlet Upper Attachment

- 1 - Attachment Features
-

-
3. Install one HVAC outlet at a time. Rotate the top ribs of HVAC outlet into the upper attachment features of ICS Bezel (Fig. 3).

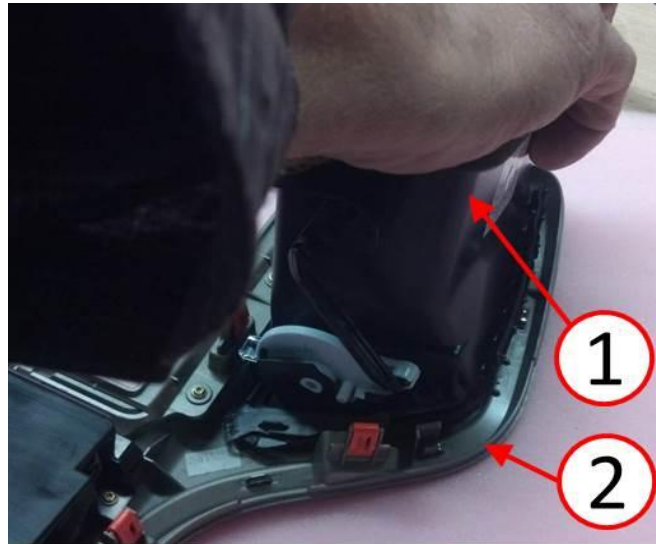
Fig. 4 HVAC Outlet Lower Attachment

- 1 - HVAC outlet
- 2 - ICS Bezel

4. Apply equal pressure with palm of hand to the bottom portion of the HVAC outlet (1) to engage the remaining HVAC outlet to ICS bezel (2) attachment features (Fig. 4).

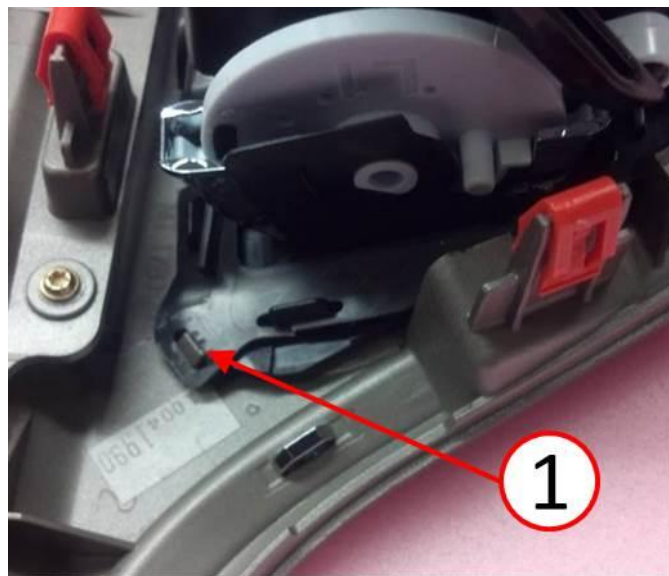
Fig. 5 HVAC Outlet Lower Inner Corner Attachment

- 1 - Attachment Feature
-

-
5. Ensure the lower inner corner of the HVAC outlet is properly attached (Fig. 5).

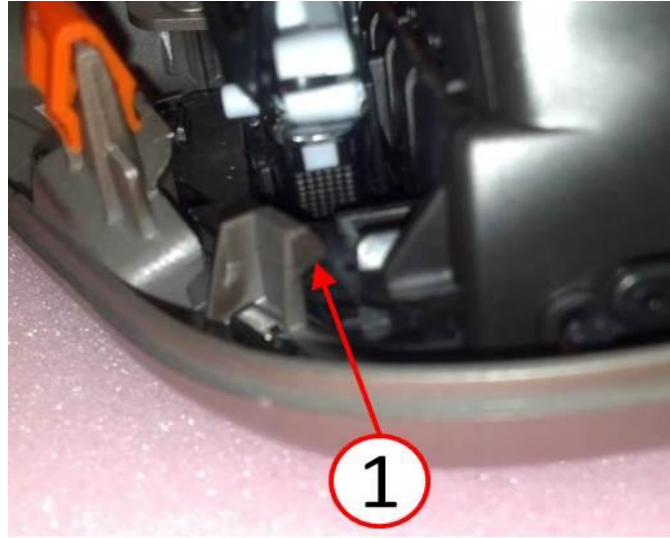
Fig. 6 HVAC Outlet Lower Outer Corner Attachment

1 - Attachment Feature

6. Ensure the lower outer corner of the HVAC outlet is properly attached ([Fig. 6](#)).

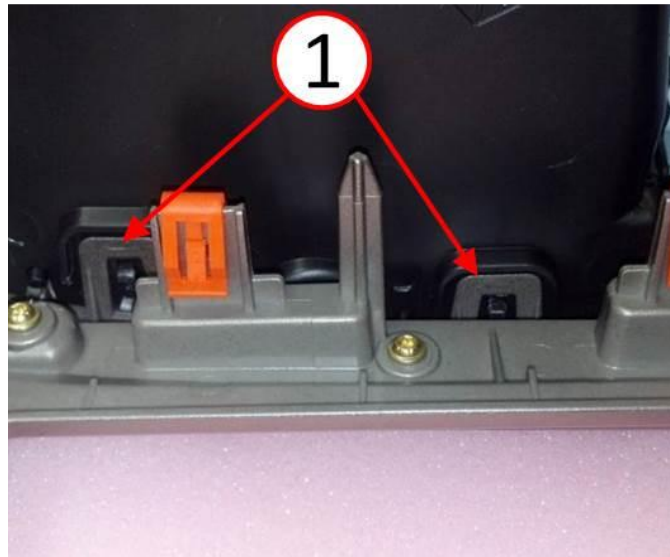
Fig. 7 HVAC Outlet Inner Side Edge Attachment

1 - Attachment Features

7. Ensure the inner side edge of the HVAC outlet is properly attached ([Fig. 7](#)).

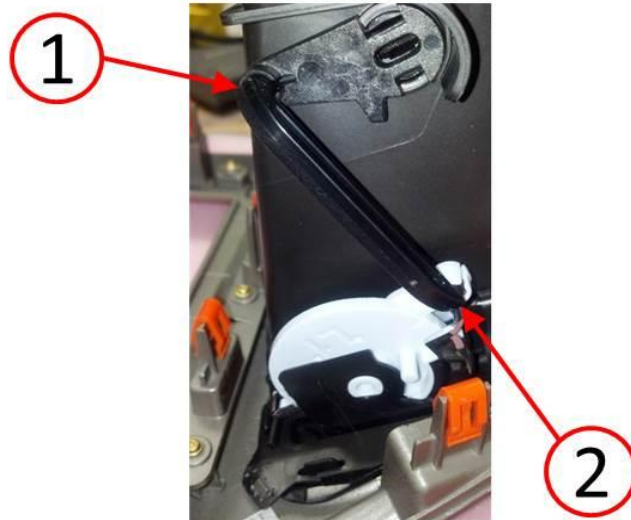
Fig. 8 HVAC Outlet Linkage Attachment

- 1 - Damper Door Lever
- 2 - Control-Wheel

8. Ensure that the linkage arm is attached to the damper door lever (1) and the control-wheel (2) ([Fig. 8](#)).

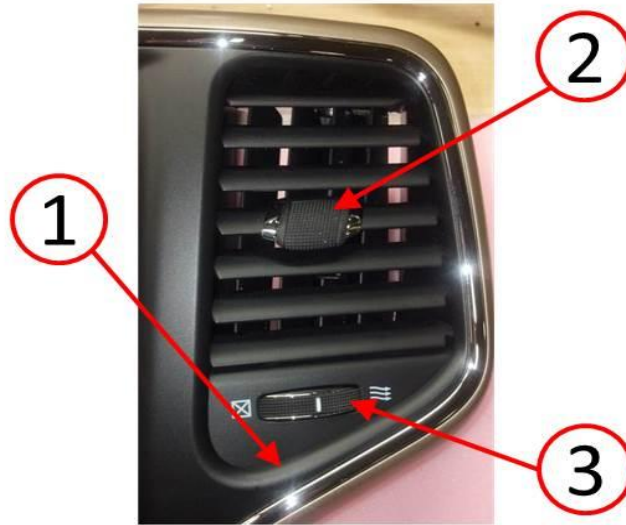
Fig. 9 HVAC Outlet Installation And Function

- 1 - HVAC Outlet Mating Surface
- 2 - Center-Knob
- 3 - Control-Wheel

-
9. Ensure there are no gaps between the ICS bezel and the HVAC outlet perimeter mating surface (1) (Fig. 9).
 10. Using the center-knob (2), cycle the air vanes up, down, and side to side to ensure they move freely (Fig. 9).
 11. Cycle the control-wheel (3) side to side while inspecting the damper door is functioning properly in open and closed positions (Fig. 9).

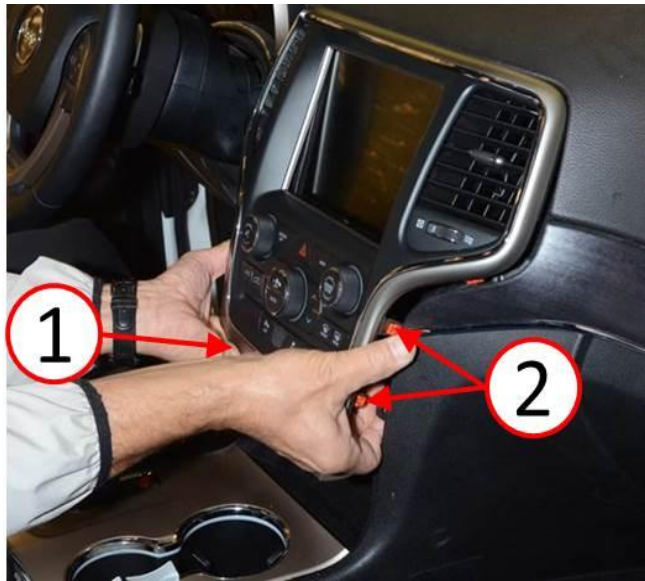
Fig. 10 ICS Bezel Removal Lower

- 1 - ICS Bezel
- 2 - HVAC Outlets

-
- 12. Repeat steps 3 through 11 for opposite side HVAC outlet installation to ICS bezel.
 - 13. Open console bin door and grasp bottom edge of ICS bezel (1) (Fig. 10).
 - 14. Pull firmly rearward to disengage the lower attachment clips (2) (Fig. 10).

NOTE: Do not use a trim stick to remove the center stack as damage to instrument panel surface is possible.

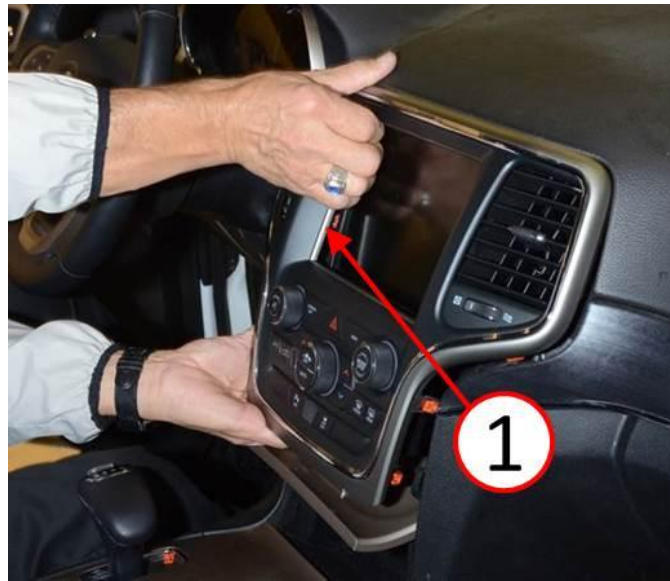
Fig. 11 ICS Bezel Removal Upper

1 - ICS Bezel

15. Continue working around the ICS Bezel to disengage the remaining attachment clips on the right side and left side grasping inside the display screen opening ([Fig. 11](#)).

NOTE: Verify that no damage has been done to wood appliques.

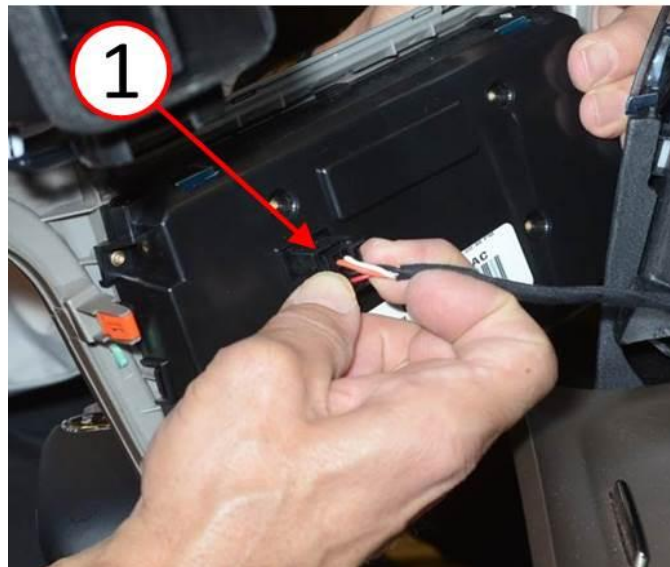
Fig. 12 ICS Electrical Connector

1 - Electrical Connector

- 16. Disconnect the electrical connector from the ICS ([Fig. 12](#)).
- 17. Connect the electrical connector to the NEW ICS ([Fig. 12](#)).

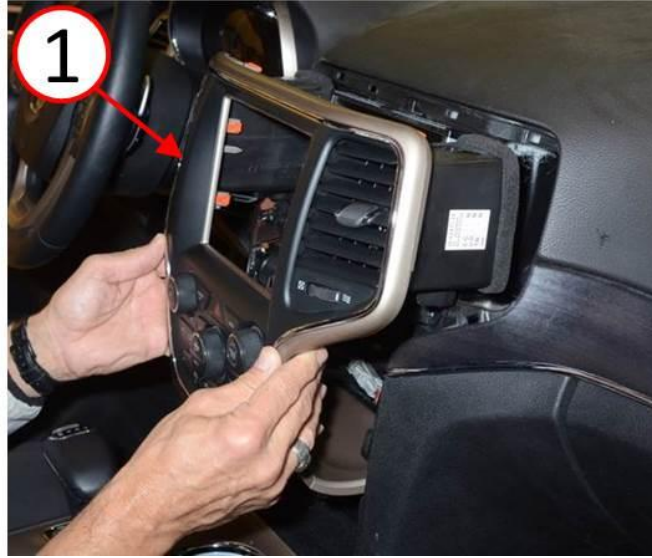
Fig. 13 ICS Bezel Installation

1 - ICS Bezel

- 18. Gently wiggle the ICS bezel into place ensuring the HVAC outlets properly engage the HVAC ducts ([Fig. 13](#)).
