NUMBER: 08-054-17

GROUP: 08 - Electrical

SUBJECT:

RG4 Radio Enhancements

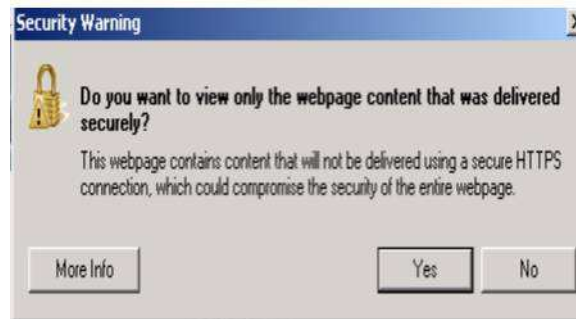
Fig. 1
Pop-up Security Message

1. Has the USB flash drive been created?
 - a. Yes >>> Proceed to [Step 5](#).
 - b. No >>> Proceed to [Step 2](#).
2. Go to DealerCONNECT>Service>Uconnect Command Center>Uconnect>More Information >Dealer software downloads to download the files.
3. If a security message appears “Do you want to view only the webpage content that was delivered securely?” see ([Fig. 1](#)) . Press **No** to continue.

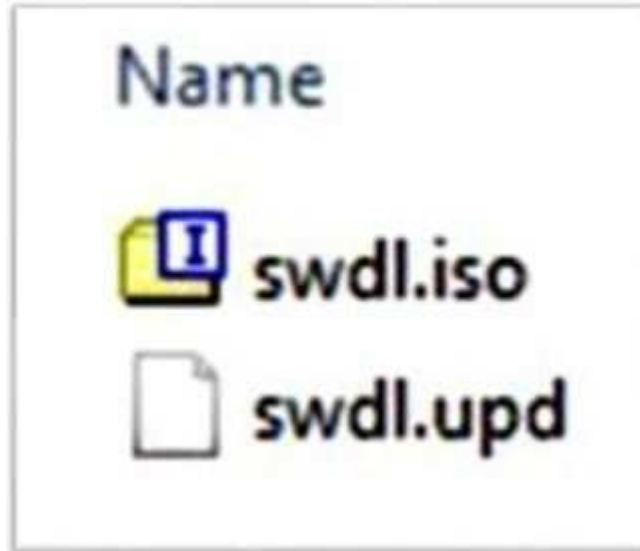
Fig. 2
Two USB Files

4. To download the software files to a USB flash drive, follow the on-screen instructions and perform the following.
 - a. Acquire a blank USB flash drive with at least 4GB of space.
 - b. Download the software update file to your local PC's desktop.
 - c. Be sure to extract the file before copying it to the blank USB flash drive.
 - d. A blank USB flash drive will be needed for each radio update, additional updates can not be on the same USB flash drive.
 - e. Once the file is saved to the USB flash drive, it is recommended you physically label the USB flash drive with the bulletin number and proper radio sales codes.

NOTE: Two files will be loaded onto the USB flash drive, see (Fig. 2) .
